South Perkasio Covered Bridge Inspection Report

SUBMITTED TO:
Borough Of Perkasio
149 W Walnut St,
Perkasio, PA 18944
(Phone Number TBD); (Email TBD)

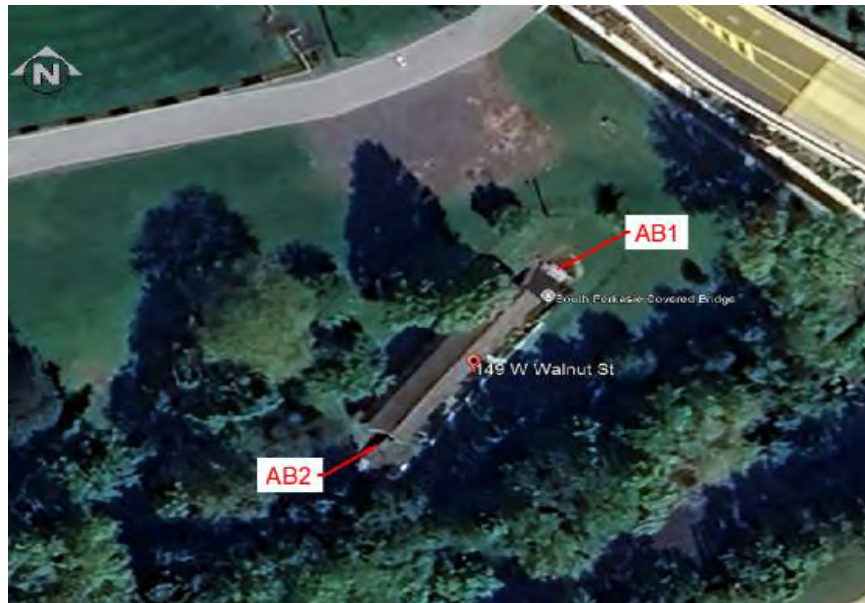
Figure 1-1: Site plan view of the South Perkasio Covered Bridge.

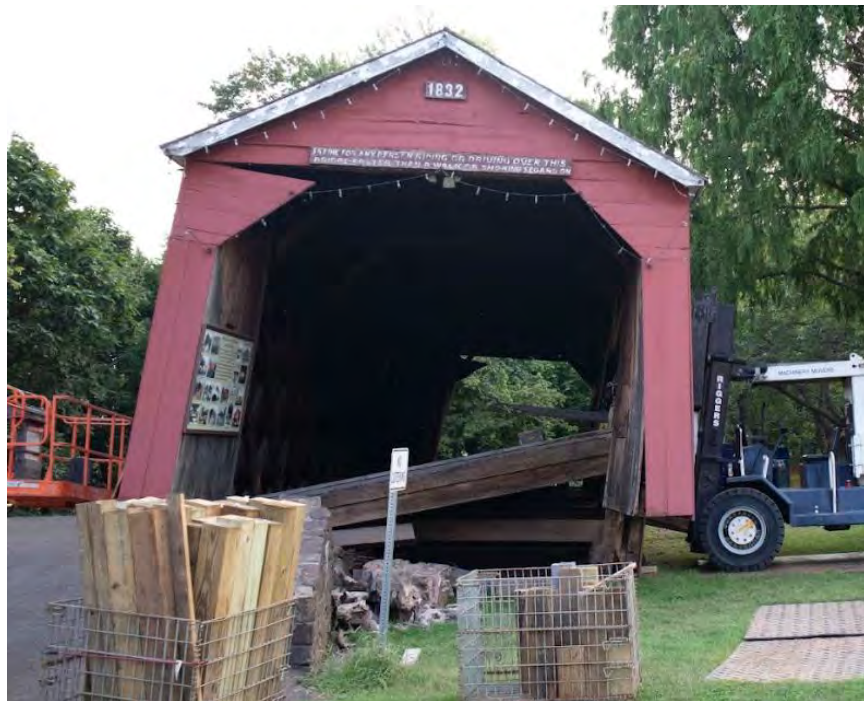
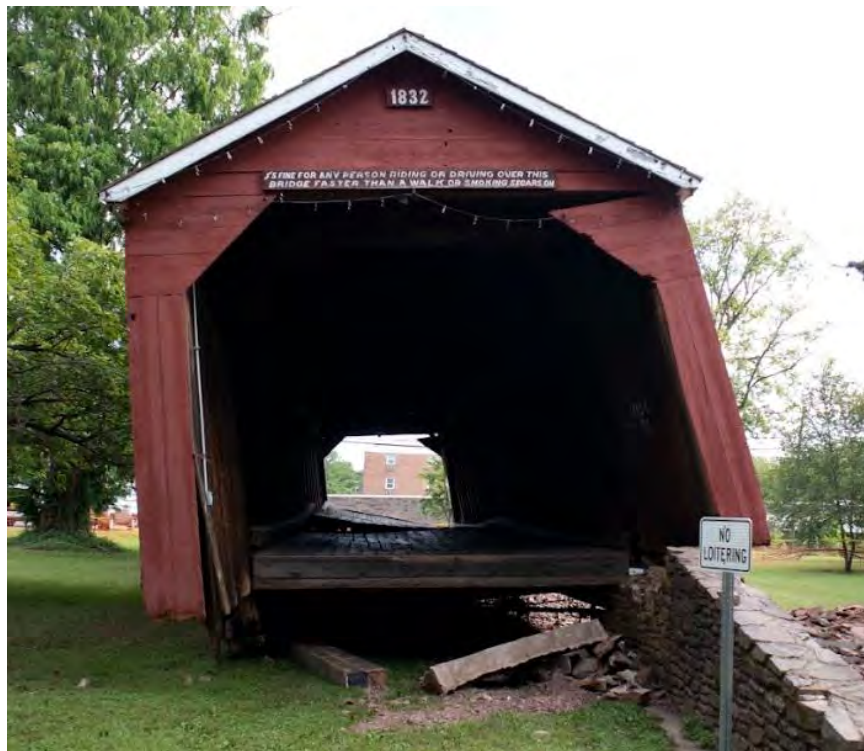
Figure 1-2: A view from Abutment 1 (top) and Abutment 2 (bottom) of the Bridge after the flood event.

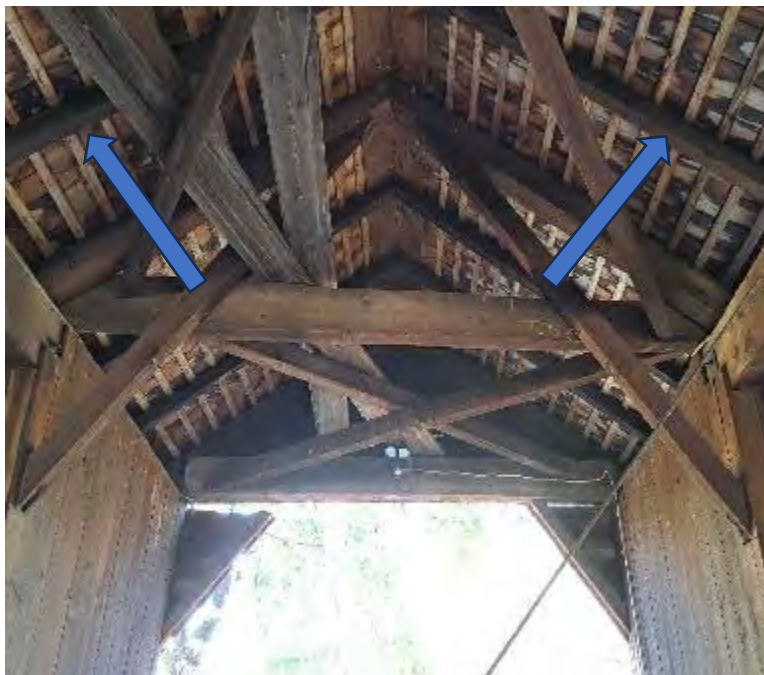
Figure 1-3: Roof rafters that were inaccessible for ladder use while doing the inspection.

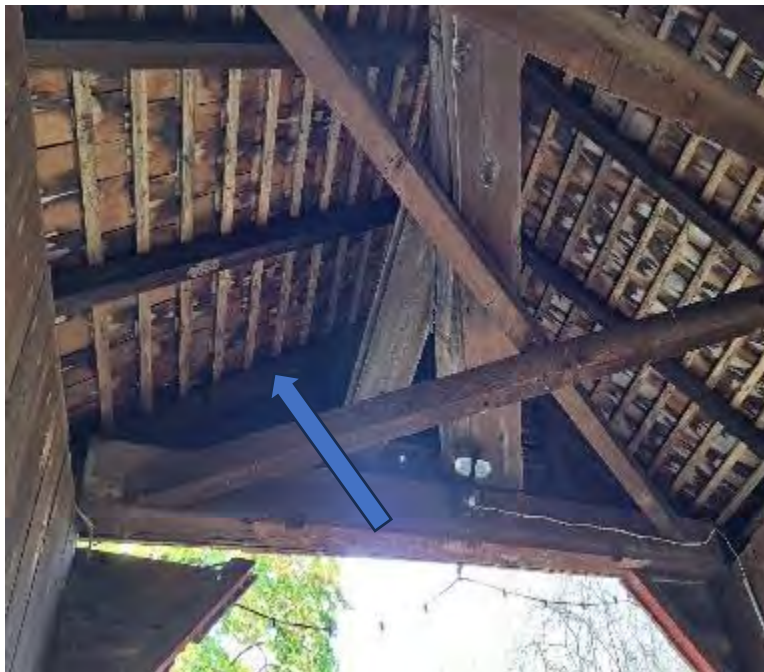
Figure 1-5: Abutment 2 Truss rafters, could not access the end near wing walls.

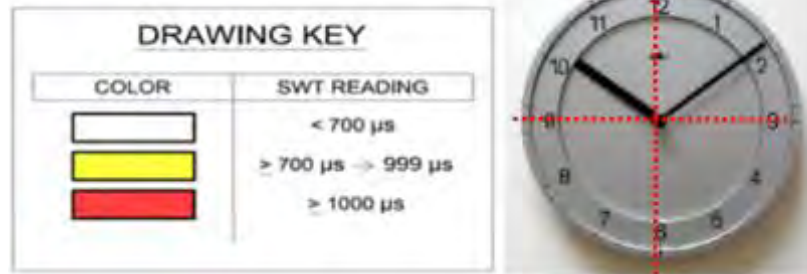
Figure 1-6: Stress wave time results key and configuration.

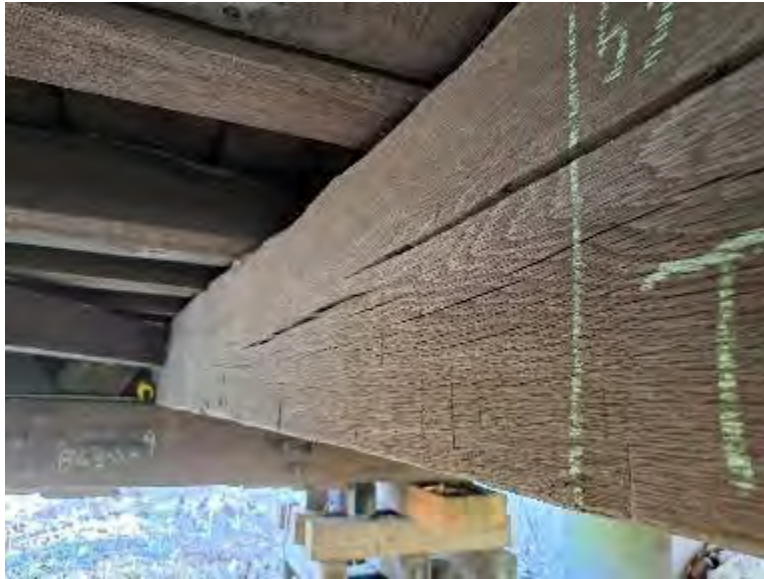
Figure 4-1: Example of moderate shrinkage checks in a transverse beam on the Bridge.

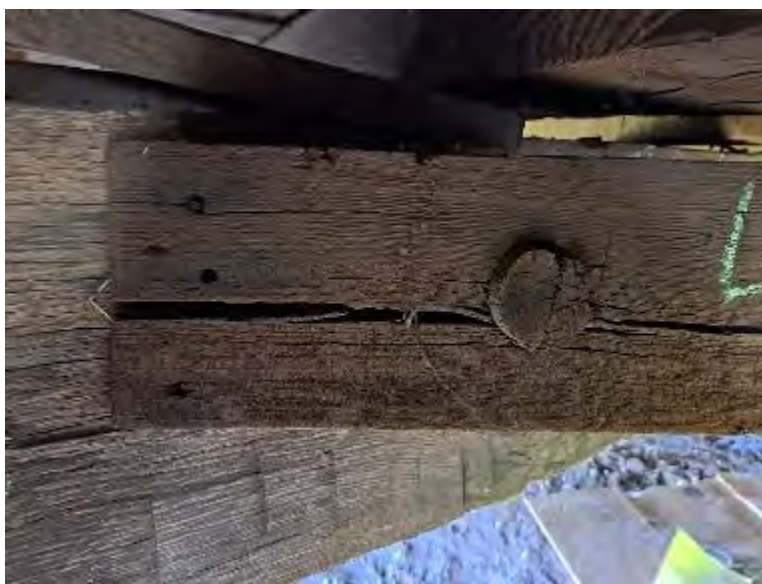
Figure 4-2: End splitting at a lower cross brace at the end connection.

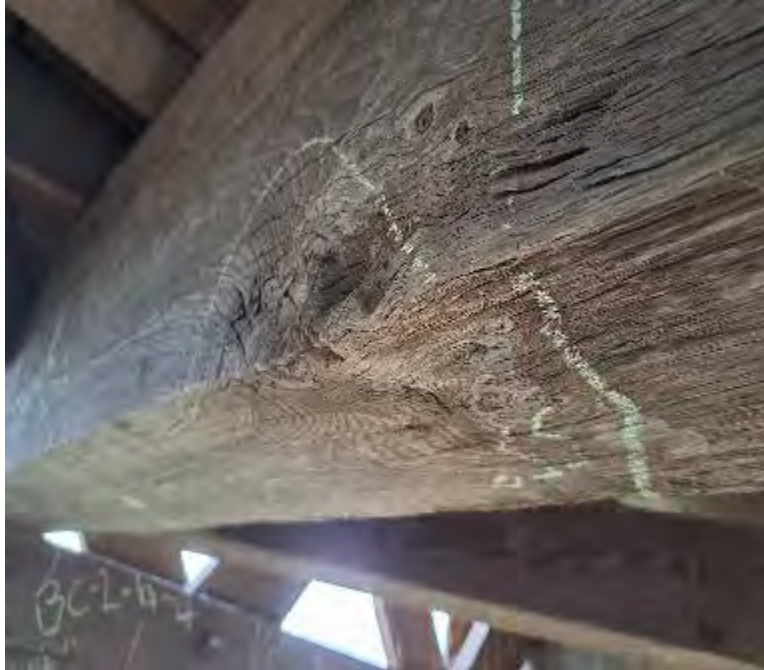
Figure 4-3: Knot on bottom face of a transverse beam

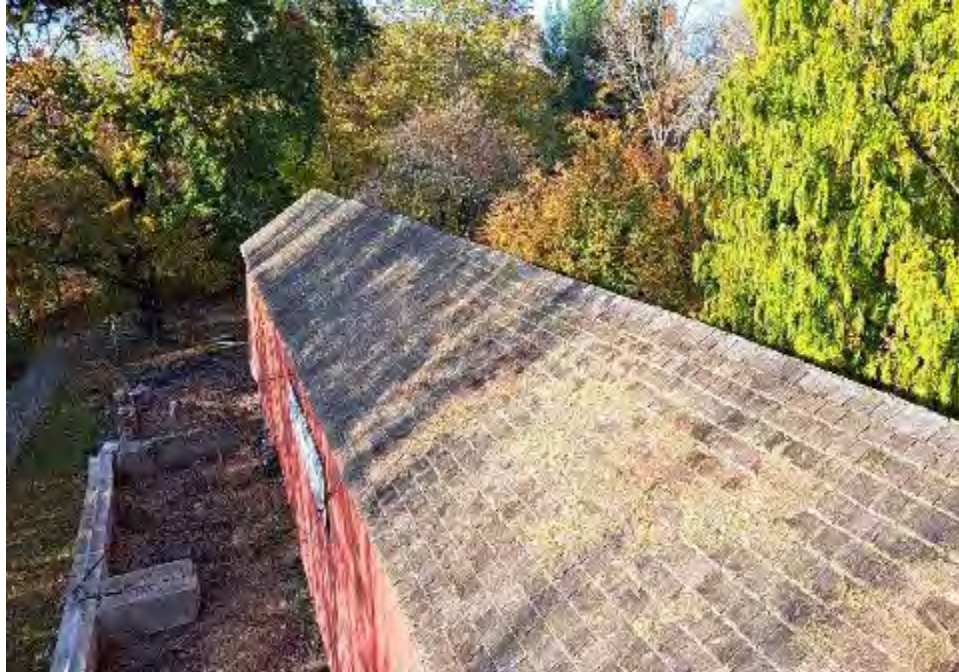
Figure 6-1: South side roof top of the Bridge with significant areas of fungal colonies present and shrinkage of the shakes.

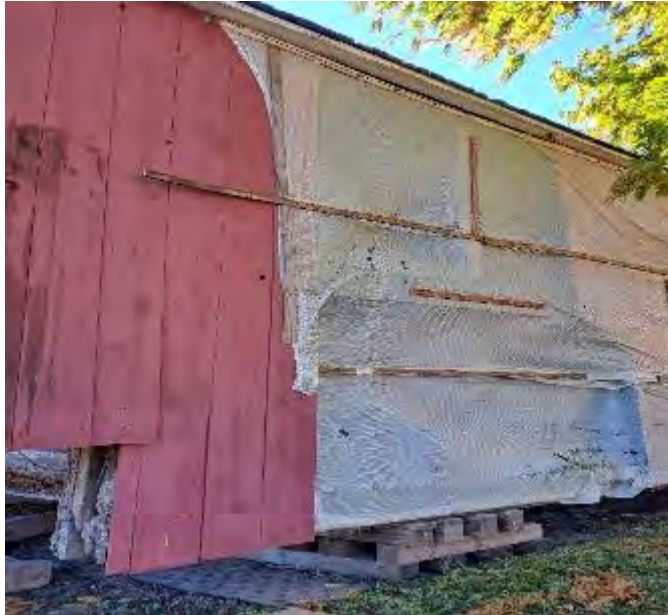
Figure 6-8: Siding on Northeast side showing missing boards in multiple locations behind the temporary plastic wrapping.

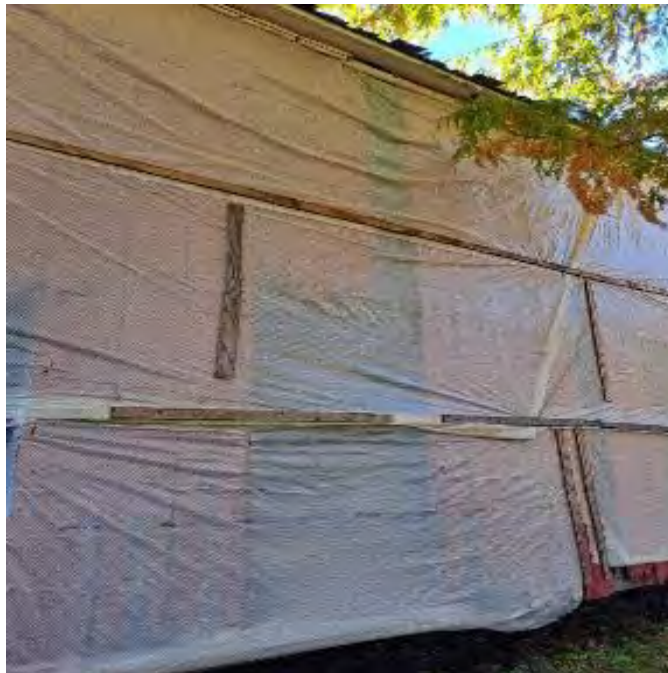
Figure 6-9: Siding on Northeast side showing missing boards in multiple locations behind the temporary plastic wrapping.

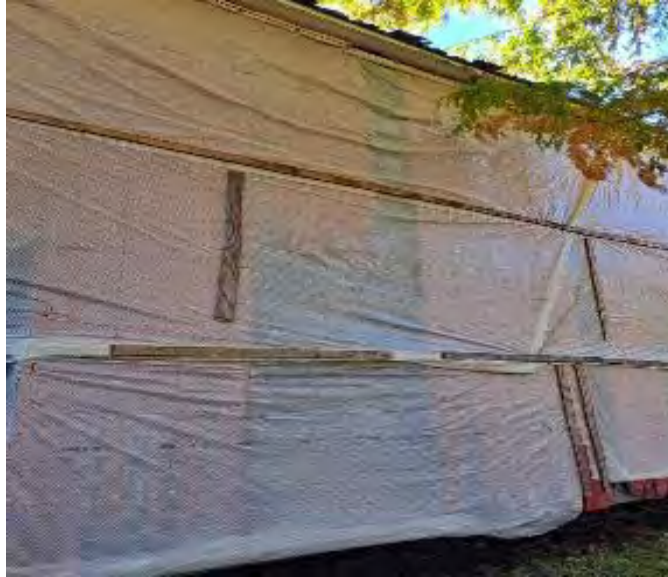
Figure 6-10: Siding on the North side showing missing boards in multiple locations behind the temporary plastic wrapping.

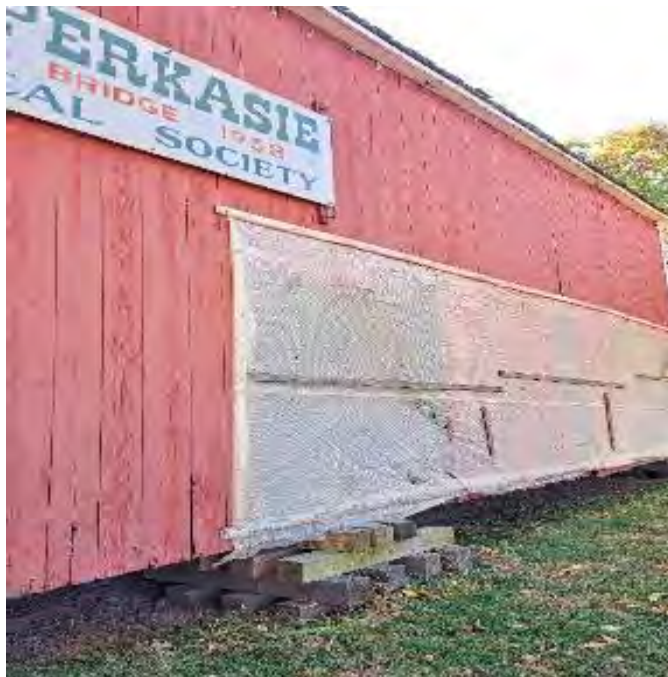
Figure 6-11: Siding on Northwest side showing missing boards in multiple locations behind the temporary plastic wrapping.

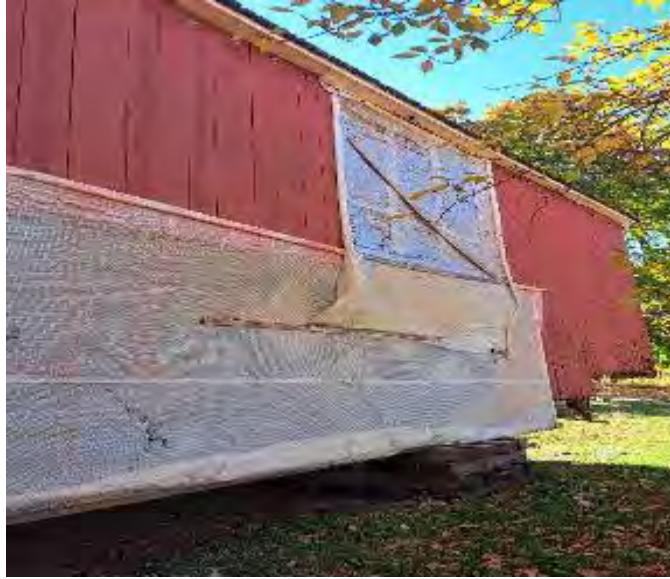
Figure 6-12: Siding on the Northwest side showing missing boards in multiple locations behind the temporary plastic wrapping.

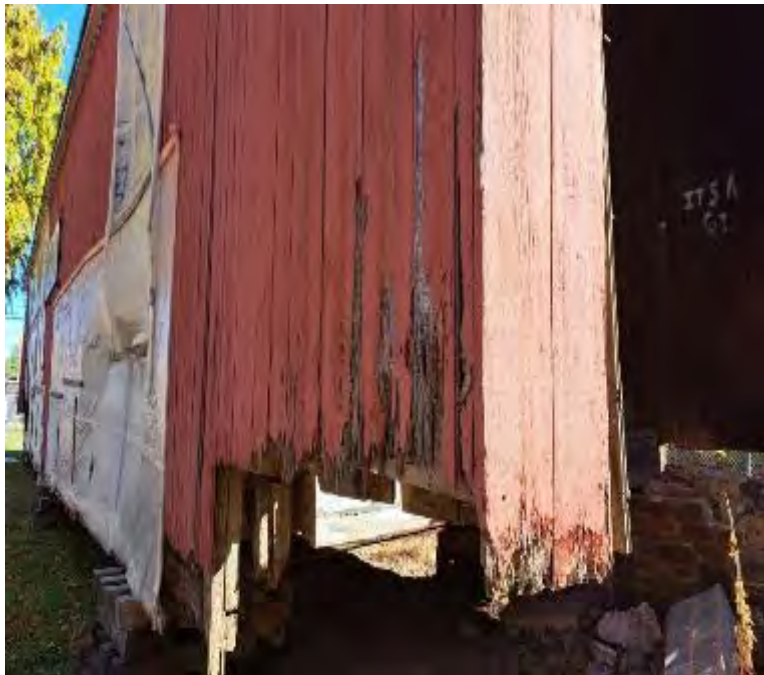
Figure 6-13: Siding on Northwest side end wing wall at Abutment 2 showing section loss and decay on bottom of boards.

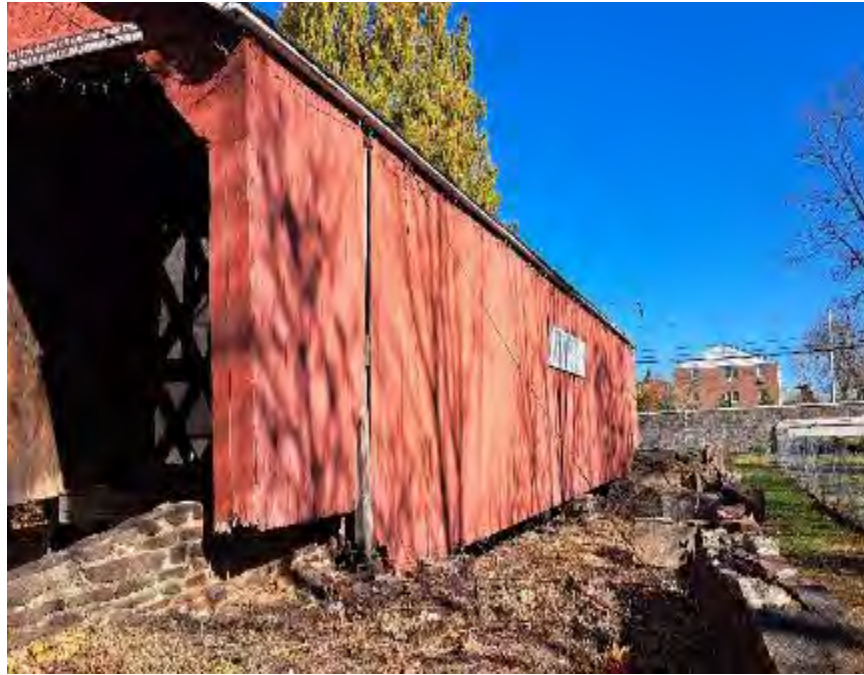
Figure 6-14: Siding on the South side.

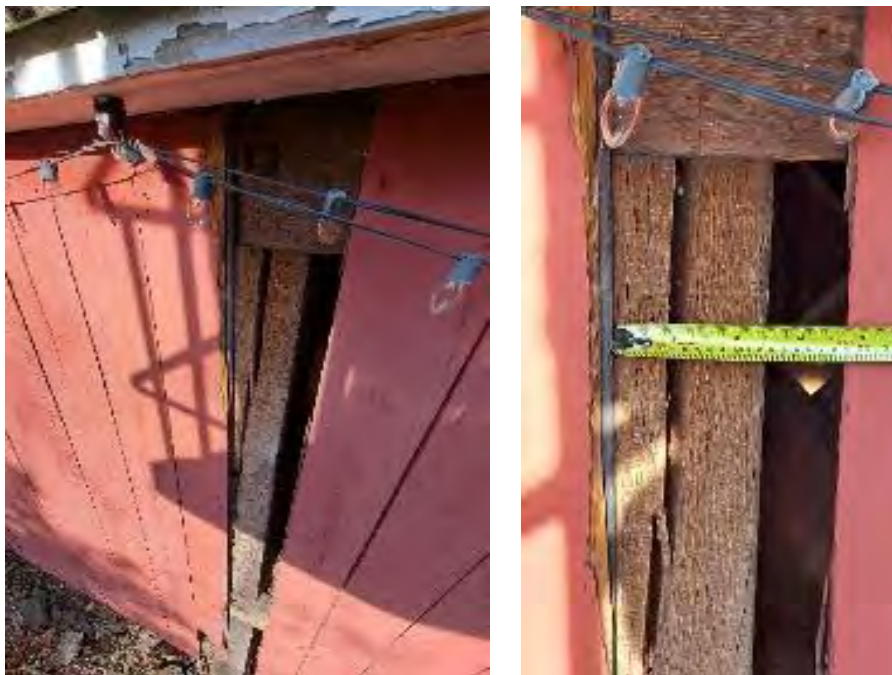
Figure 6-15: Missing boards at Post 8 at Abutment 2 on the South side.

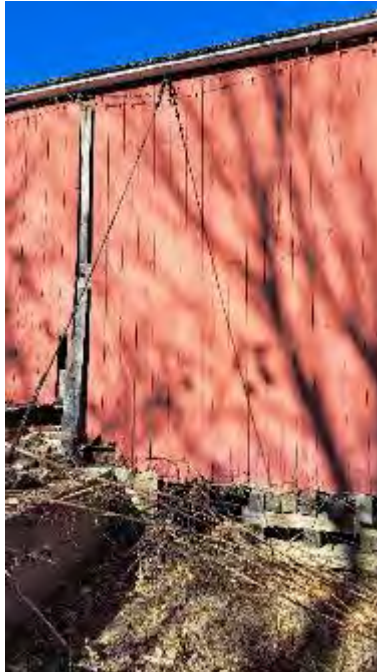
Figure 6-16: Missing boards at Post 8 at Abutment 2 on the South side.

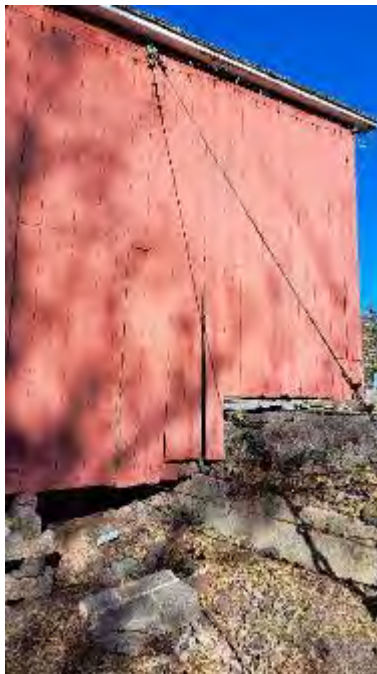
Figure 6-17: South side has some section loss and deterioration on the bottom of the wing wall siding at Abutment 1.

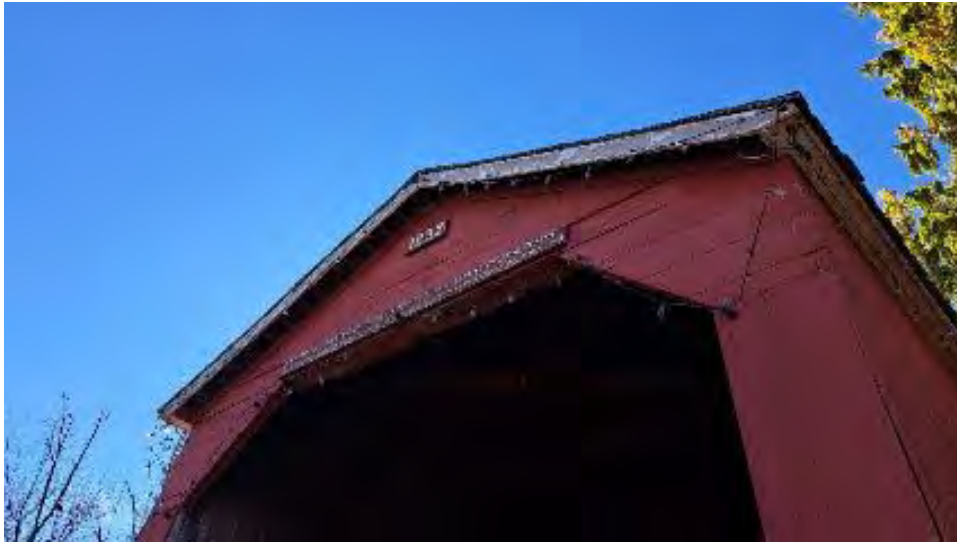
Figure 6-18: Abutment 1 front view of siding in fair condition.

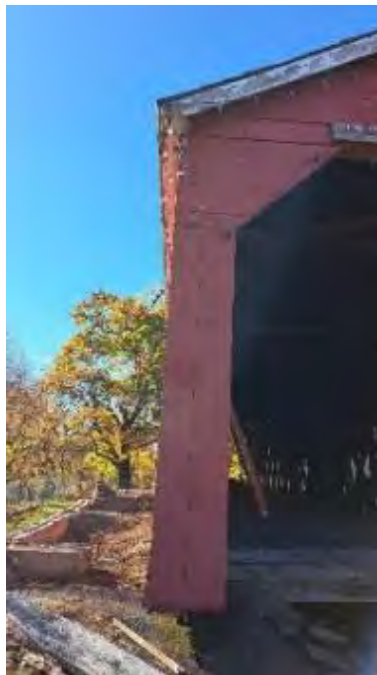
Figure 6-19: Abutment 1 South side front view of siding in fair condition.

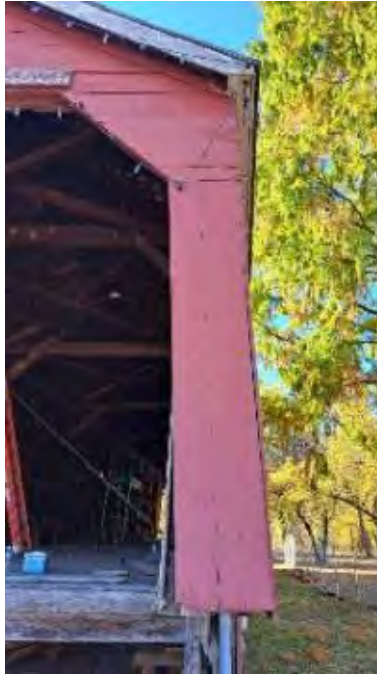
Figure 6-20: Abutment 1 North side front view of siding in fair condition.

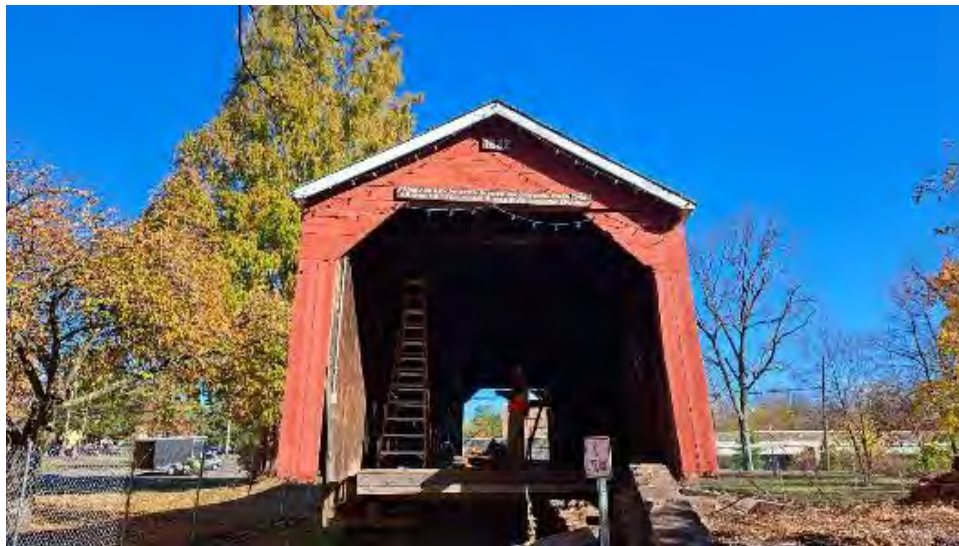
Figure 6-21: Abutment 2 front view of siding.

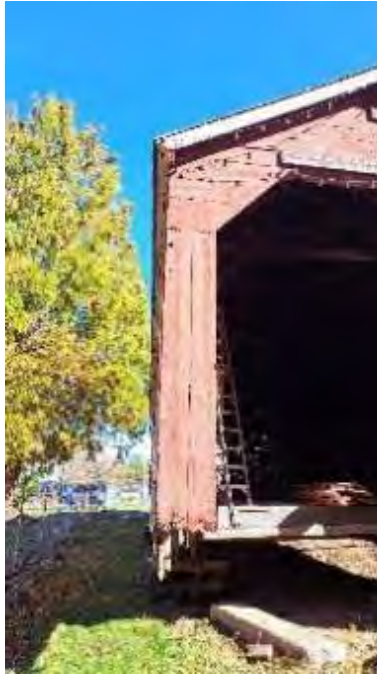
Figure 6-22: Abutment 2 North side front view of siding. Some decay/section loss on bottom.

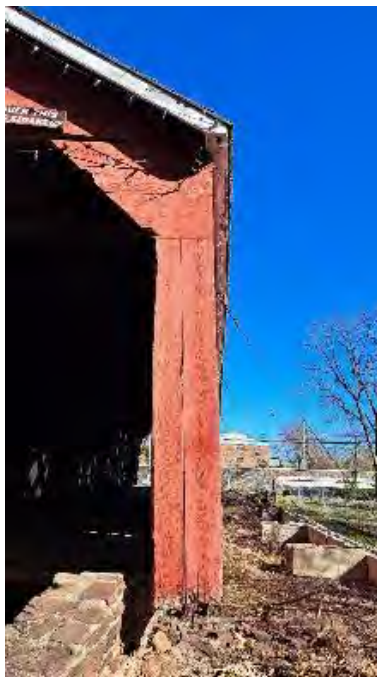
Figure 6-23: Abutment 2 South side front view of siding with some section loss and decay at the bottom.

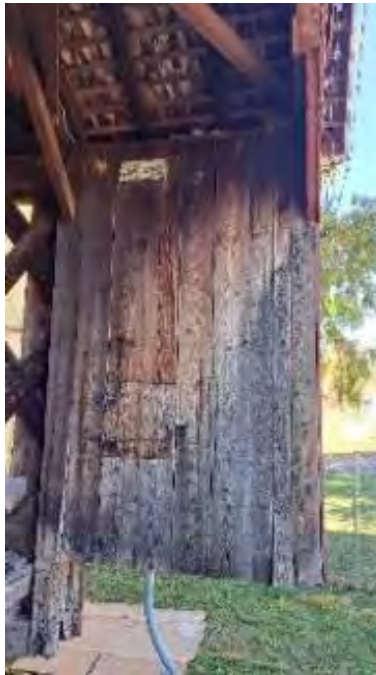
Figure 6-24: Abutment 1 North side wing wall view of internal siding.

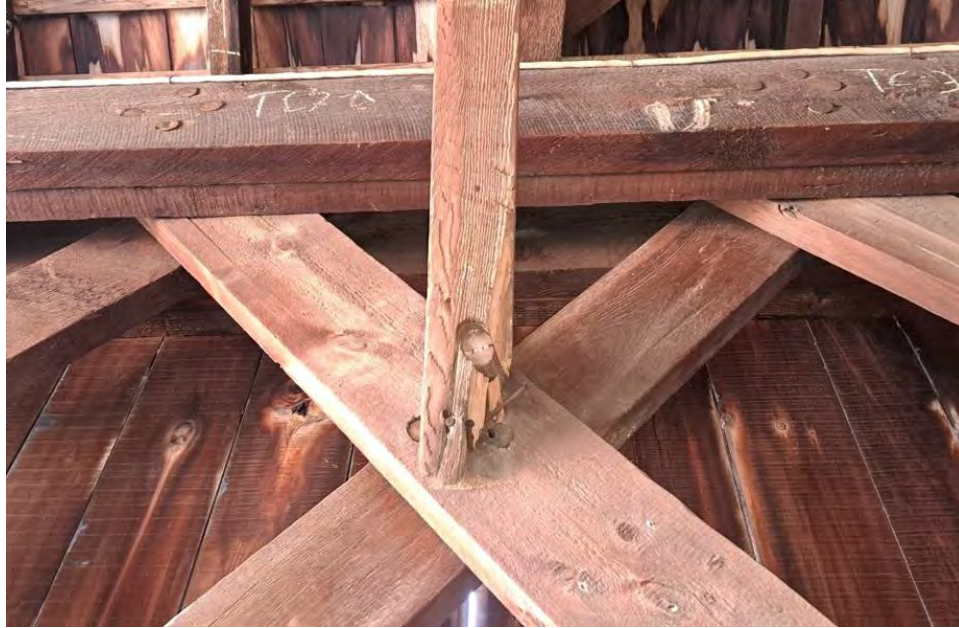
Figure 7-1: Broken / cleaved dowel connection at knee brace KN2-S.

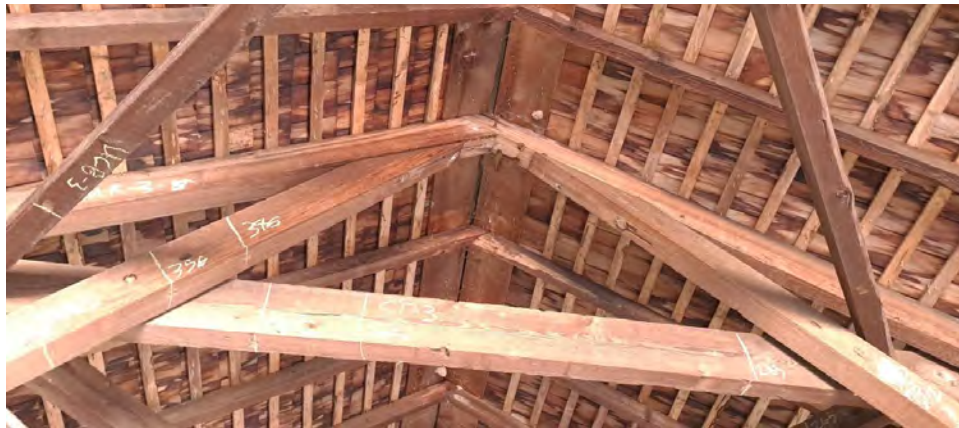
Figure 7-2: Knee braces KN3-N and KB3-S are out of alignment with CT3. KN3-S has separated from the main rafter R2N-3.

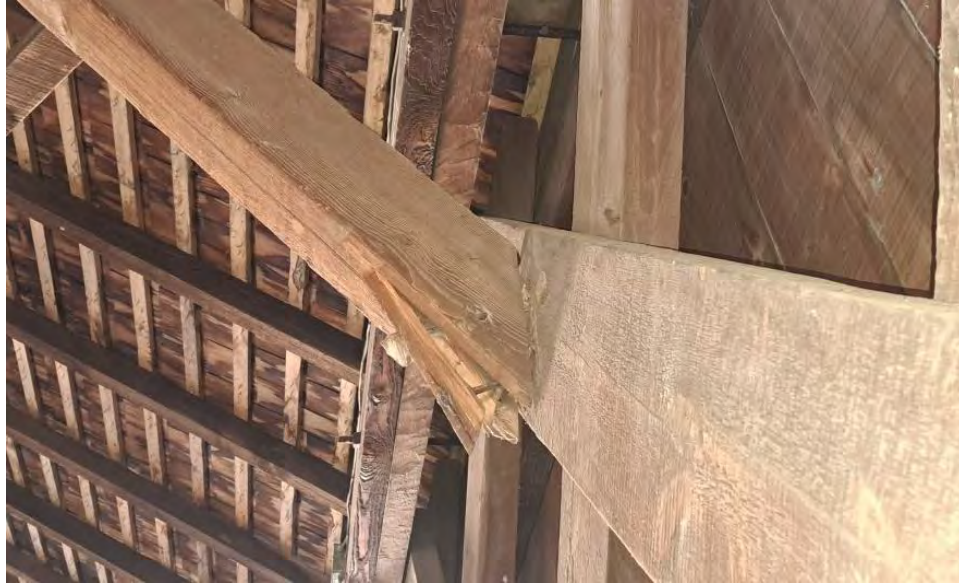
Figure 7-3: Cleaved and broken lower end of knee brace KN4-S.

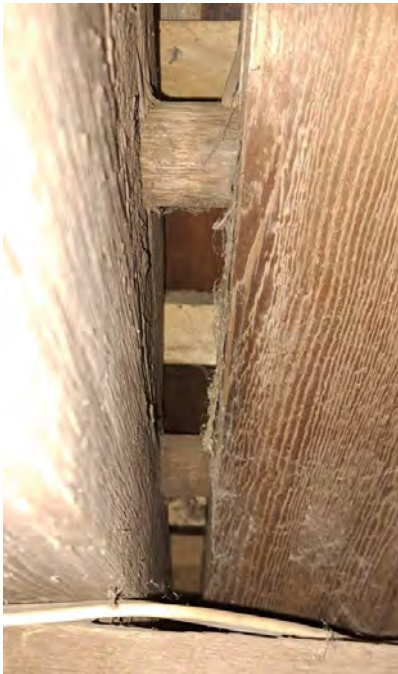
Figure 7-4: Separation of CT4 from the main rafter on the south side.

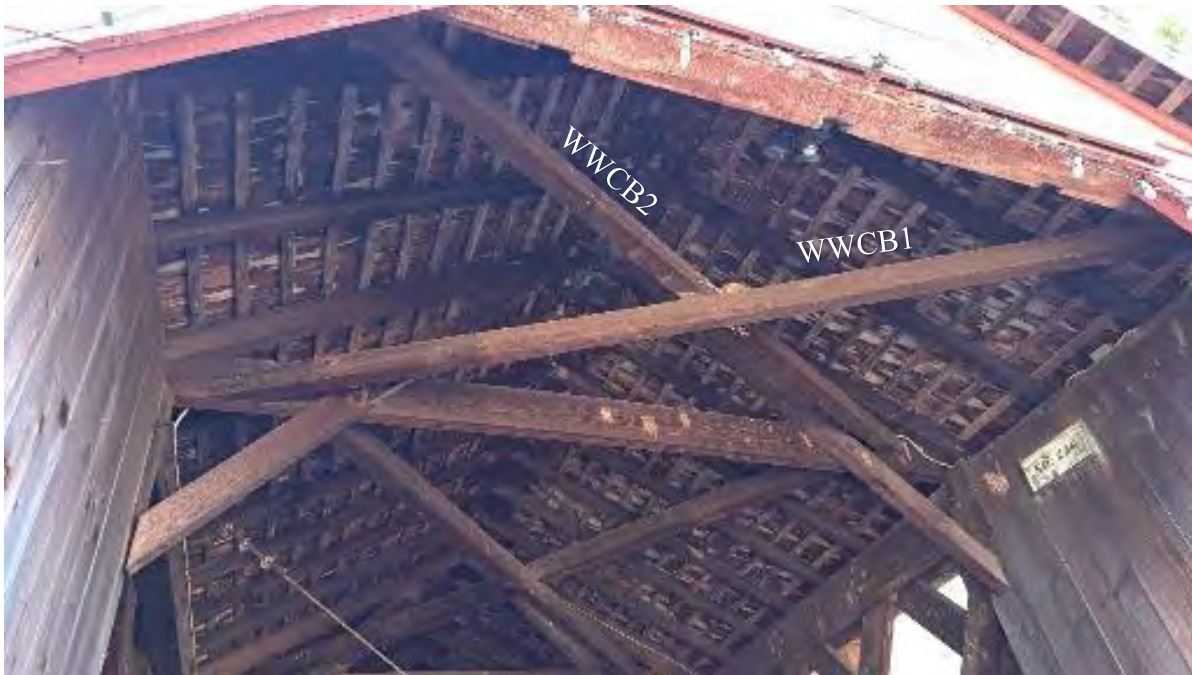
Figure 7-7: Wing wall upper cross braces WWCB1 and WWCB2 are in fair condition.

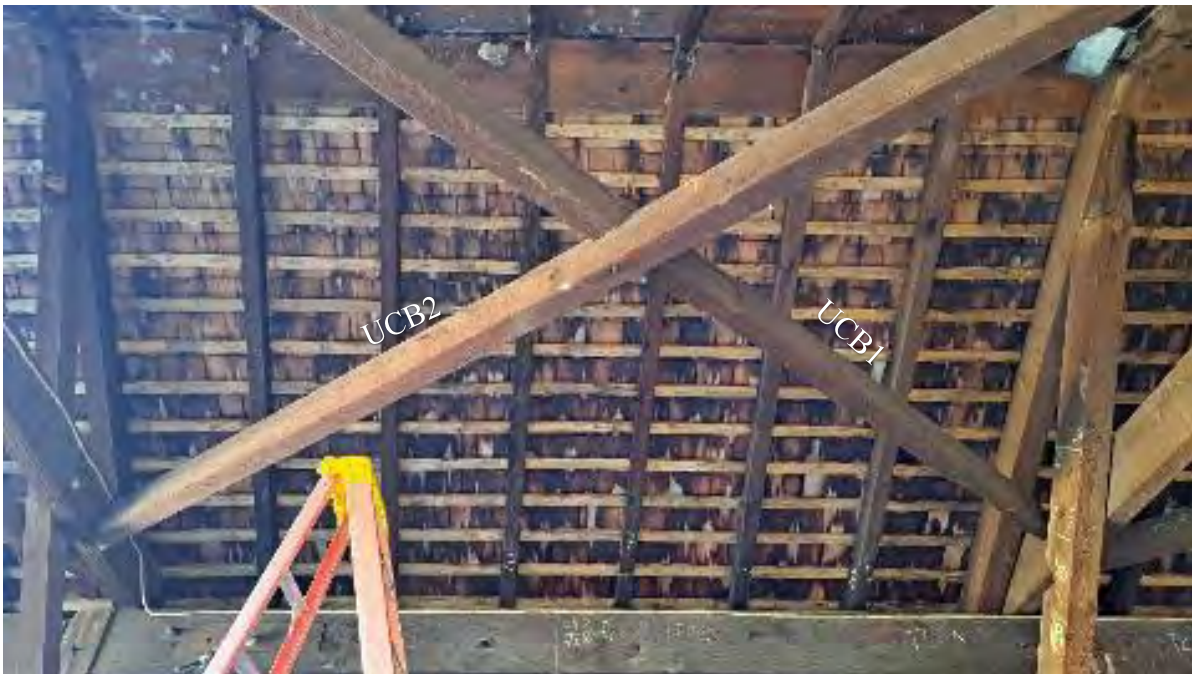
Figure 7-8: Upper cross braces UCB1 and UCB2 are in fair condition.

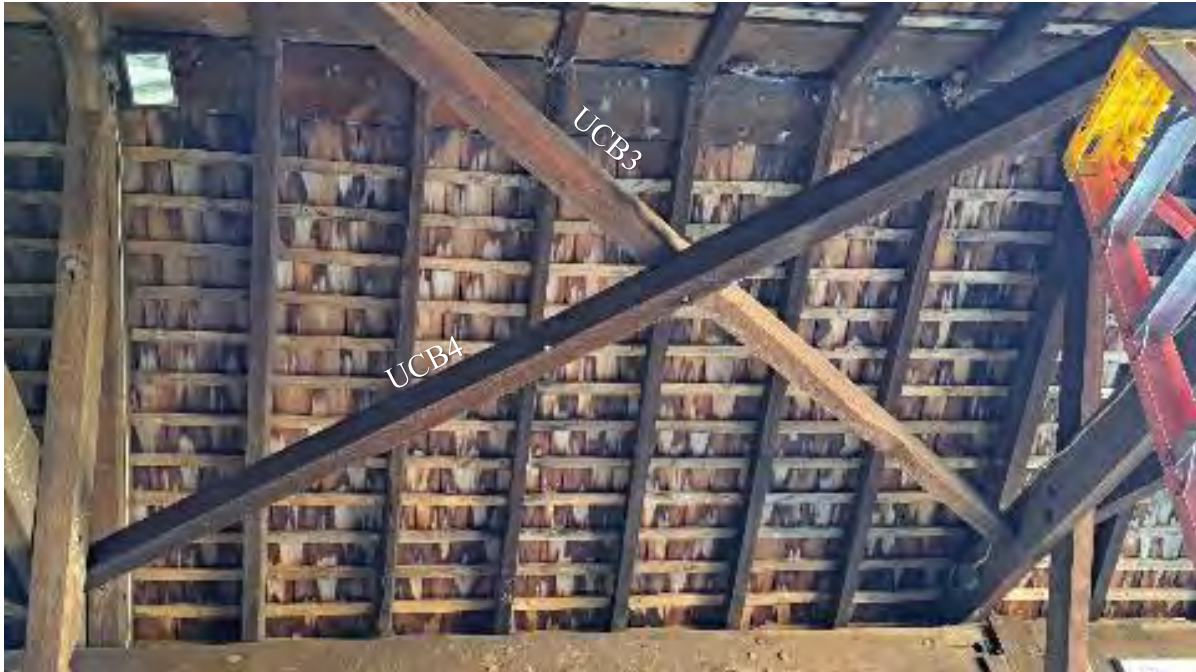
Figure 7-9: UCB3 / UCB4 in fair condition.

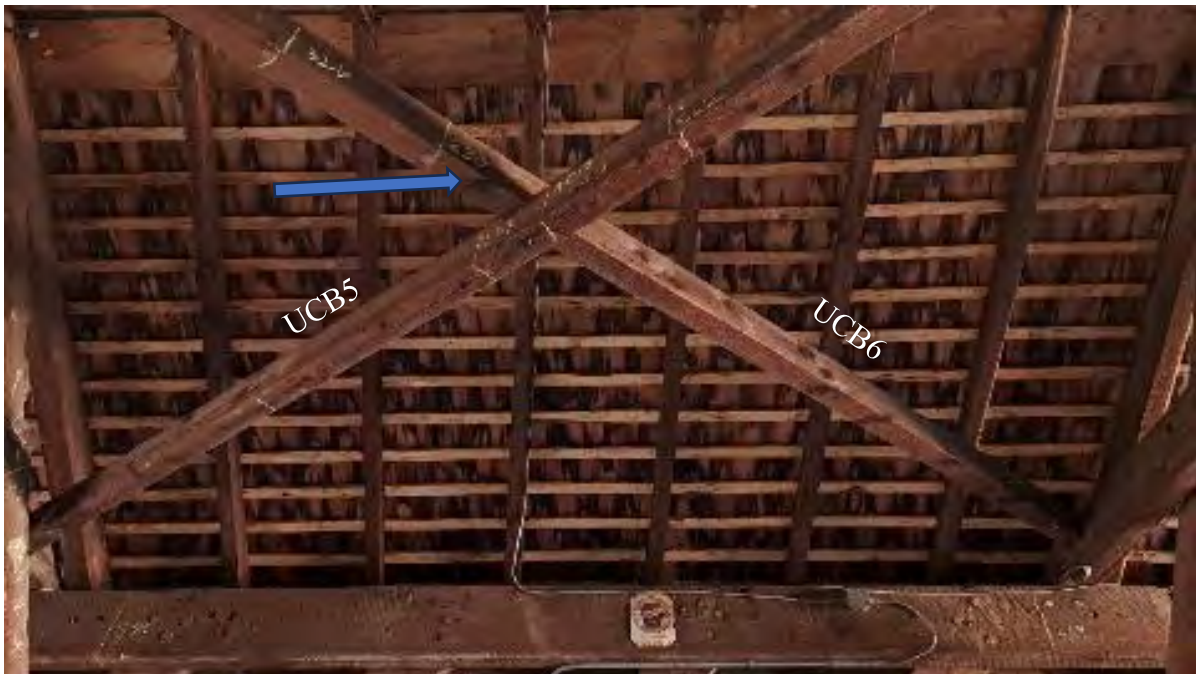
Figure 7-10: Upper cross braces UCB5 and UCB6 with a split 2-inches from middle of UCB6.

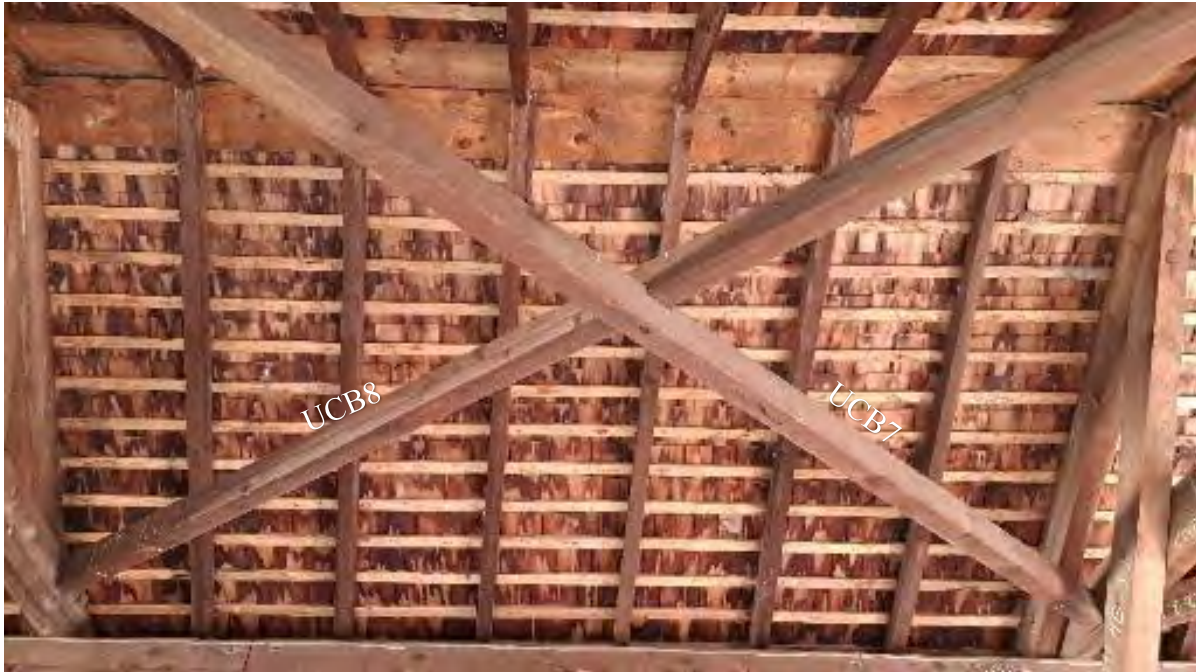
Figure 7-11: Upper cross braces UCB7 and UCB8 are in fair condition.

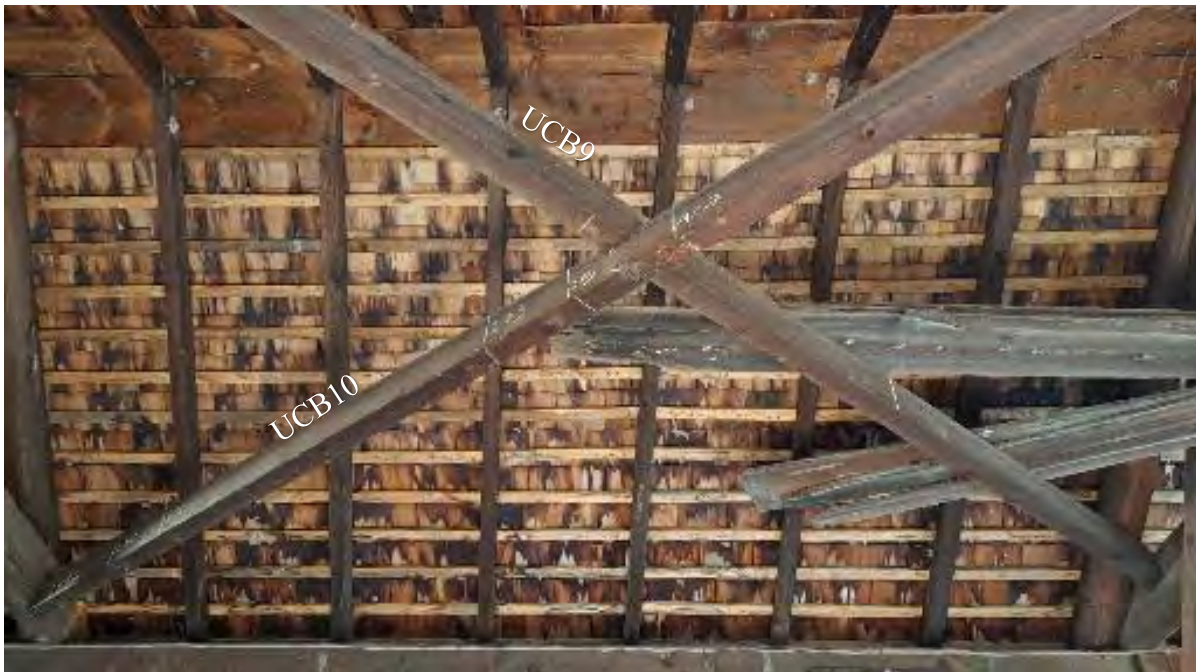
Figure 7-12: Upper cross braces UCB9 and UCB10. UCB9 is in fair condition.

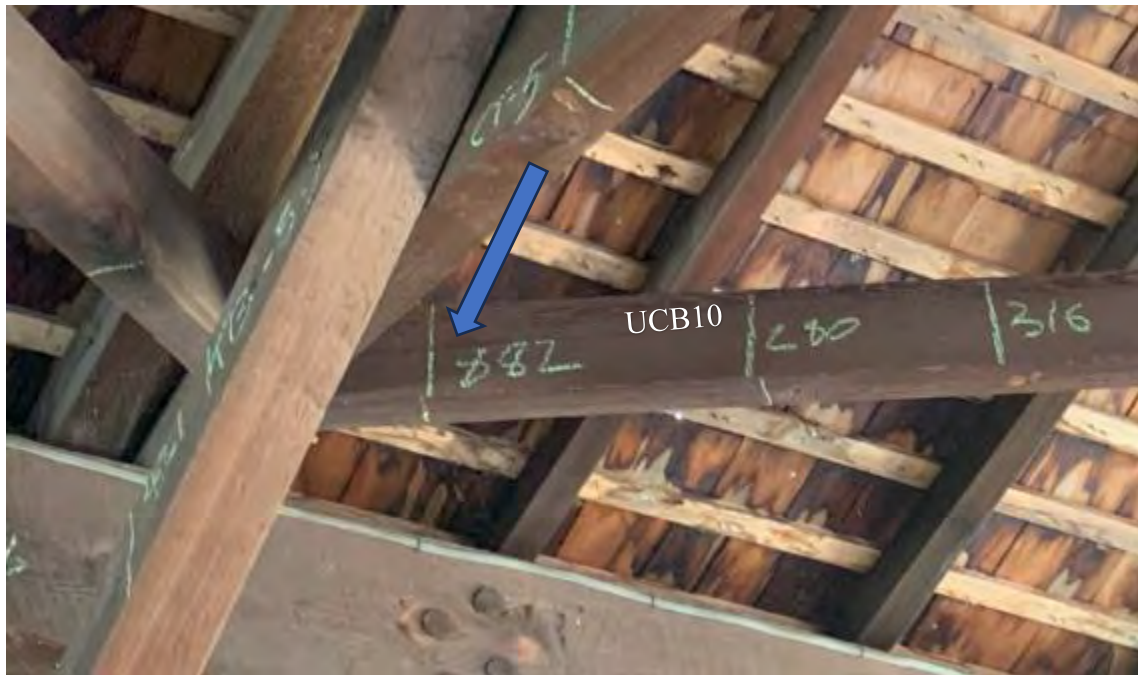
Figure 7-13: Upper cross brace UCB10 has a split 6-inches from CT-5 on the South side.

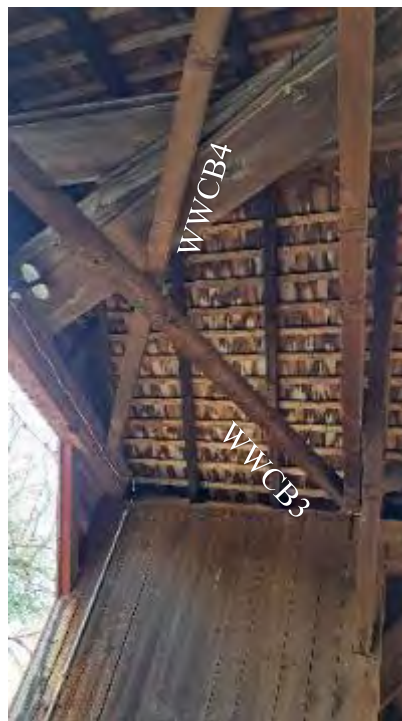
Figure 7-14: Wing wall upper cross braces WWCB3 and WWCB4 are in fair condition.

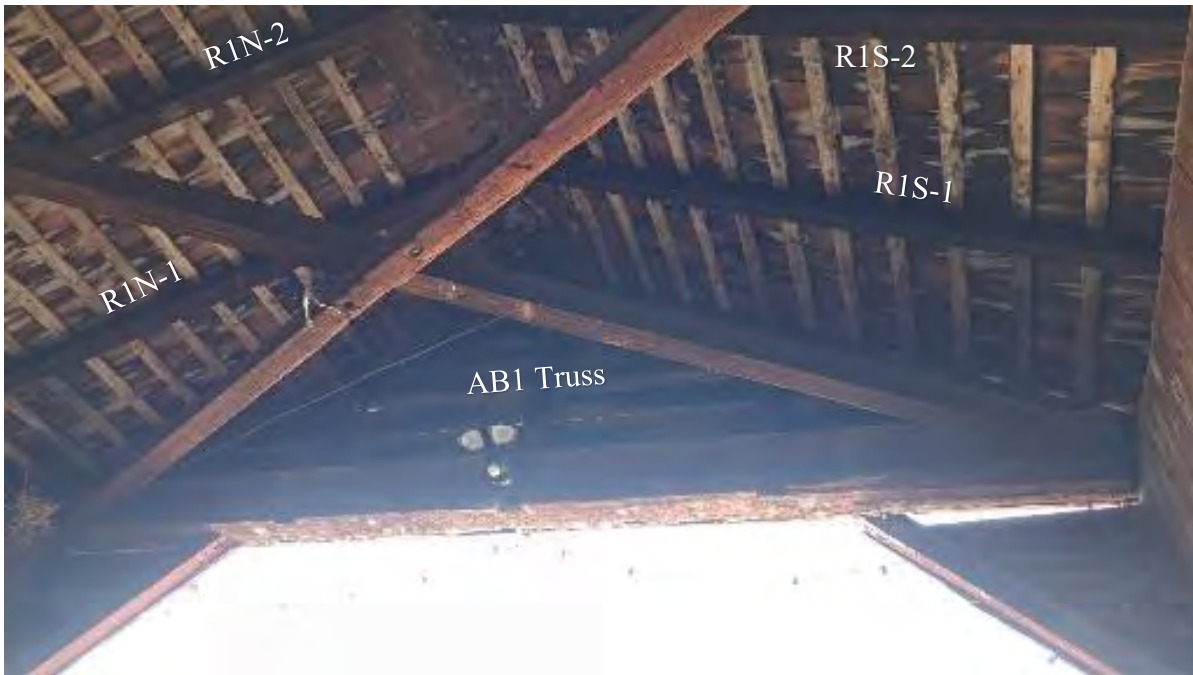
Figure 7-15: No access to Abutment 1 truss main rafters with limited visual accessibility. R1N & R1S appear to be in fair condition.

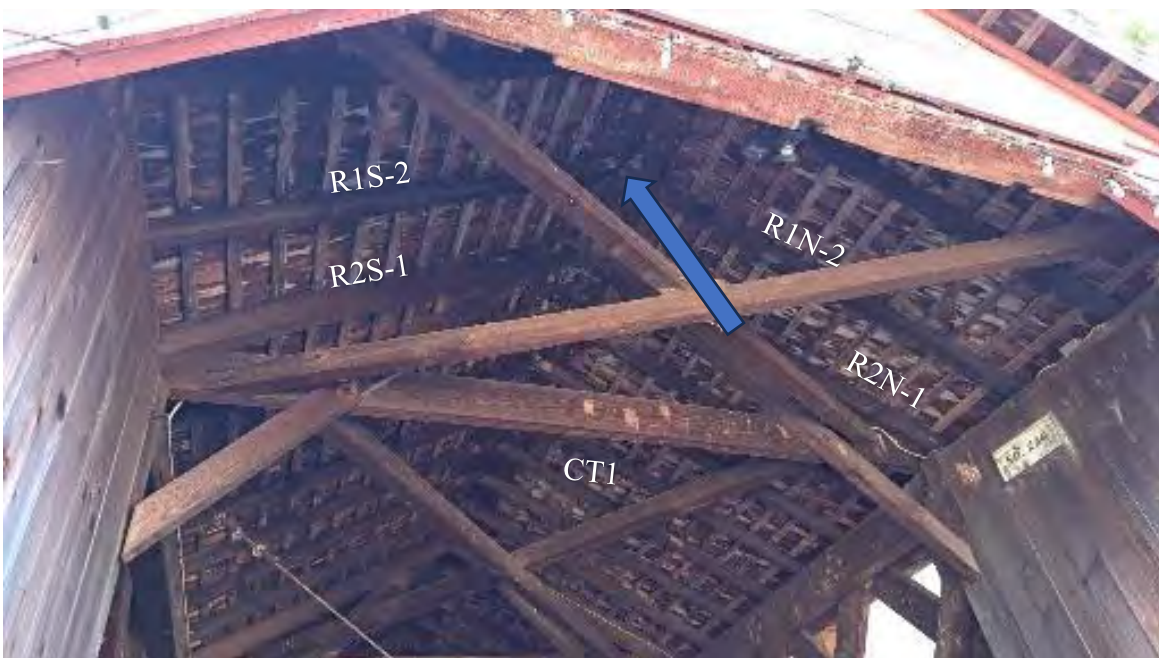
Figure 7-16: Arrow points to an abandoned wasp nests and spider webs between R-S2/R1N-2 near the apex. Insect nests are typically located near the apex of all rafters.

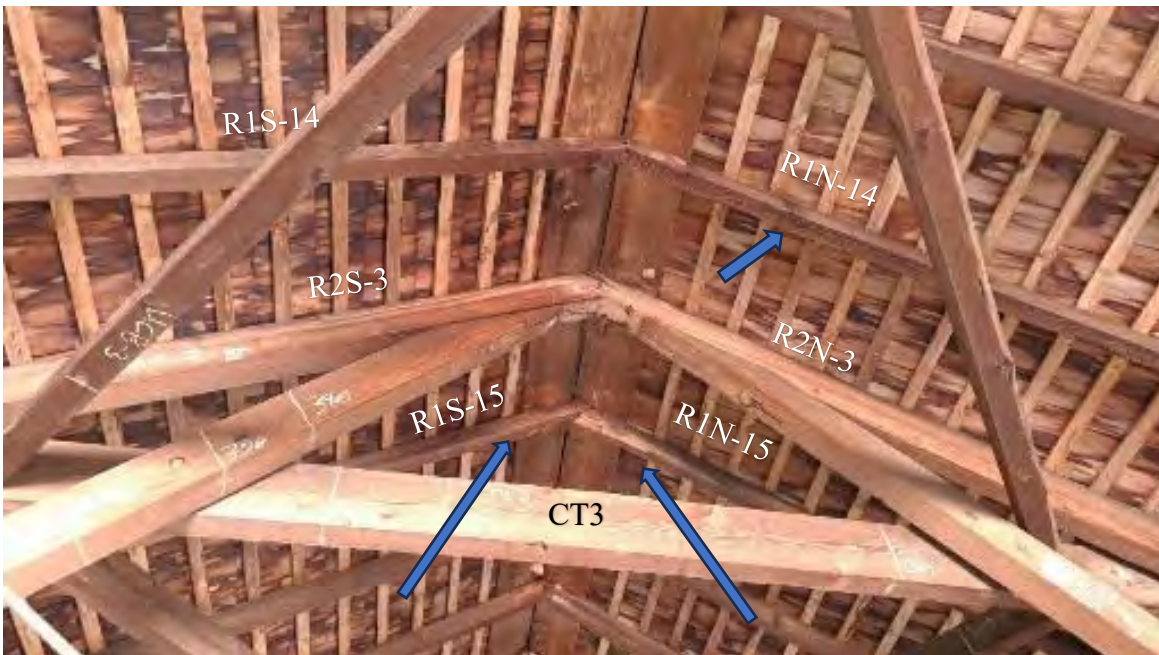
Figure 7-18: R1N-14 has multiple knots. R1N-15 shows deterioration at the top end near the apex that is 2-3-feet in length. R1S-15 has some deterioration near the apex.
