South Perkasio Covered Bridge Inspection Report

SUBMITTED TO:
Borough Of Perkasio
149 W Walnut St,
Perkasio, PA 18944
(Phone Number TBD); (Email TBD)

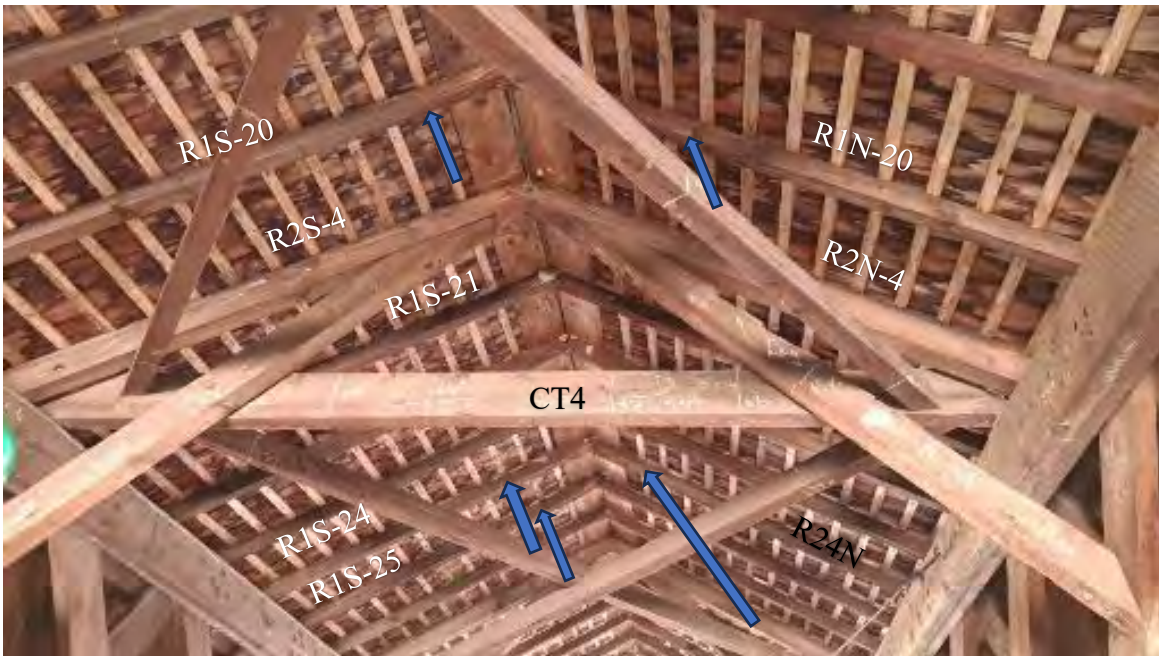
Figure 7-19: R1S-20 has some shrinkage checks. Three knots are seen on R1N-20. R1N-24 and R2S-24 have cracks, splits and deterioration at bottom surfaces. R1S-25 has some shrinkage checks.

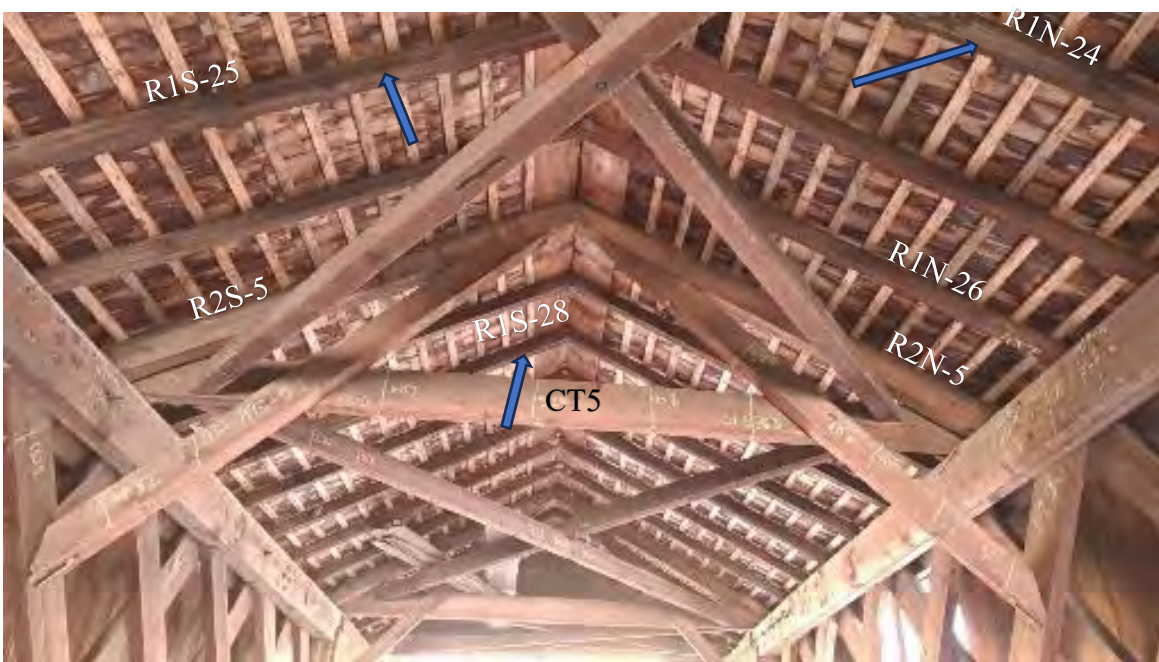
Figure 7-20: R1S-25 has severe shrinkage checks. R1N-24 has cracks, splits and deterioration at the bottom face. R1S-28 has shrinkage checks, cracks and splits.

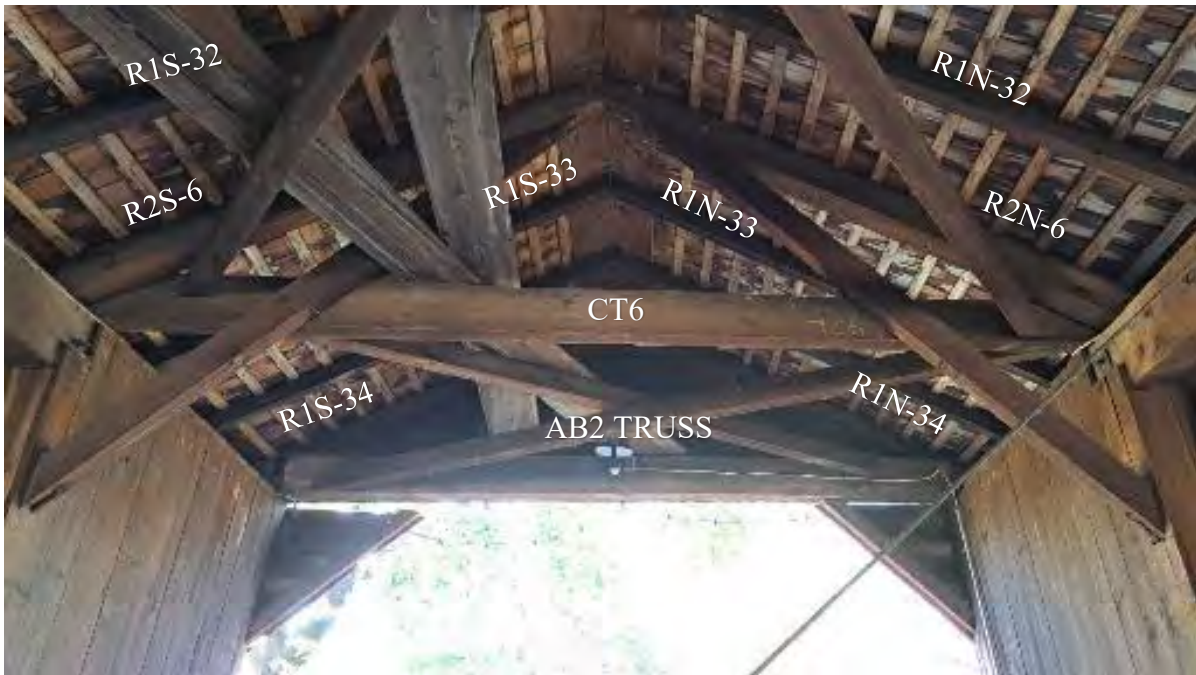
Figure 7-21: AB2 truss end, rafters seem to be in fair condition.

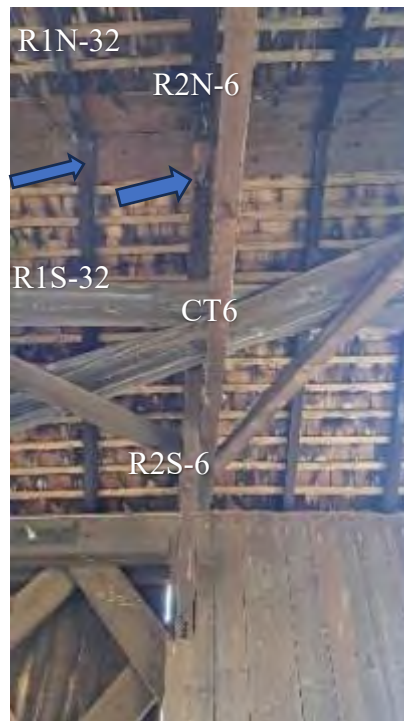
Figure 7-22: R2S-6 and R1N-32 are showing some deterioration on bottom surface.

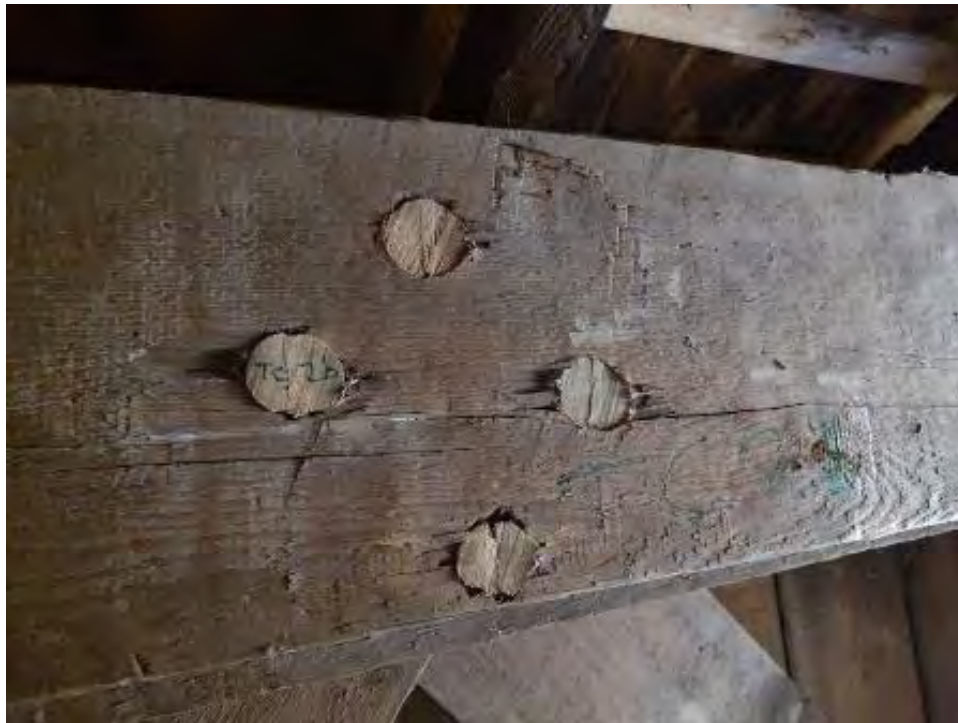
Figure 8-1: Shrinkage checks on dowels to TC2B connection with lattice.

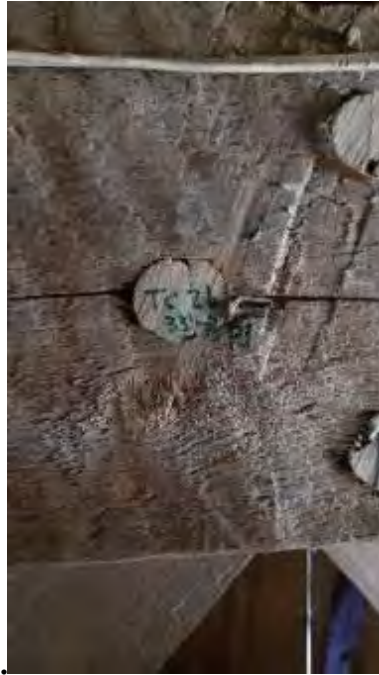
Figure 8-2: TC2B is crack through dowels located 33-feet from post P1.

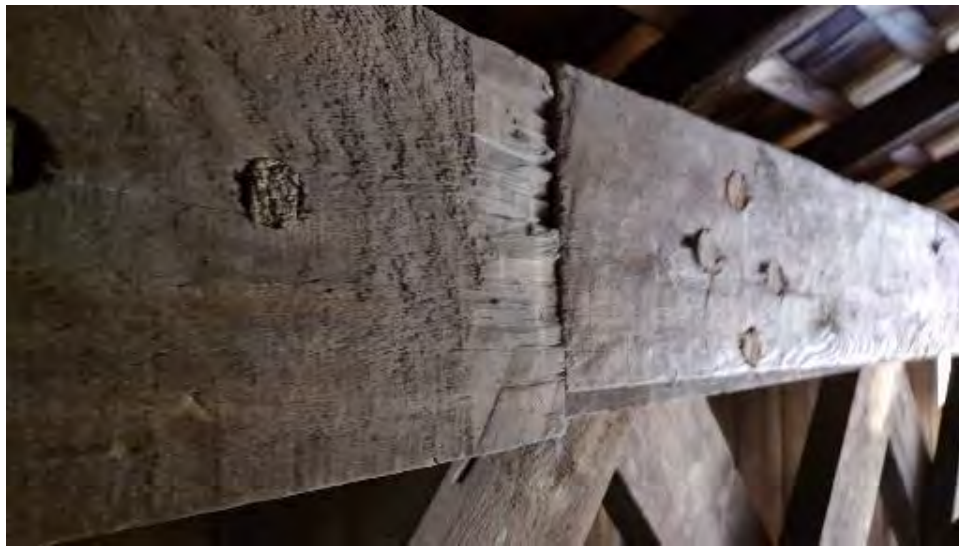
Figure 8-3: TC2A splice location.

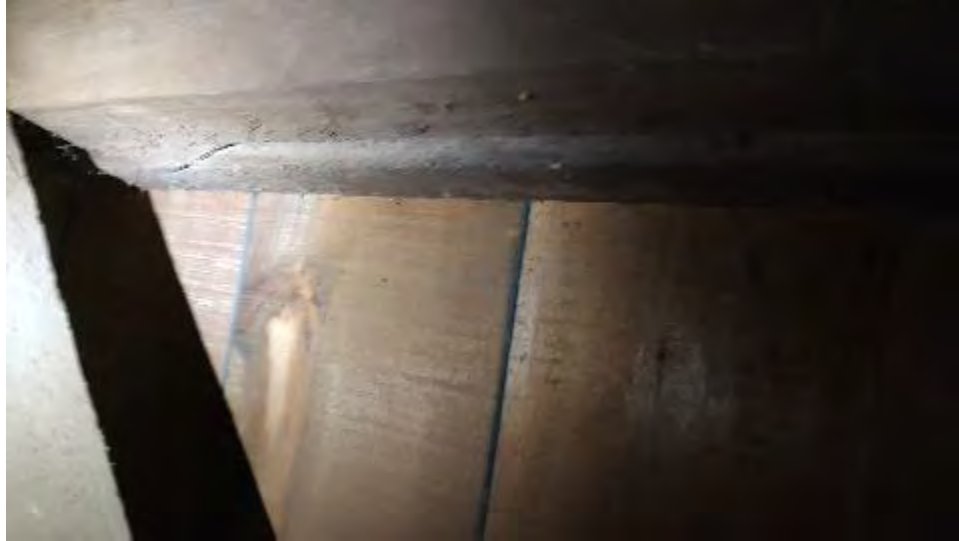
Figure 8-6: The crack in a small section on the bottom face of TC1B does not appear to extend to the top or through the member.

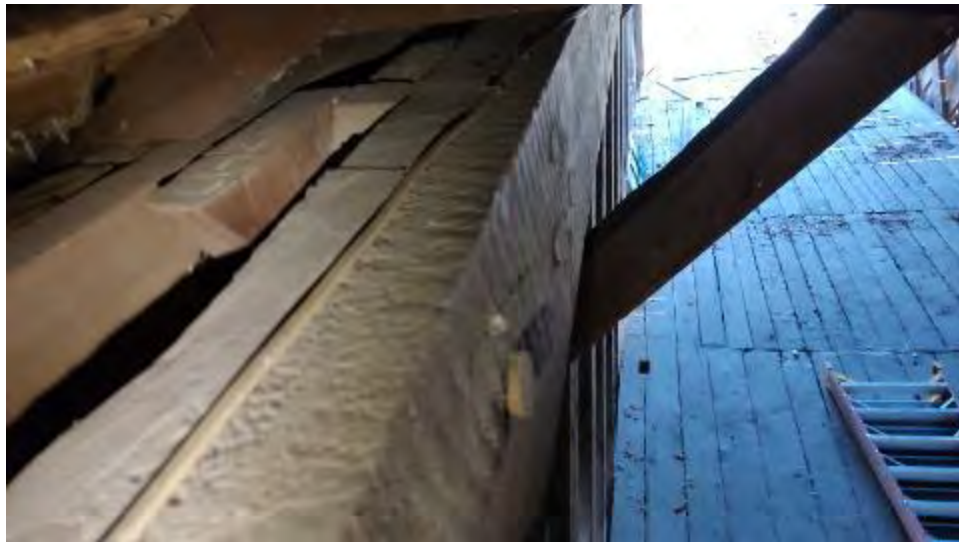
Figure 8-7: TC1B splice location.

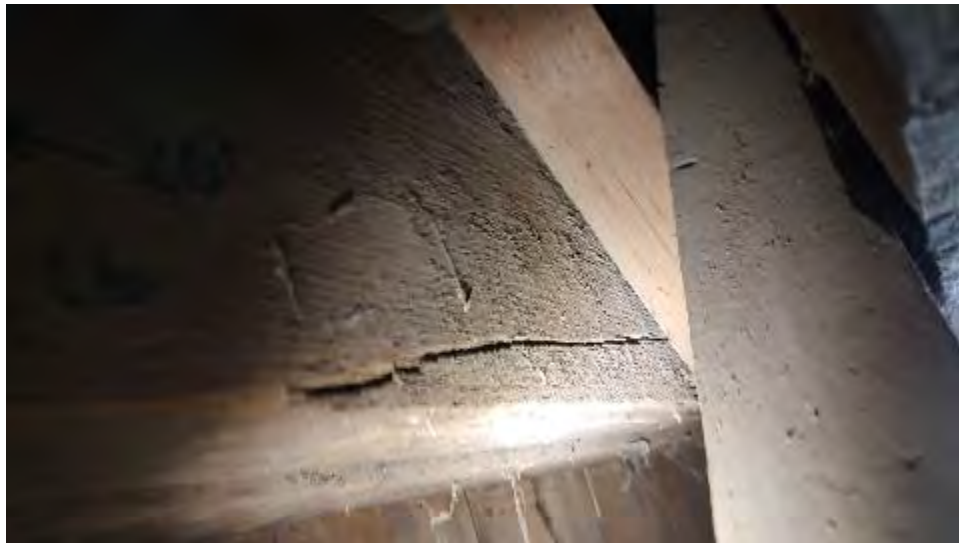
Figure 8-9: Small crack on bottom face of TC1B.

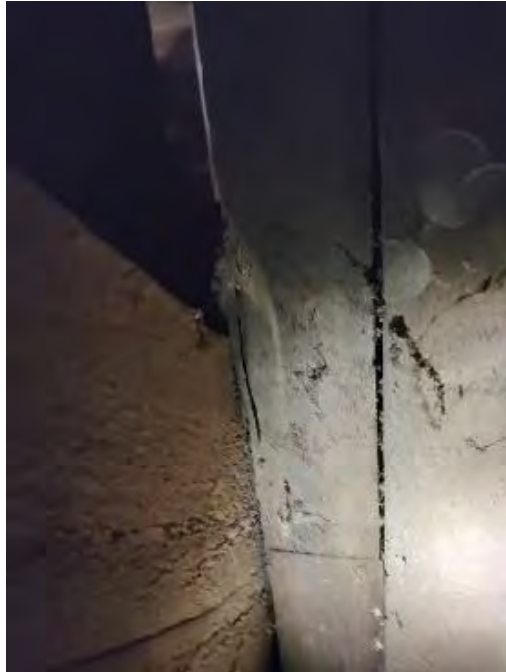
Figure 8-10: Small crack on bottom face of TC1B.

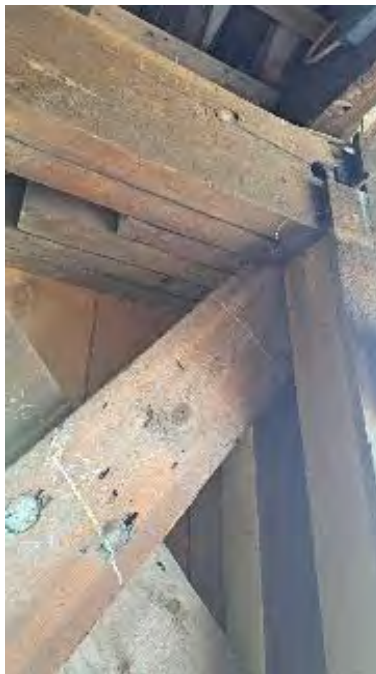
Figure 8-11: TC2B is cleaved through a peg hole (no peg) above post P2 and at a peg hole located 10-inches from P2.

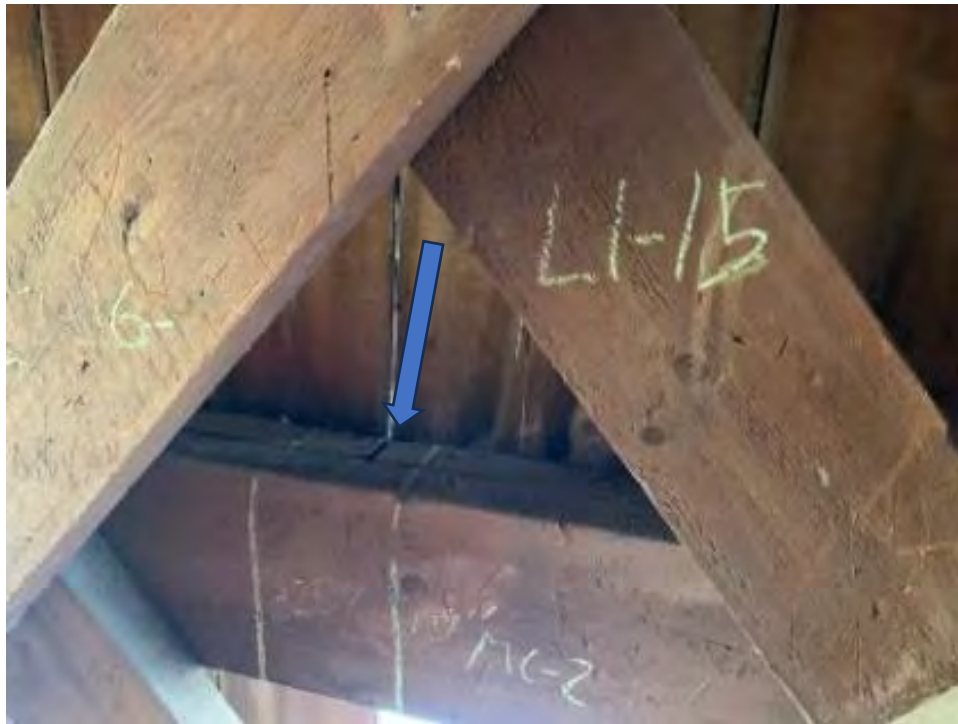
Figure 8-14: Middle chord MC1 showing a splice location behind MC2.

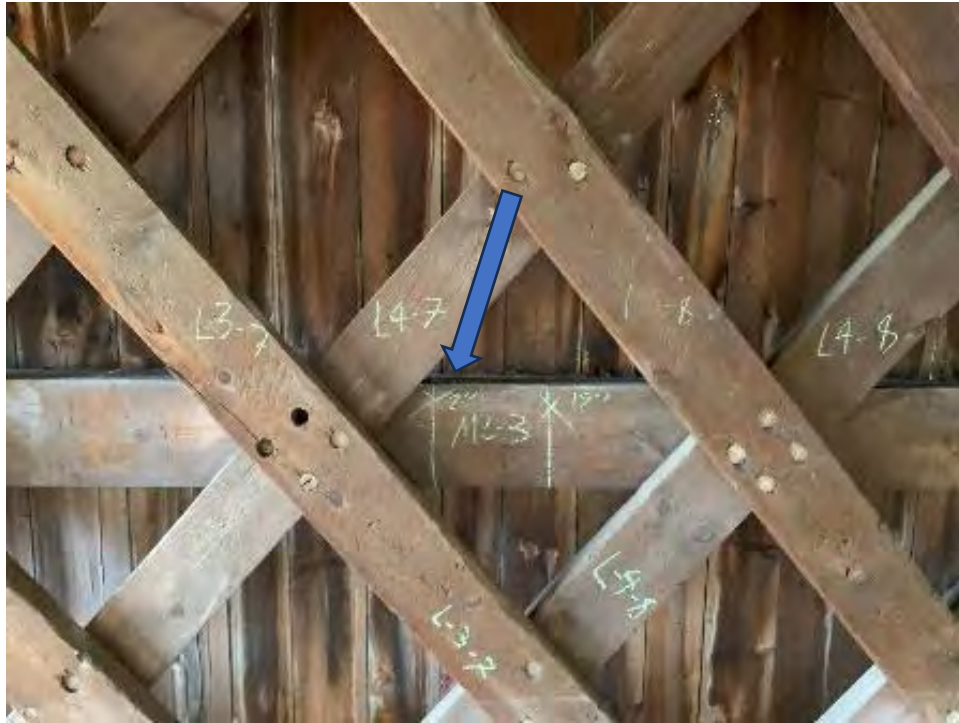
Figure 8-19: MC3 & MC4 has decay 2-inches from lattice member L4-7.

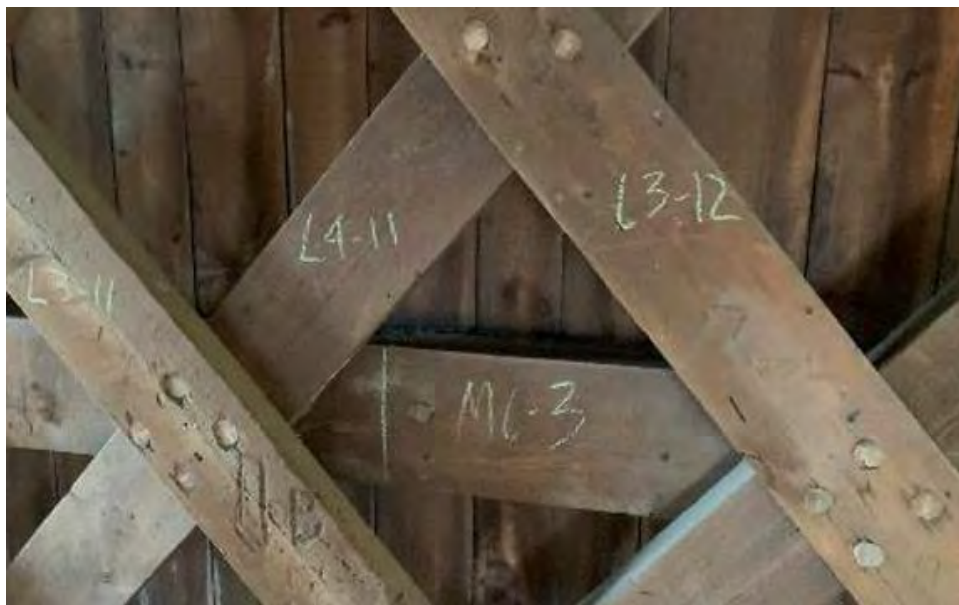
Figure 8-20: MC3 & MC4 splice location.

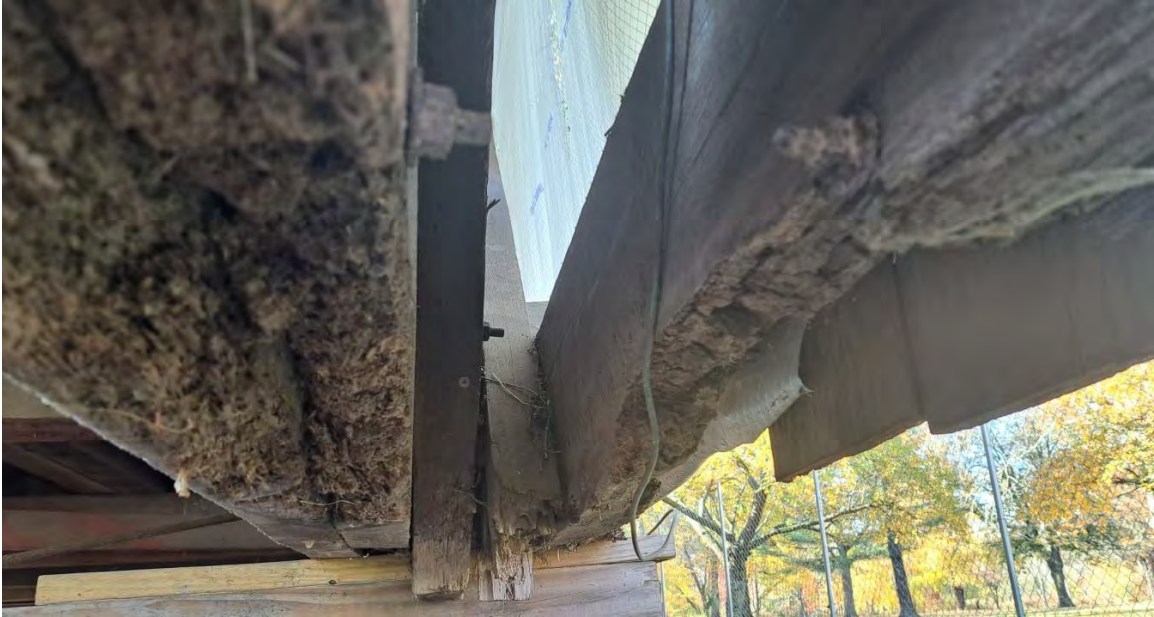
Figure 8-24: The first 40-inches of bottom chord BC1A and BC1B from Post P1 has significant decay and 2-inches section loss on bottom faces. The bottom half of BC1B is decayed/crushed for the first 3-feet from P1. The next 5-feet of the bottom face is decayed/crushed. The bottom third of BC2A is decayed with significant section loss for the first 39-inches from P2. The next 40-inches is crushed on the bottom face for a depth of 1-inch and extends over the cribbing. BC2A is spliced 49-inches from the end. Significant section loss exists for the first 6-inches of BC2B from P2. The next 3-feet is decayed for the bottom third. BC2B is spliced at 6-feet from P2.

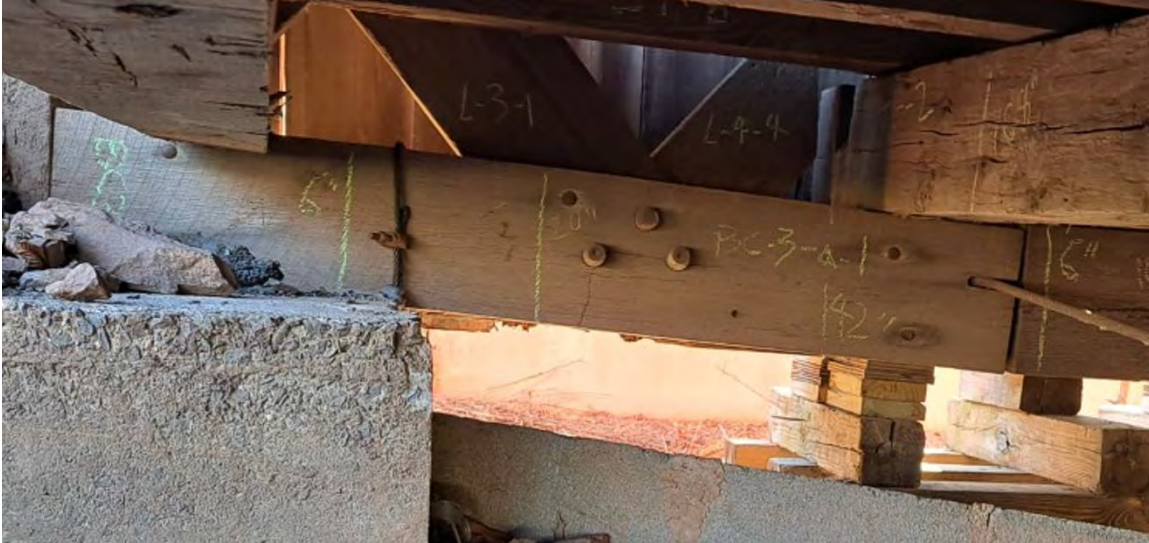
Figure 8-25: BC3A is broken at a dowelled connection to the lattice members L3-1 and L4-4 and is spliced at 61-inches from the end.

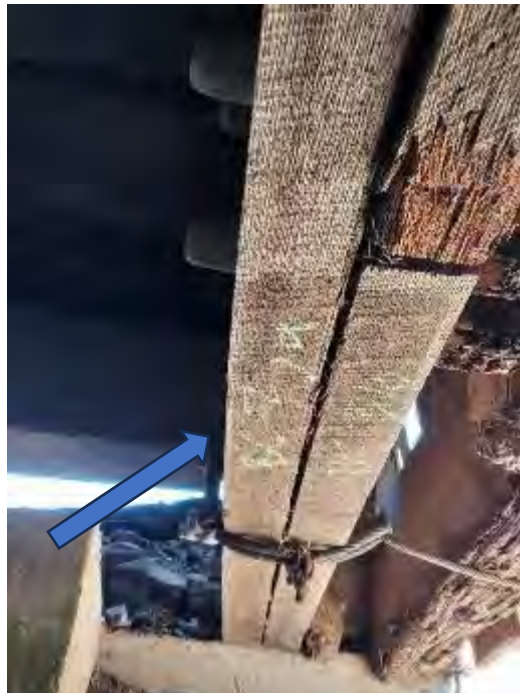
Figure 8-26: The bottom face of BC3A is crushed by approximately 1/8-inch depth for 8-inches from P3. Segment A of BC3A is curving toward the south side at the splice with Segment B. The bottom face of BC3B is crushed for 12-13-inches from P3 and is spliced at 42-inches from the end.

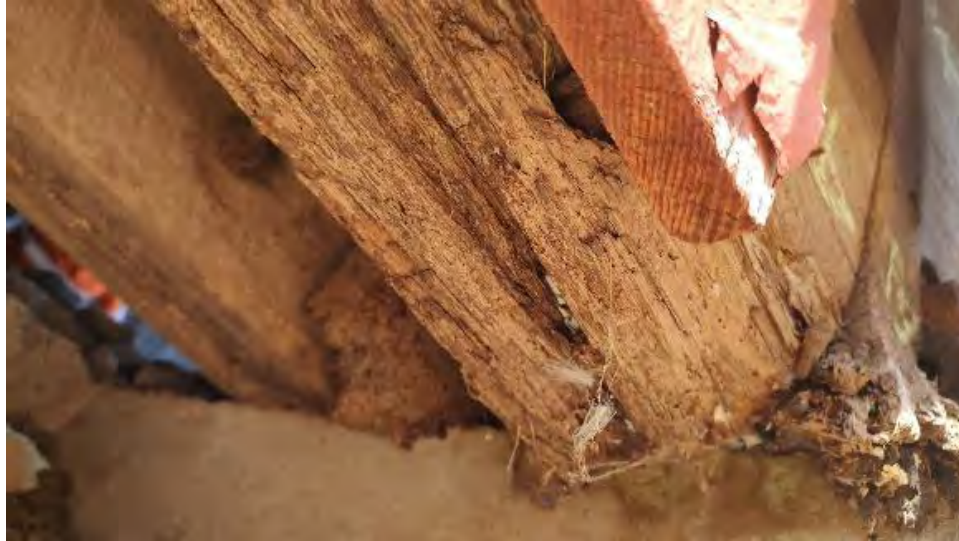
Figure 8-27: The first 6 1/2-feet of the bottom third of BC4A from P4 is decayed. The first 7-feet of the bottom third of BC4B from P4 is decayed.

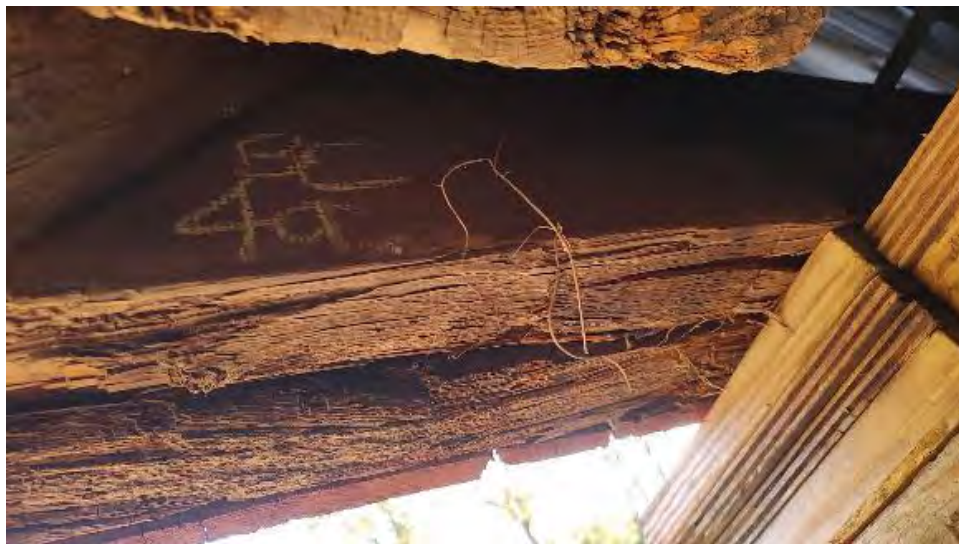
Figure 8-28: The first 7-feet of the bottom third of BC4B from P4 is decayed.

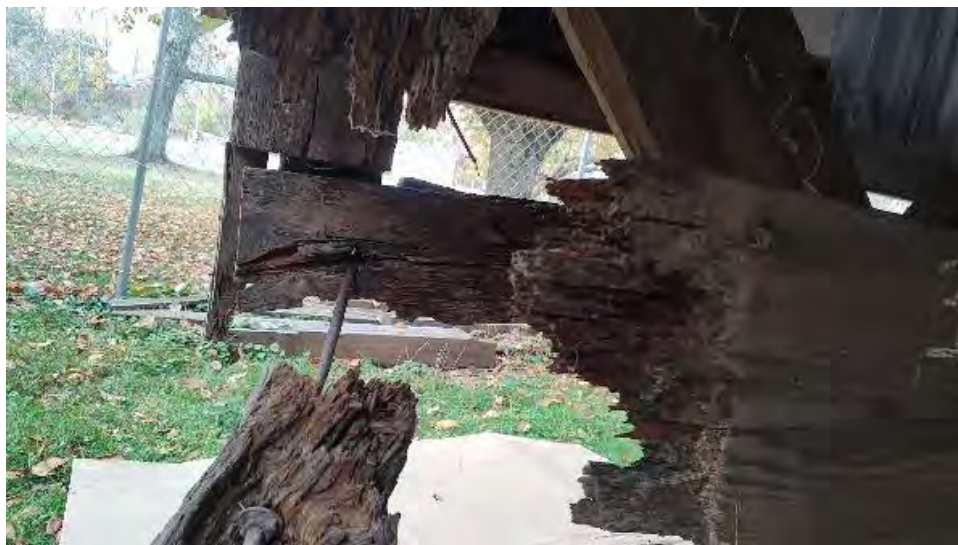
Figure 8-29: Significant decay and section loss to the AB2 ends of BC1 and BC2.

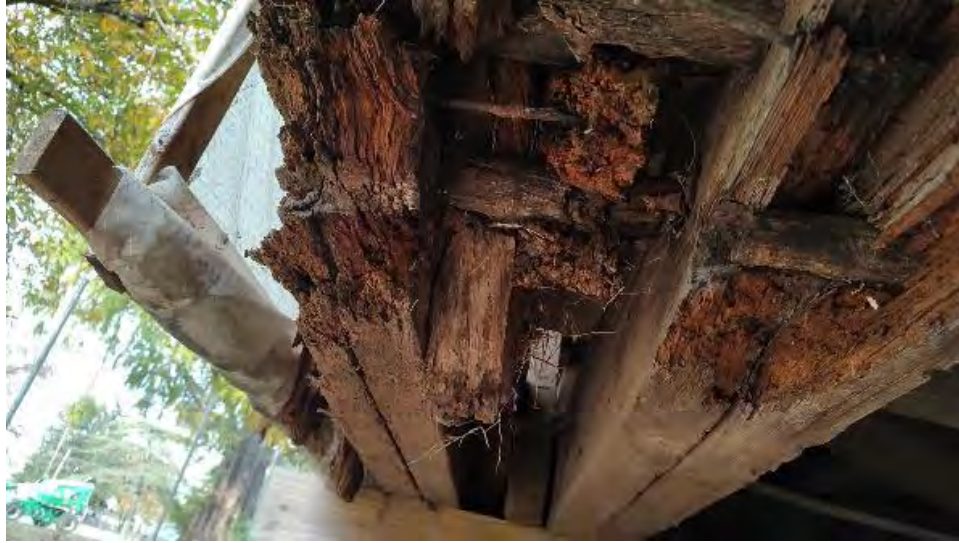
Figure 8-30: Significant decay and section loss to the AB2 ends of BC1 and BC2.

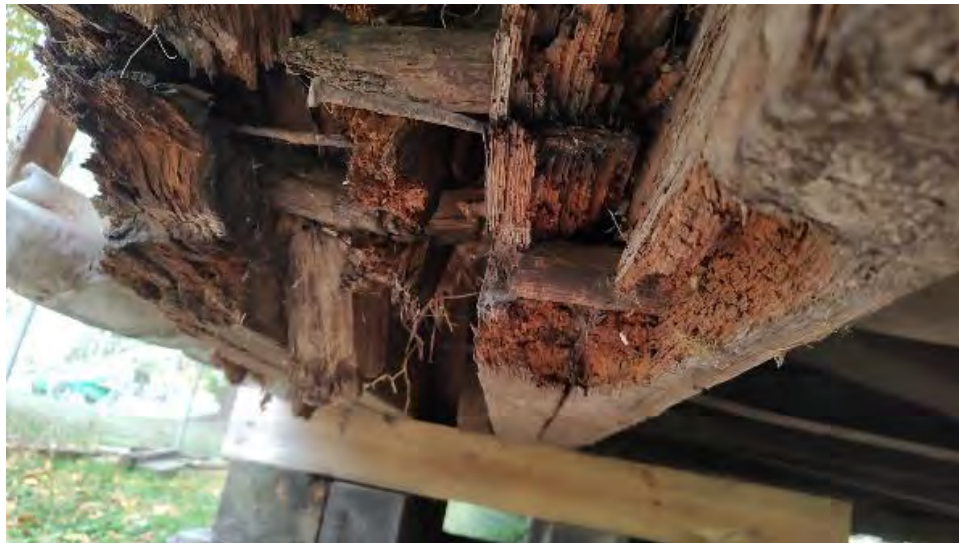
Figure 8-31: Significant decay and section loss to the AB2 ends of BC1 and BC2.

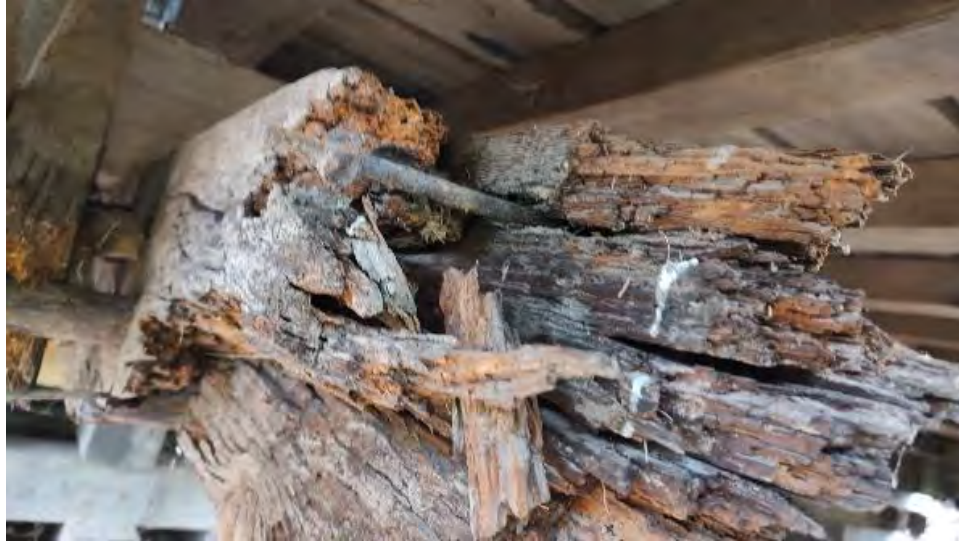
Figure 8-32: Significant decay and section loss to the AB2 ends of BC1 and BC2.

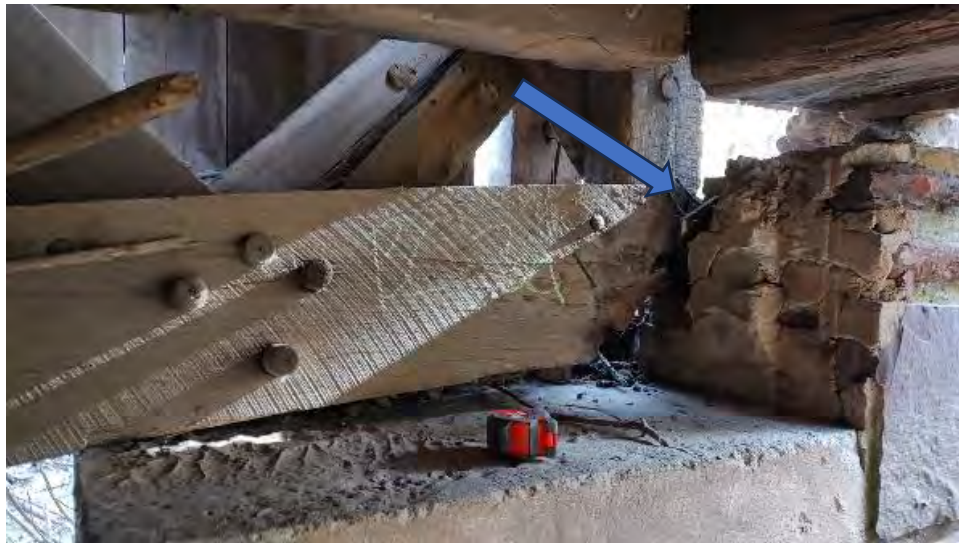
Figure 8-33: Approximately 80% of section loss exists for the first 10-inches of BC3A from P5. Segment 2 is cleaved with a split at 54-inches next to a lattice dowel joint.

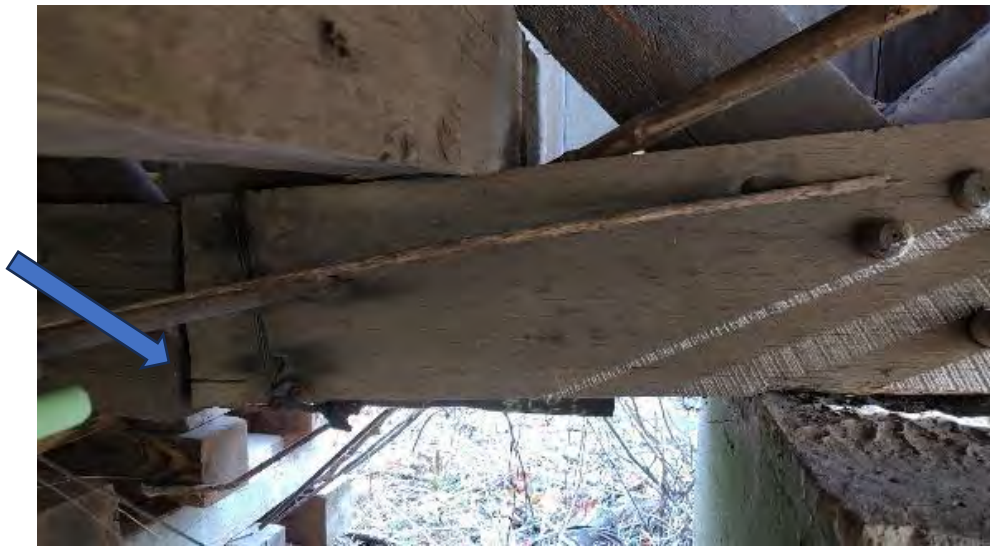
Figure 8-34: The splice of BC3B is broken at 64-inches from P7.

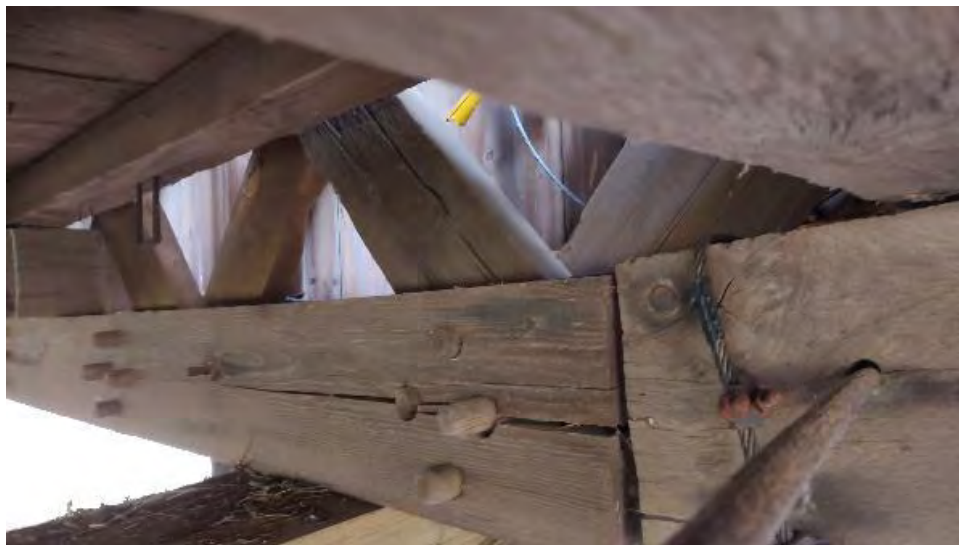
Figure 8-35: Large end split of second segment of BC2A from P7.

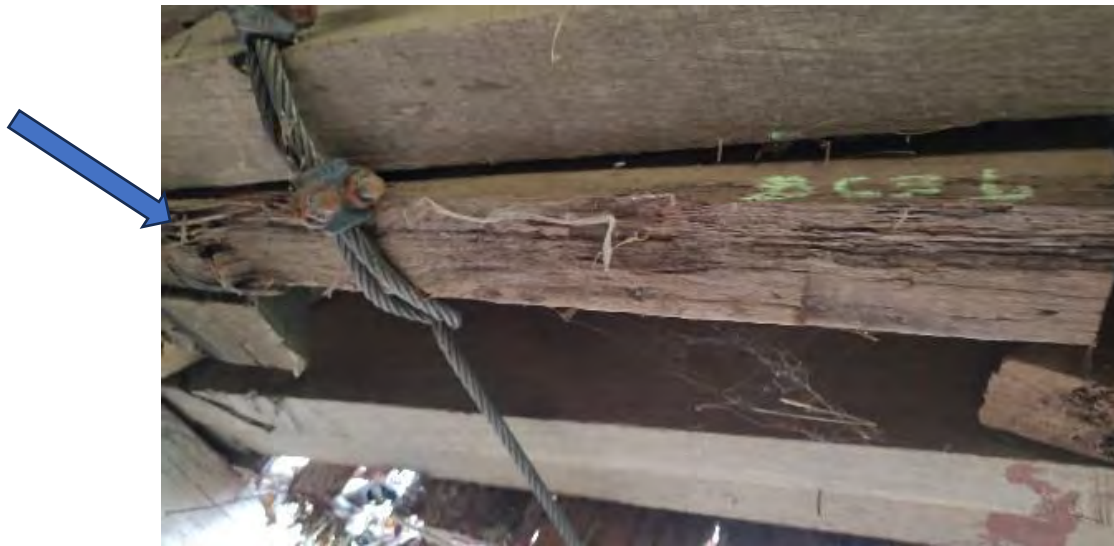
Figure 8-36: The splice of BC3B is broken at 64-inches from P7.

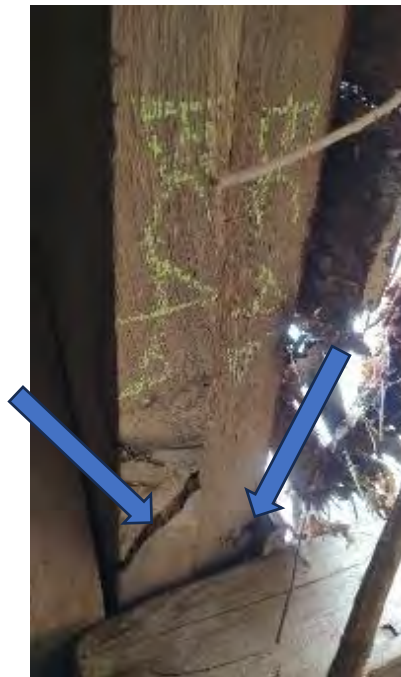
Figure 8-37: BC4A and BC4B are broken at 70-inches from P8.

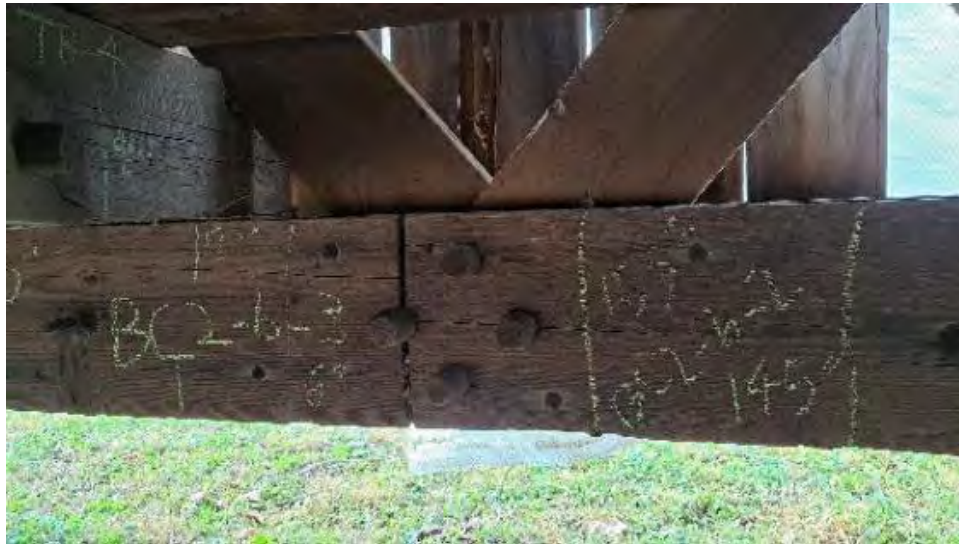
Figure 8-38 Some shrinkage checks exist to Bottom Chord 2 Ply B (BC2B) through the dowel holes at lattice connection, which is also the splice between chord segment 2 & 3 (BC2B-2 and BC2B-3).

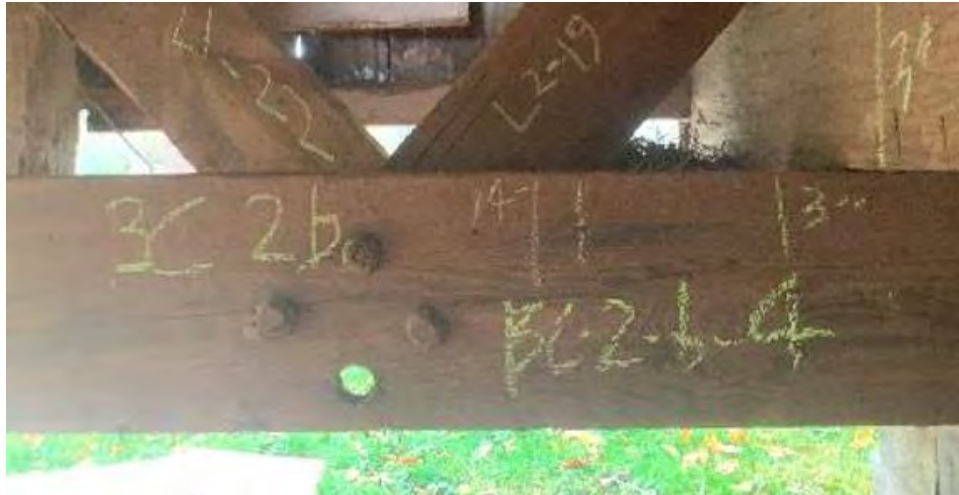
Figure 8-39: BC2B is missing a dowel on the lattice connection with L1-22 and L2-19. Some shrinkage checks exist through other dowel holes.

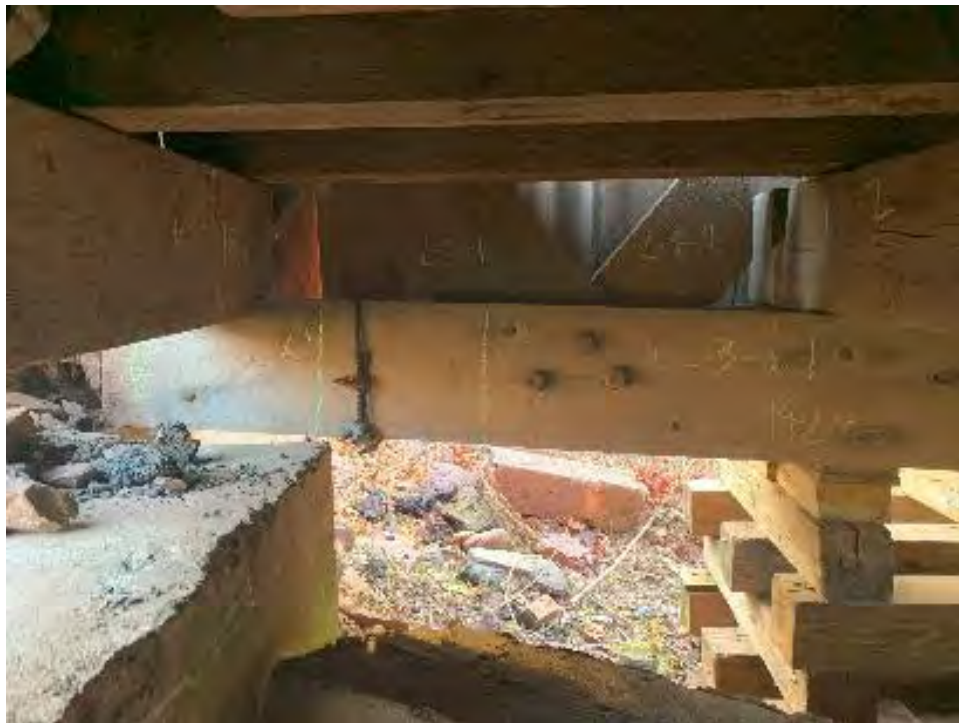
Figure 8-40: BC3A Abutment 1 end with temporary cribbing under bottom chords.

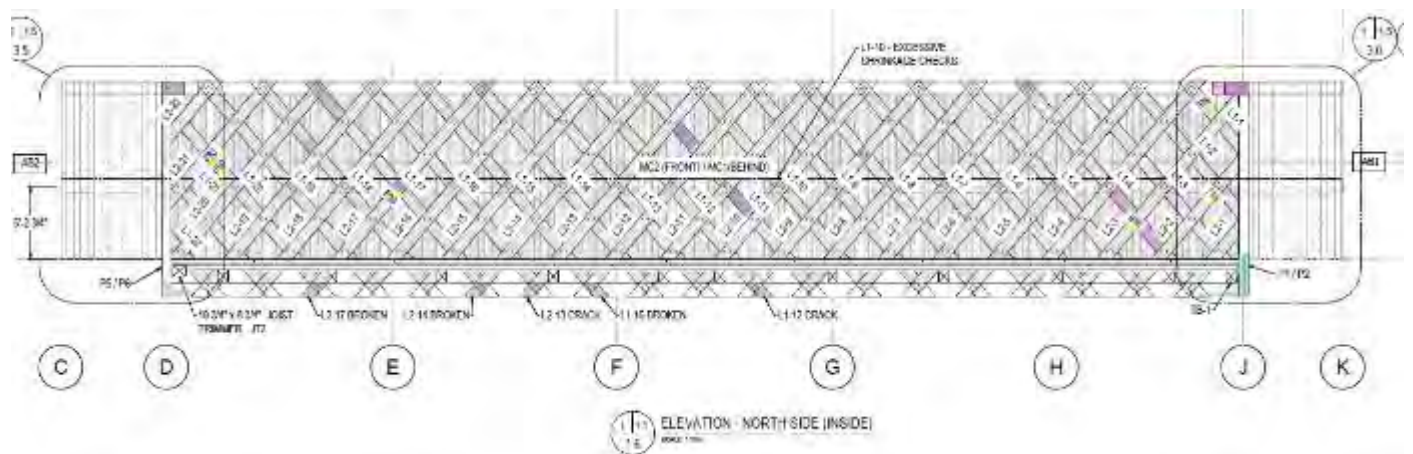
Figure 8-46: Summary of elevated SWT values on the Lattice 1 & 2 members.

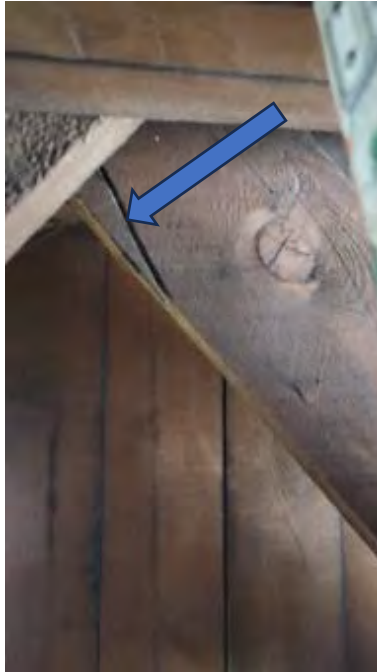
Figure 8-47: L1-4 is broken at the bottom on the outer edge.

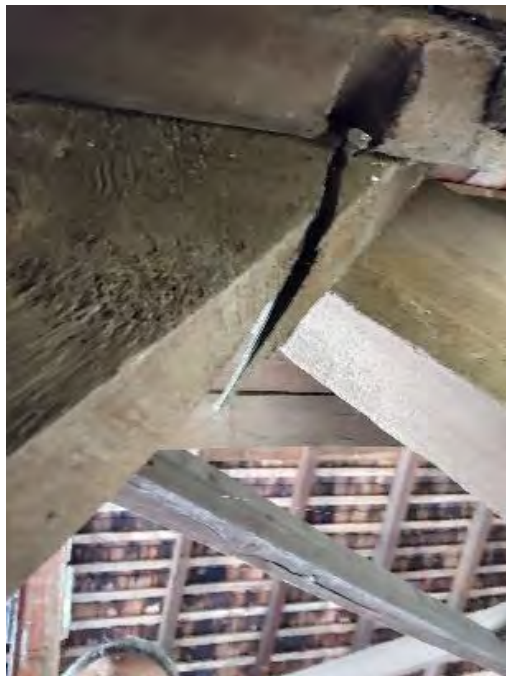
Figure 8-48: L1-4 is broken at the top from the bottom to top edge. A nail exists through the crack.

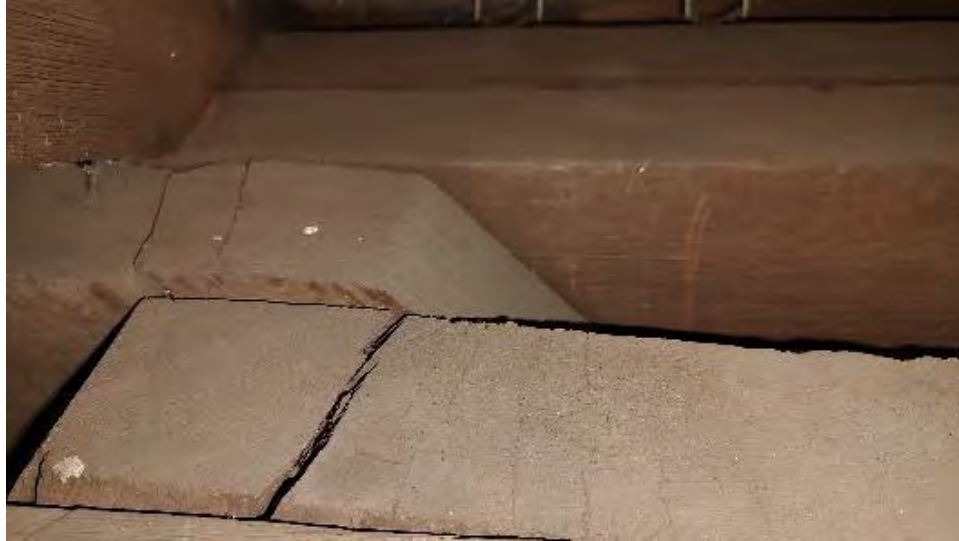
Figure 8-49: L1-4 top split on outer edge, nail is going through member on top.

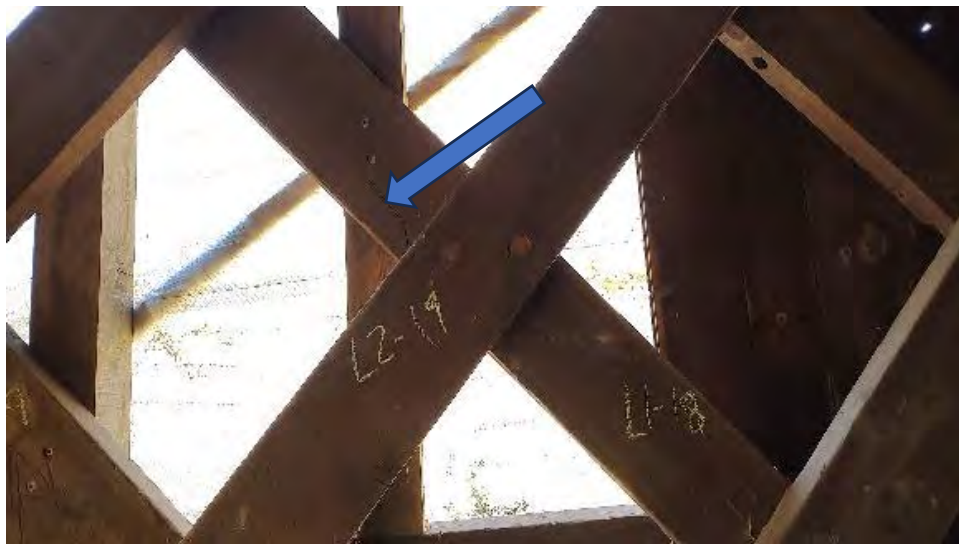
Figure 8-54: L1-18 is cracked on its side and lower edge above the intersection with L2-19.

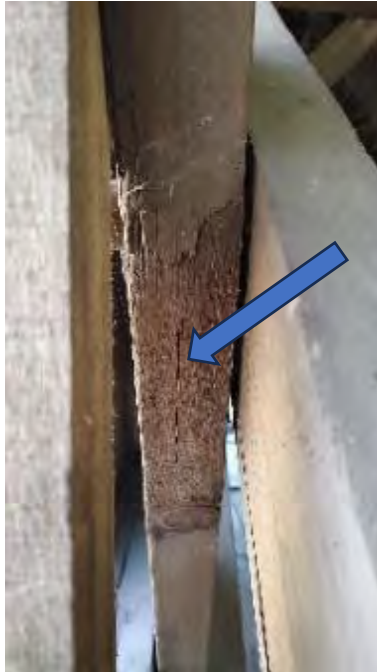
Figure 8-55: L1-18 is cracked on its side and lower edge above the intersection with L2-19.

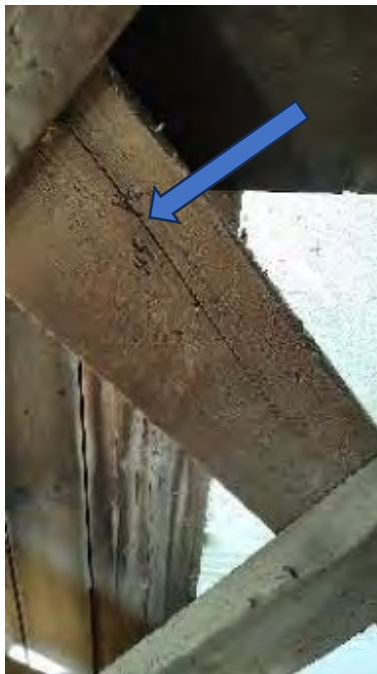
Figure 8-56: Shrinkage checks exist to L1-20 which extend from the dowelled connection with the top chord.

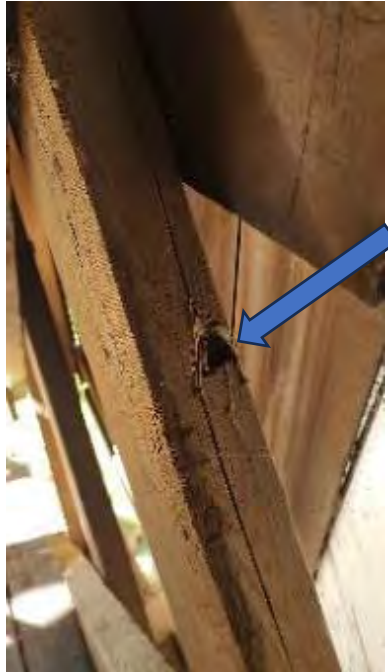
Figure 8-57: A tension crack (24-inches long) has propagated from at a knot on the top face of L1-20 below the middle chord.

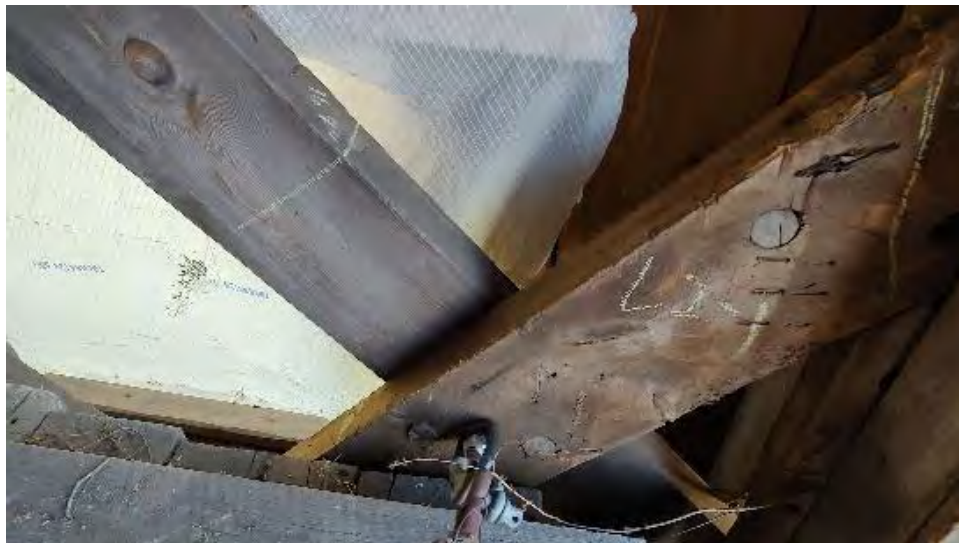
Figure 8-58: L2-1 has some deterioration and abrasion on the outer surface.

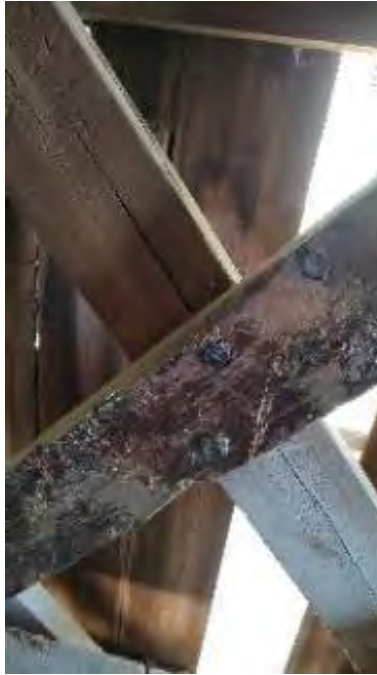
Figure 8-59: A large crack exists through Lattice 1 member at the connection with Lattice 2 member.

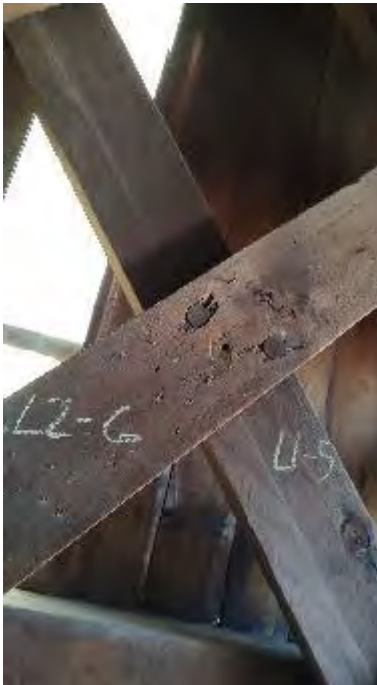
Figure 8-60: L2-6 has some damage at the dowel connection to L1-5.

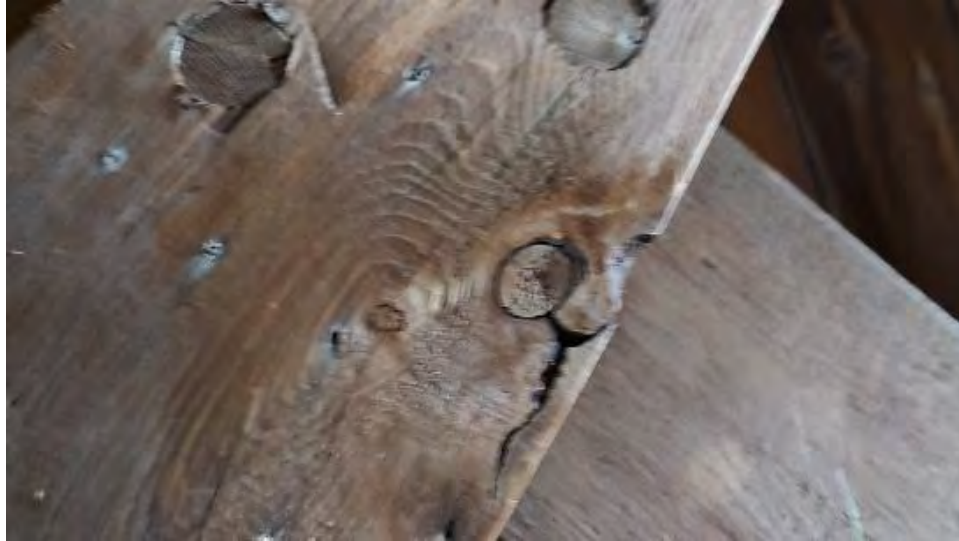
Figure 8-61: L2-9 is cracked at the dowel connection to L1-8.
