South Perkasio Covered Bridge Inspection Report

SUBMITTED TO:
Borough Of Perkasio
149 W Walnut St,
Perkasio, PA 18944
(Phone Number TBD); (Email TBD)

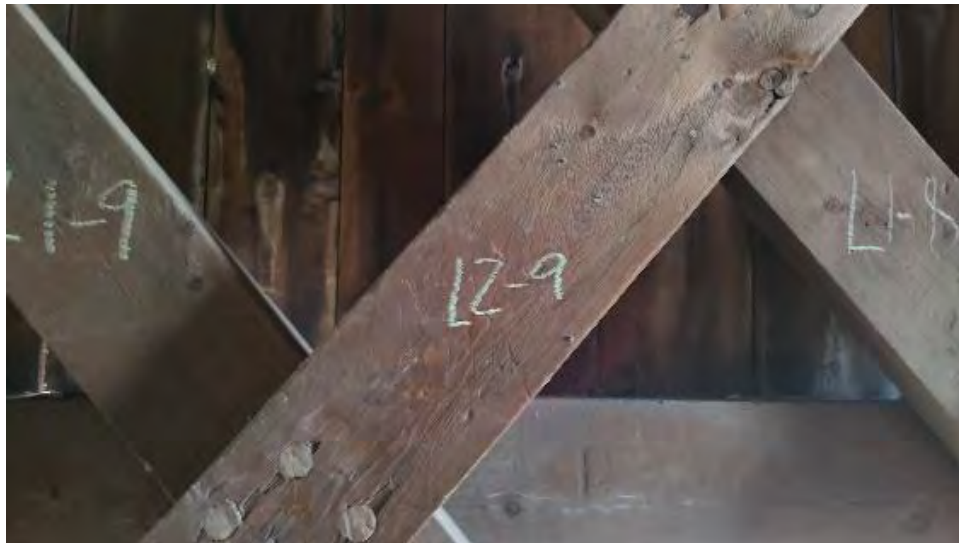
Figure 8-62: L2-9 is cracked at the dowel connection to L1-8.

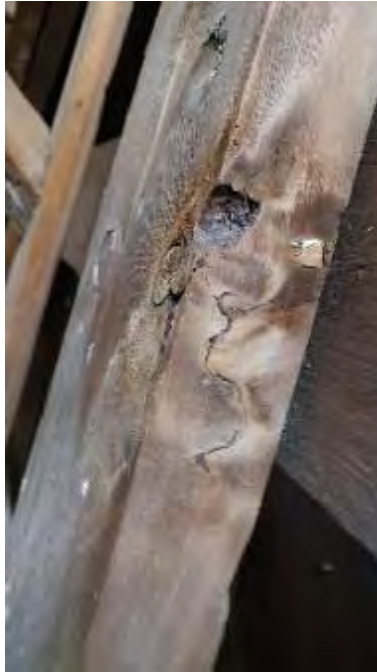
Figure 8-63: L2-9 is cracked at the dowel connection to L1-8.

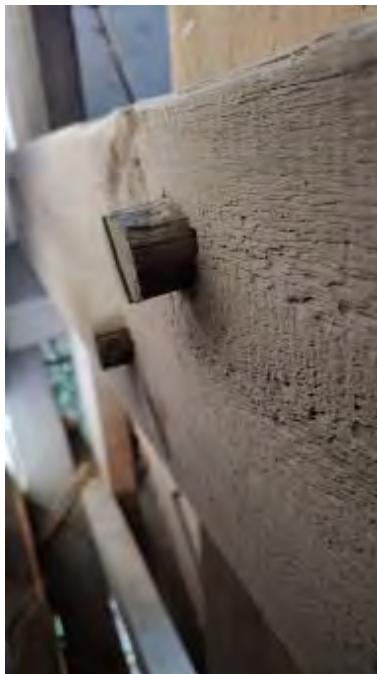
Figure 8-64: Dowels on L2-11 were replaced, likely when the bridge was moved to its current site (note they protrude about 1-inch).

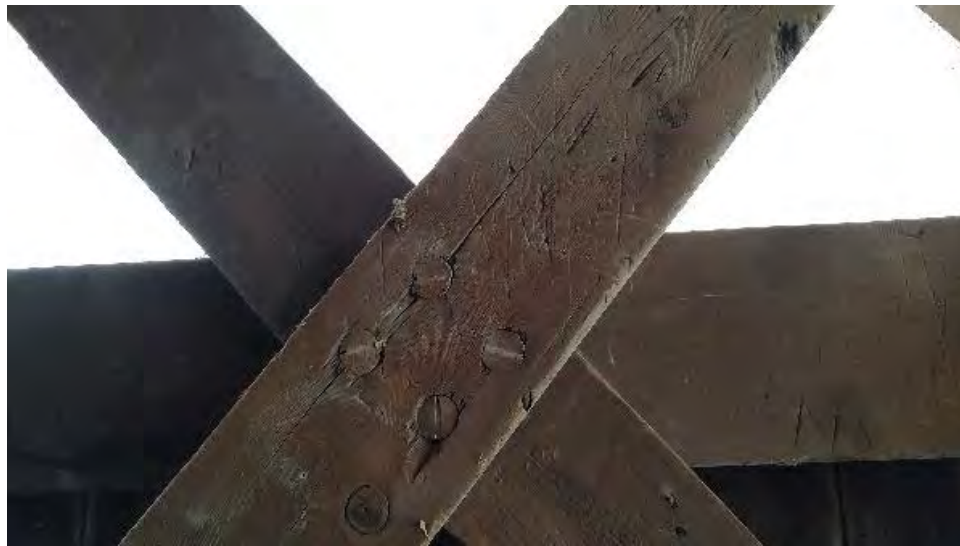
Figure 8-65: L2-17 is cracked at the dowel connection to the middle chord and Lattice 1 member.

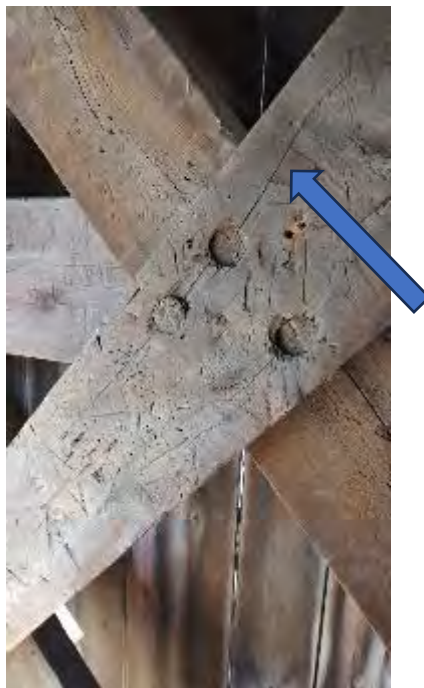
Figure 8-66: L2-20 has shrinkage checks through the dowelled connection to the middle chord and Lattice 1 member.

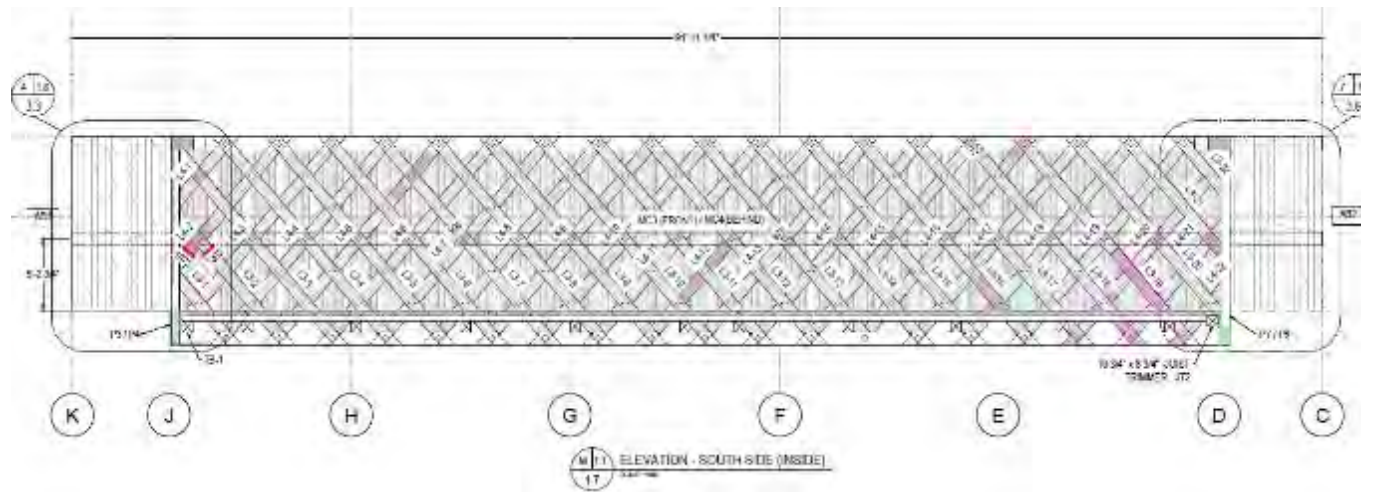
Figure 8-67: Summary of elevated SWT values on the Lattice 3 & 4 members.

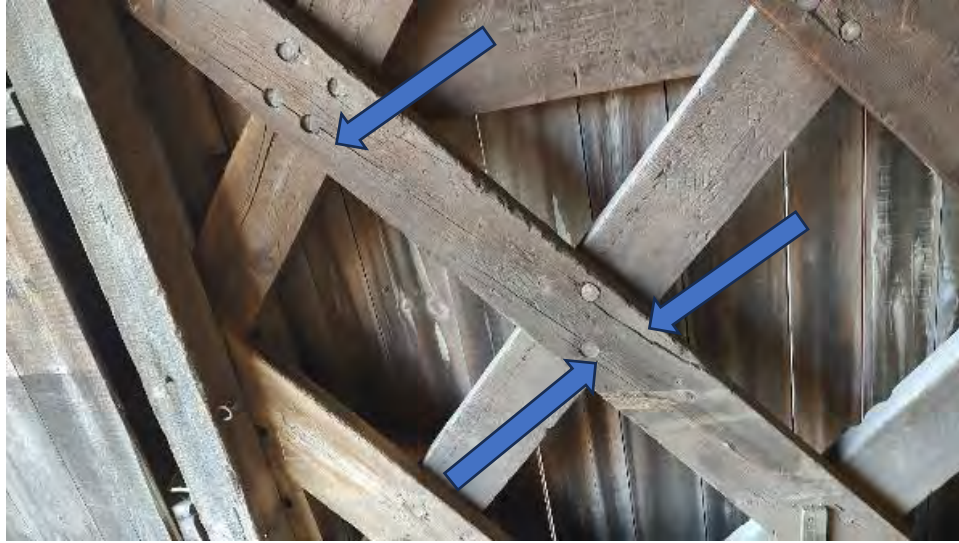
Figure 8-69: L3-2 has several cracks propagating from the dowelled connections to L4-2 & L4-3.

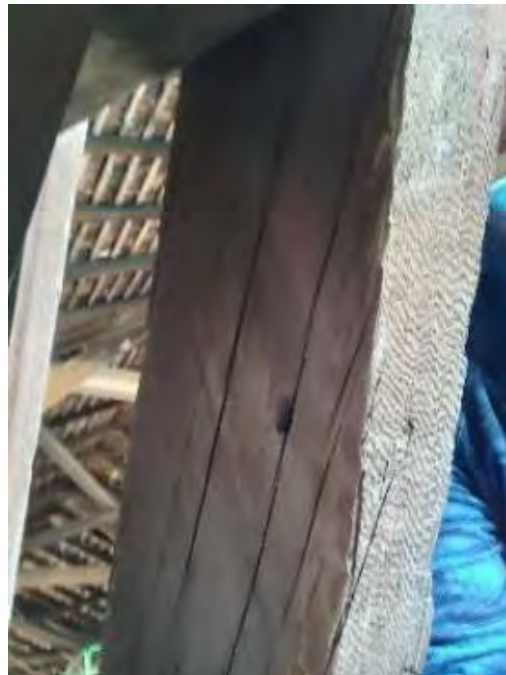
Figure 8-70: L3-2 has several cracks propagating from the dowelled connections to L4-2 & L4-3.

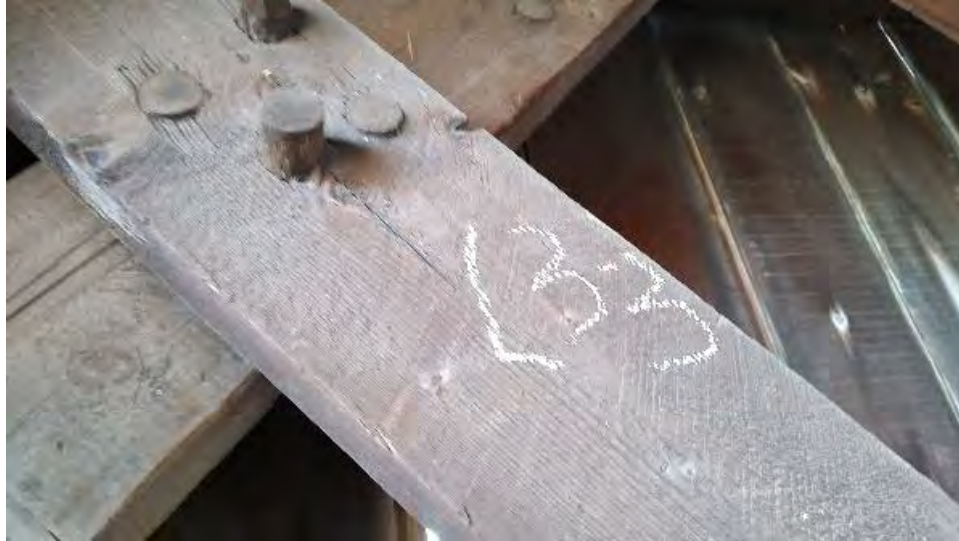
Figure 8-71: L3-3 is cracked at the dowels with L4-1 (note protruding dowels).

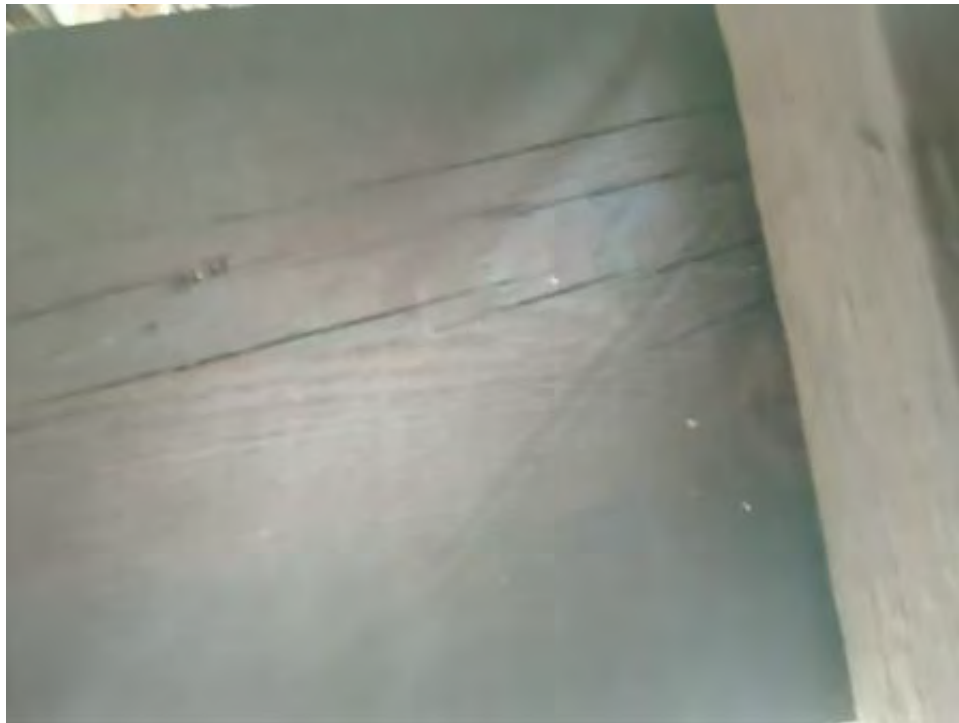
Figure 8-72: L3-3 is cracked at the dowels with L4-1.

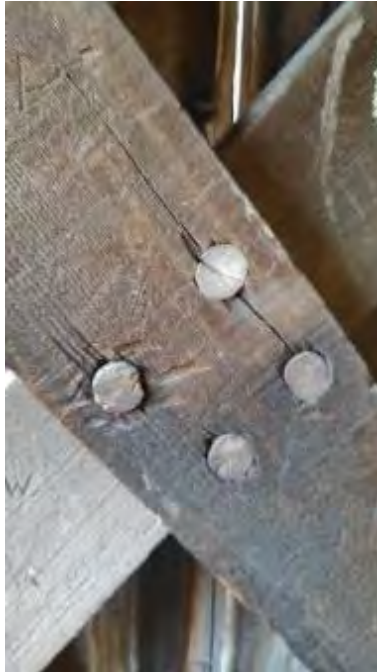
Figure 8-73: L3-4 is cracked at the dowels to the middle chord.

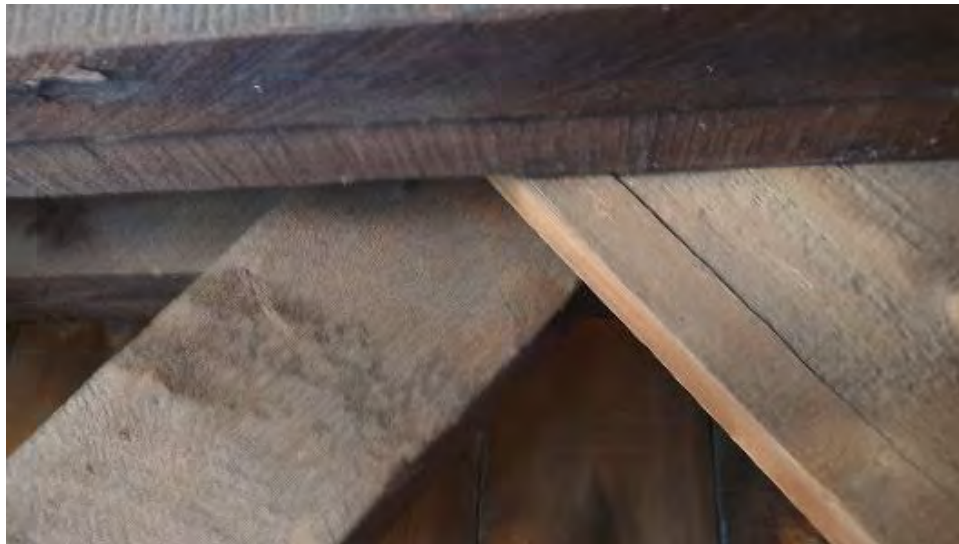
Figure 8-74: L3-6 is split from the dowel connection at the top chord.

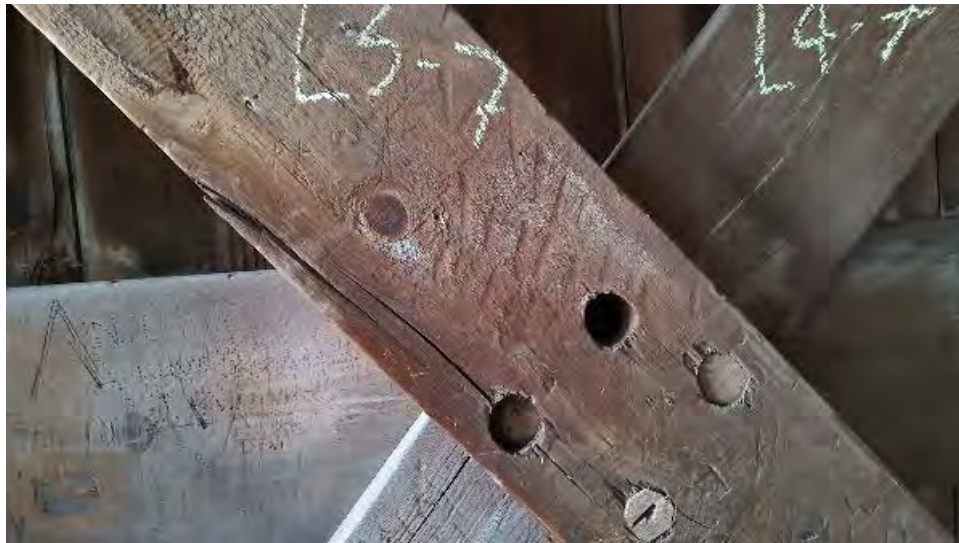
Figure 8-76: L3-7 is cracked at a dowel to L4-7 and the middle chord. The top dowel of this connection does not penetrate through L3-7.

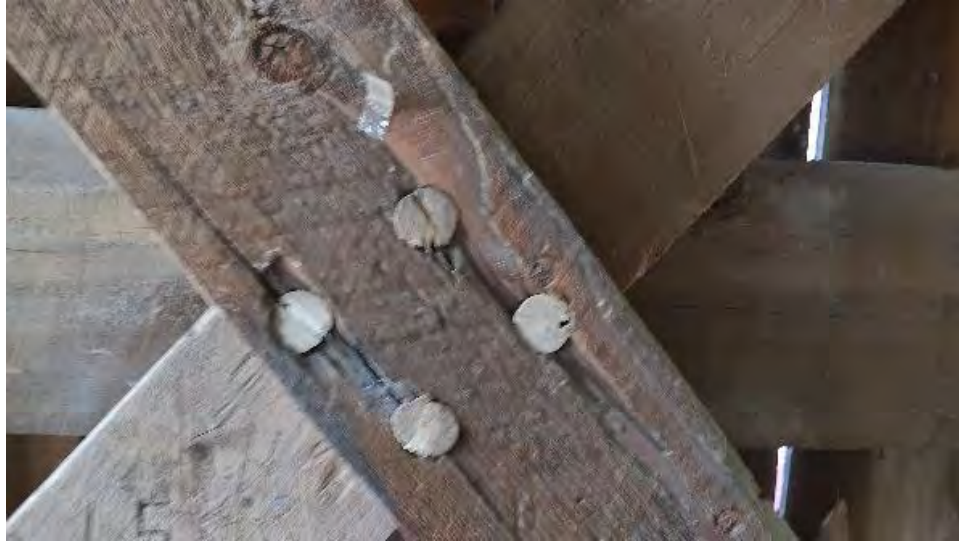
Figure 8-77: L3-9 is cracked through 1 row of dowels to the middle chord.

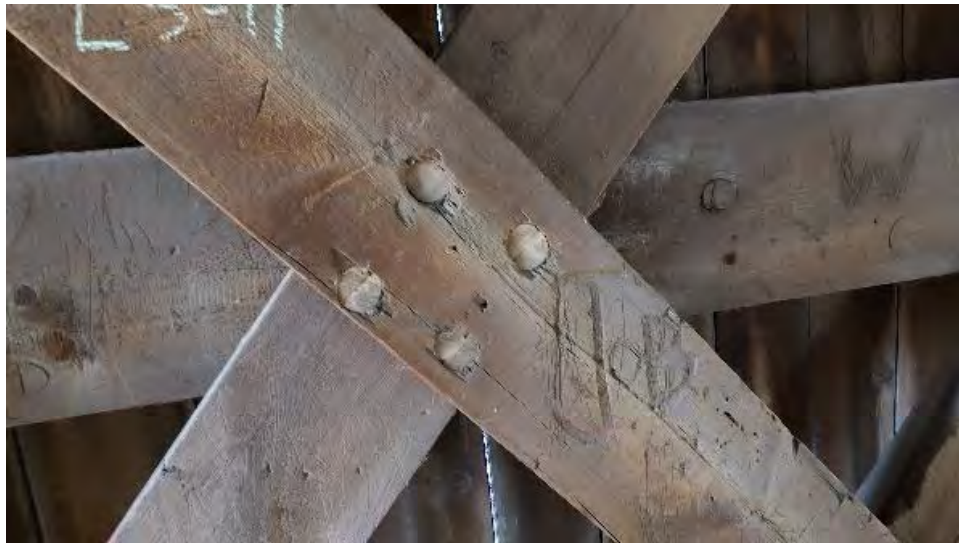
Figure 8-78: L3-11 is cupping on longitudinal alignment on the inside face where pith is evident.

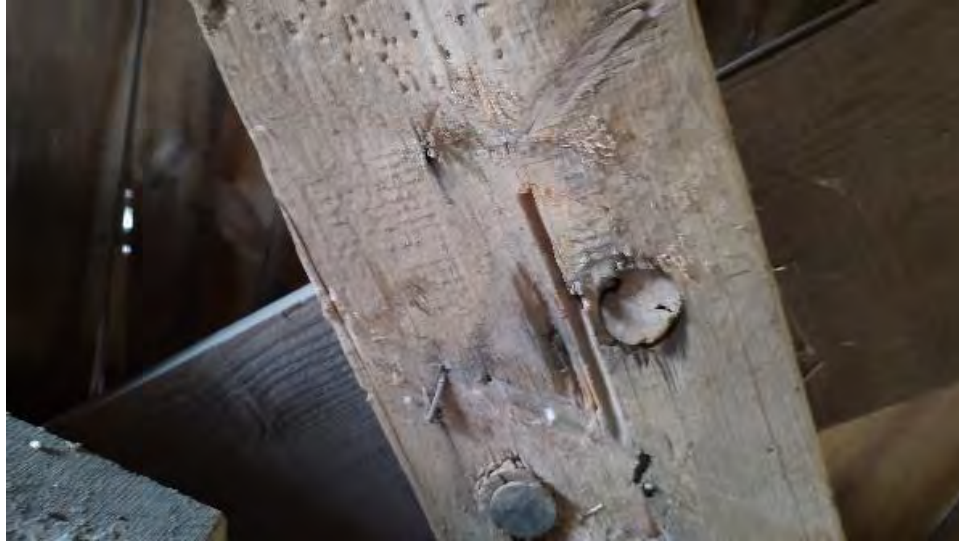
Figure 8-79: L3-11 is cupping on longitudinal alignment on the inside face where pith is evident (note the short pith segment that is missing).

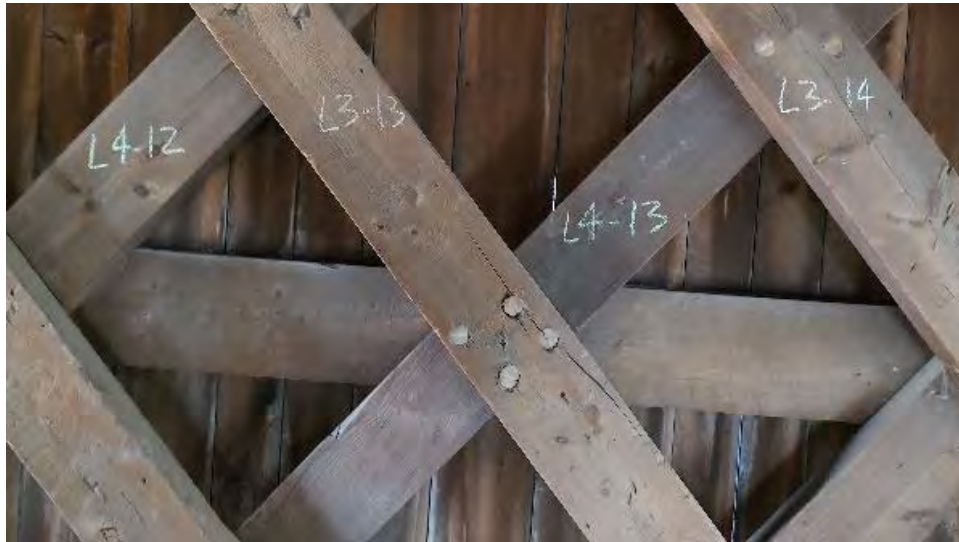
Figure 8-80: L3-13 is cracked through 1 row of dowels at the middle chord and L4-13.

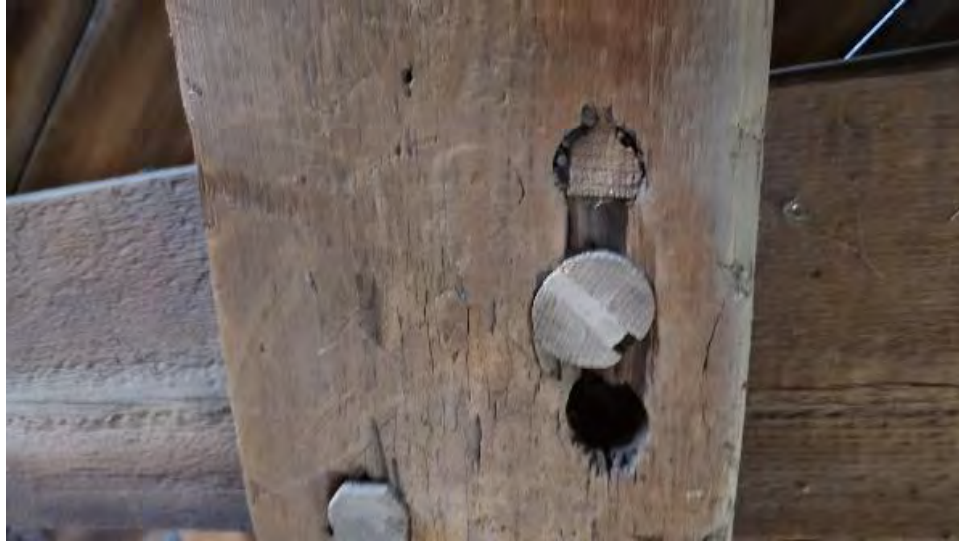
Figure 8-81: Dowel on L3-14 at L4-15 has insufficient distance to adjacent dowel and hole to be effective.

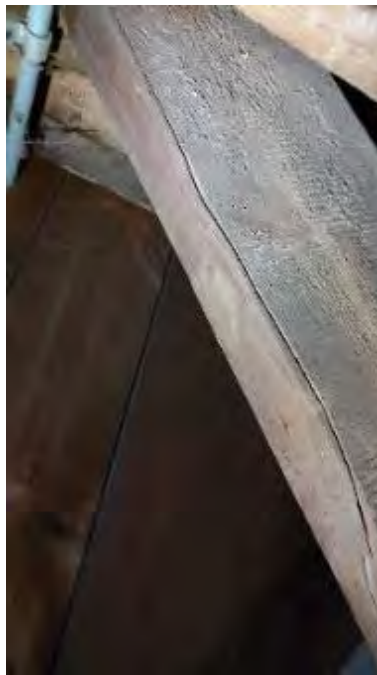
Figure 8-82: The bottom face of L4-11 is cracked.

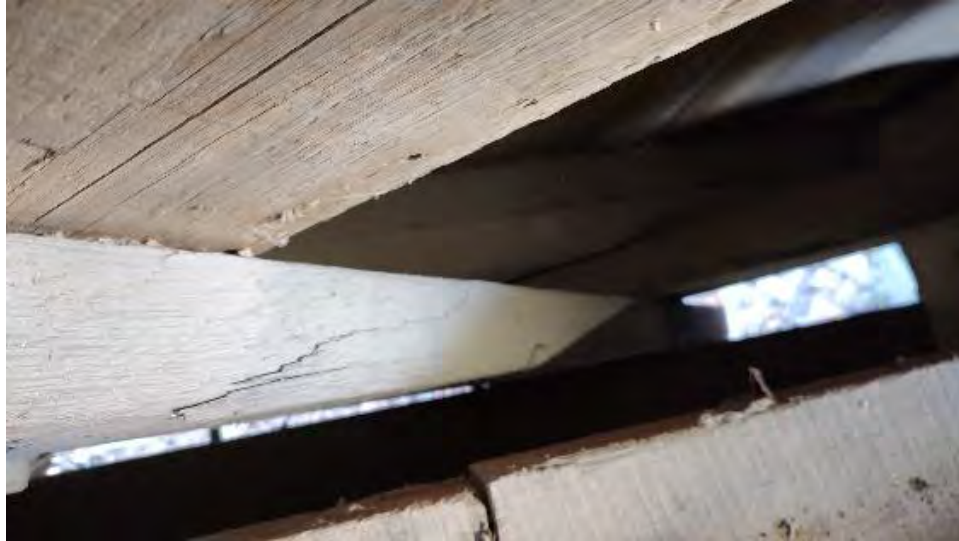
Figure 8-83: L3-16 is cracked below L4-18 towards the bottom.

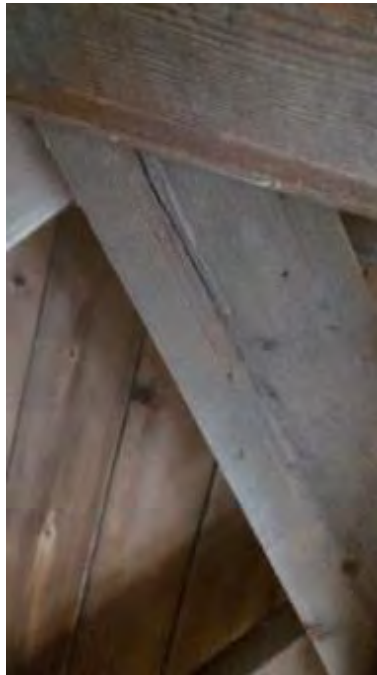
Figure 8-84: L3-18 has end splits originating at both rows of dowels at the top chord.

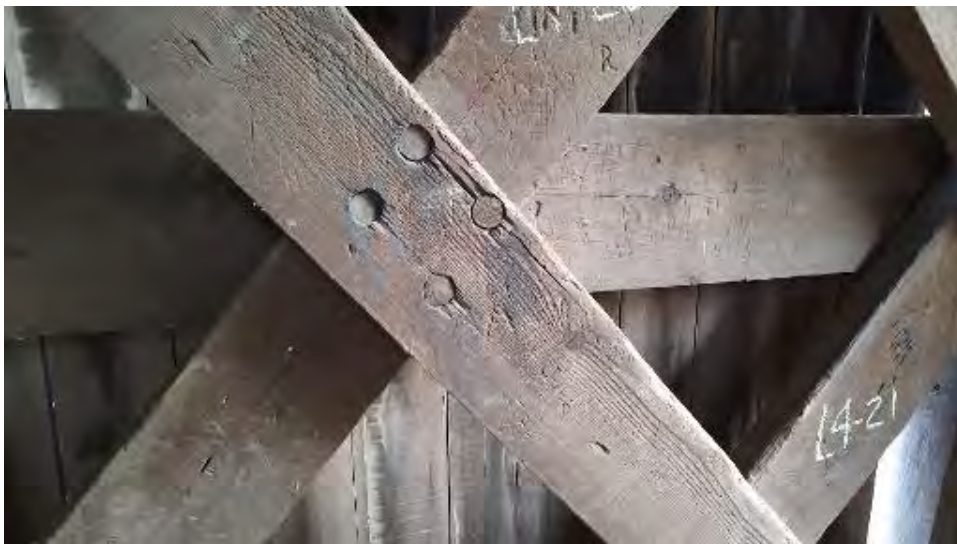
Figure 8-88: L3-20 is cracked at 1 row of dowels at the middle chord and L4-20 connection.

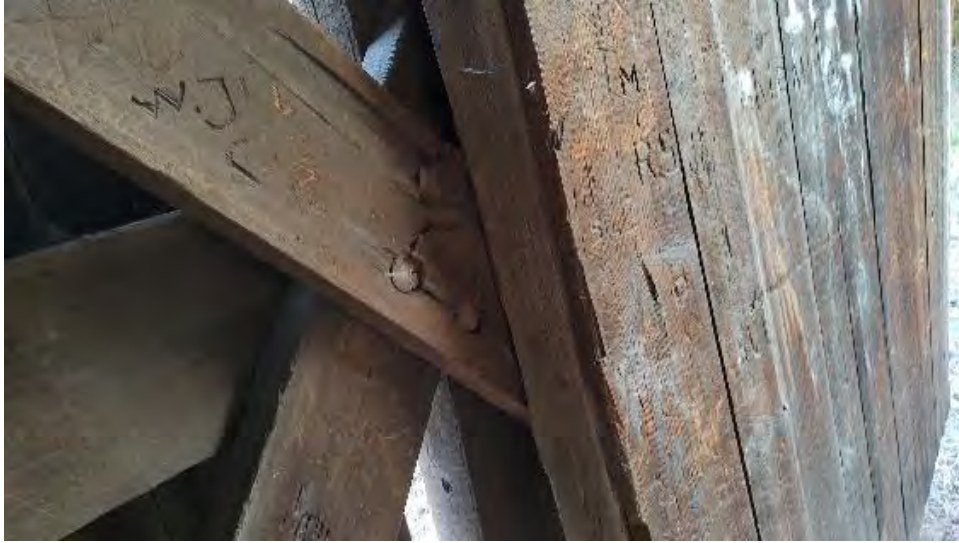
Figure 8-89: L3-21 is broken at the L4-21 connection to P7.

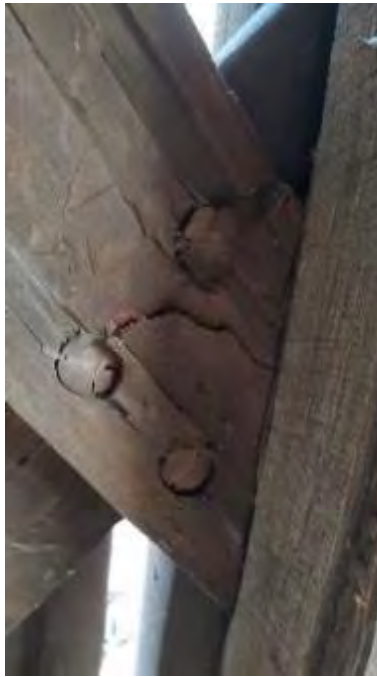
Figure 8-90: L3-21 is broken at the L4-21 connection to P7.

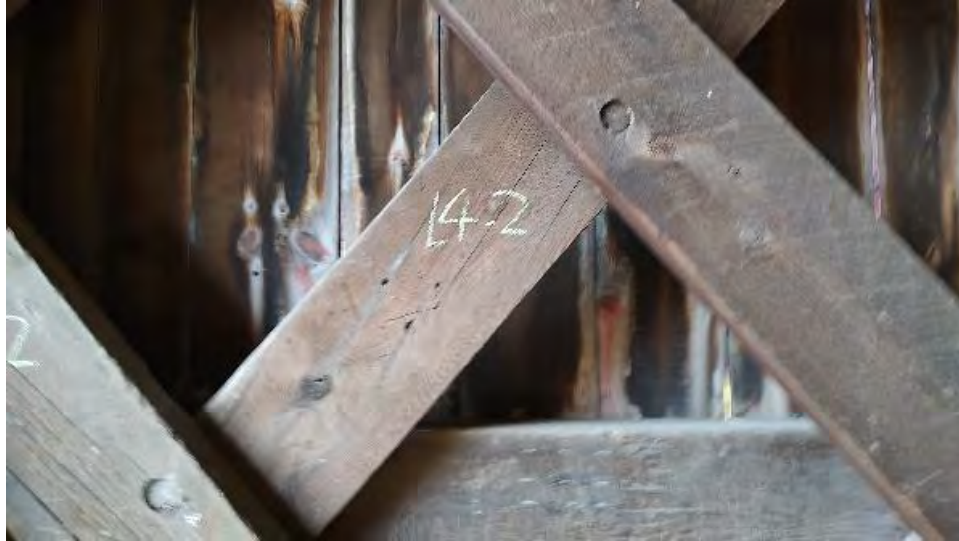
Figure 8-91: L4-2 is cracked either side of the connection to L3-2 and with shrinkage checks through 1 row of dowels.

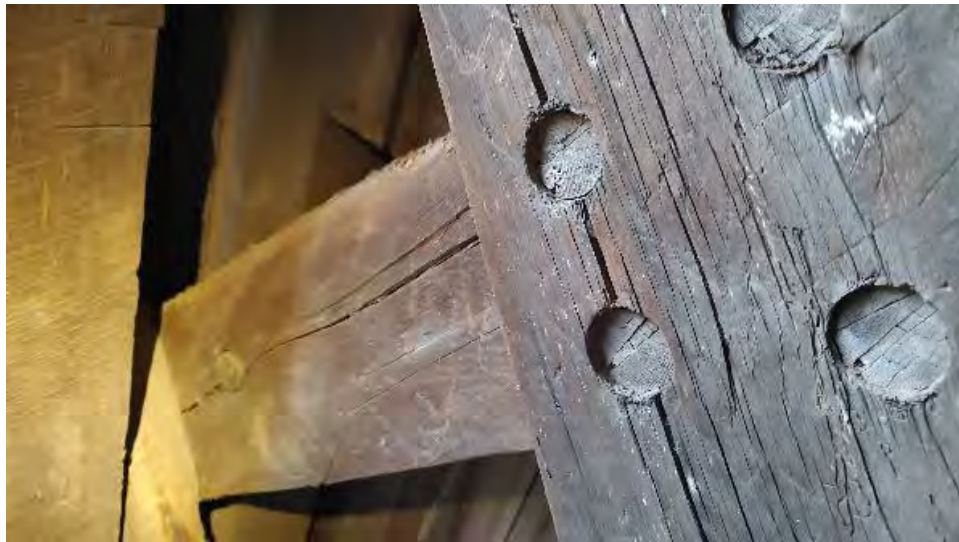
Figure 8-92: L4-2 is cracked either side of the connection to L3-2 and with shrinkage checks through 1 row of dowels.

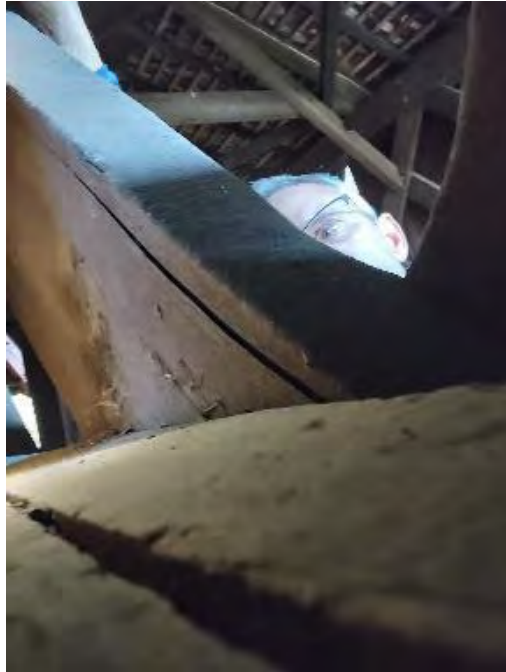
Figure 8-93: L4-2 is cracked either side of the connection to L3-2 and with shrinkage checks through 1 row of dowels.

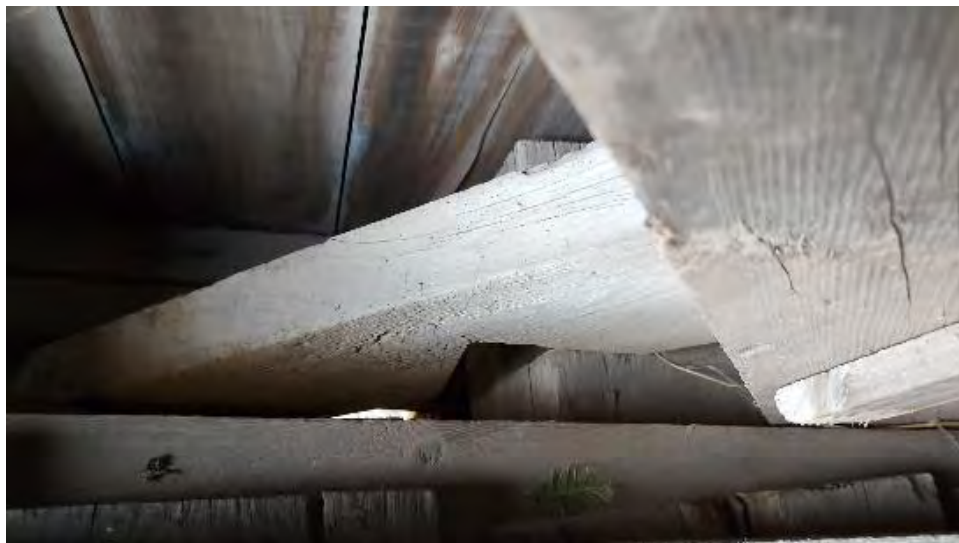
Figure 8-94: L4-4 has a notch 2/3 of its depth over a transverse beam.

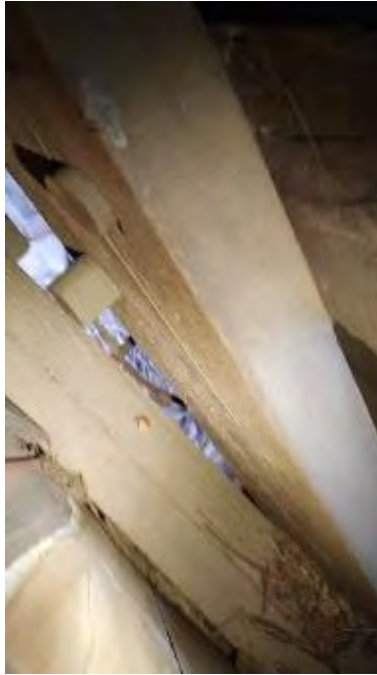
Figure 8-95: L4-5 is cracked through a dowel at the connection to L3-3.

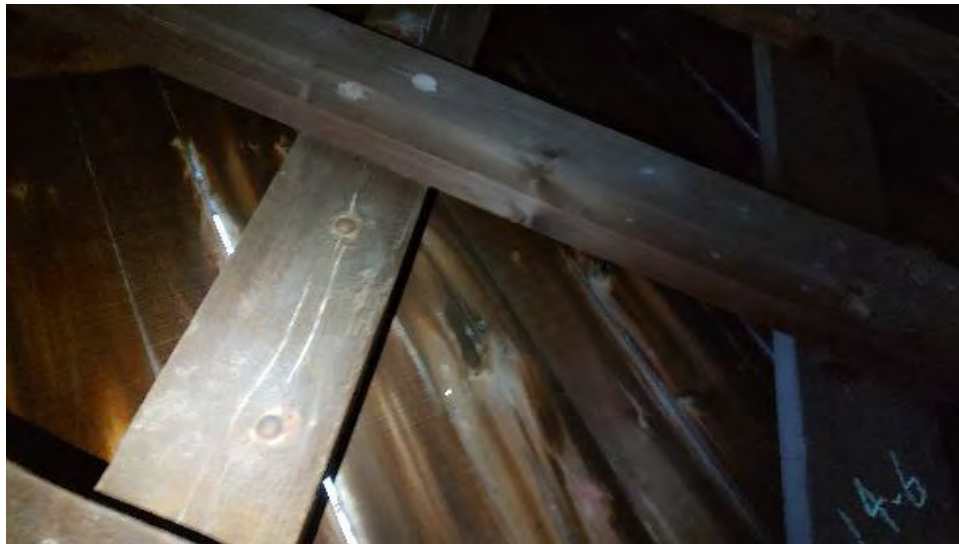
Figure 8-96: 5 is cracked through a dowel at the connection to L3-3.

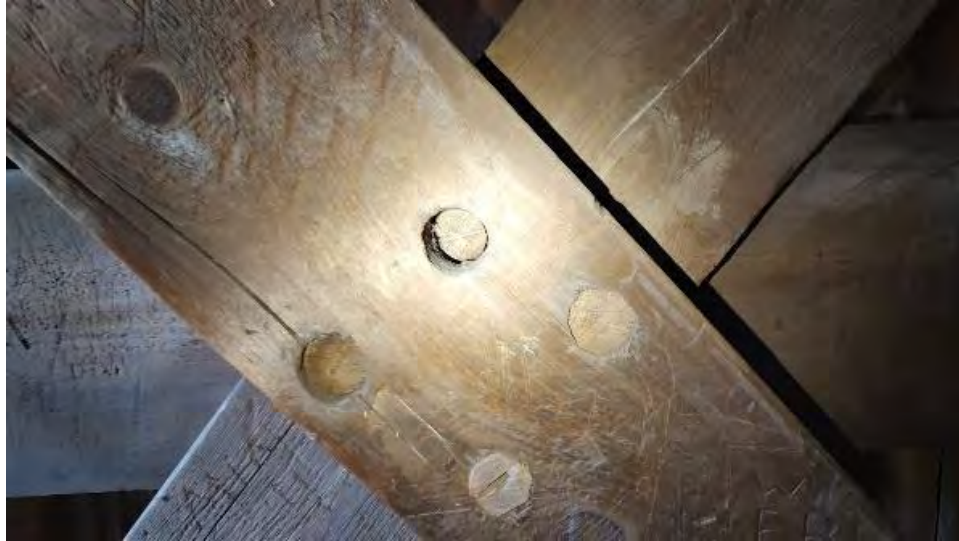
Figure 8-97: L4-7 is cracked through a row of dowels at the connection to L3-7. White surface fungi is seen on L3-7 above this connection. The top dowel does not penetrate through L4-7.

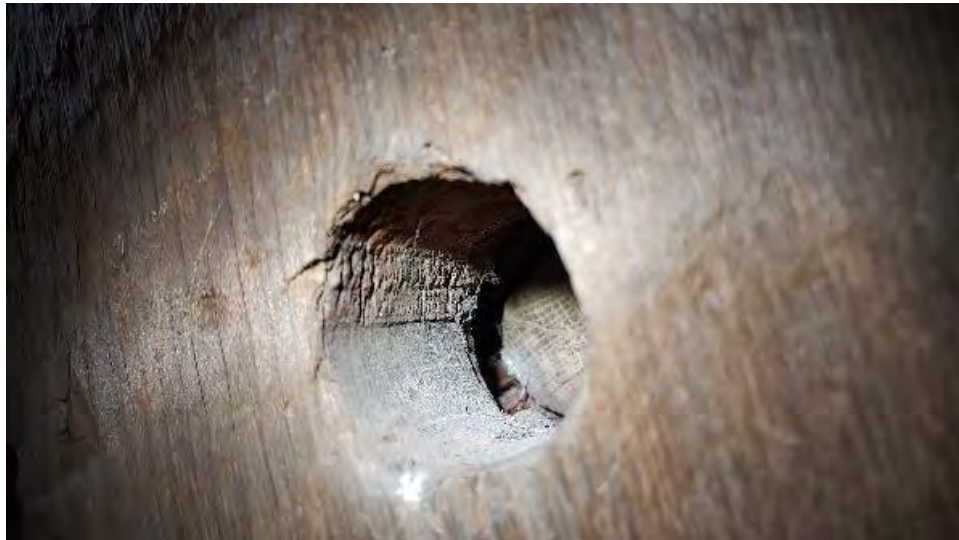
Figure 8-98: L4-7 is cracked through a row of dowels at the connection to L3-7. White surface fungi is seen on L3-7 above this connection. The top dowel does not penetrate through L4-7.

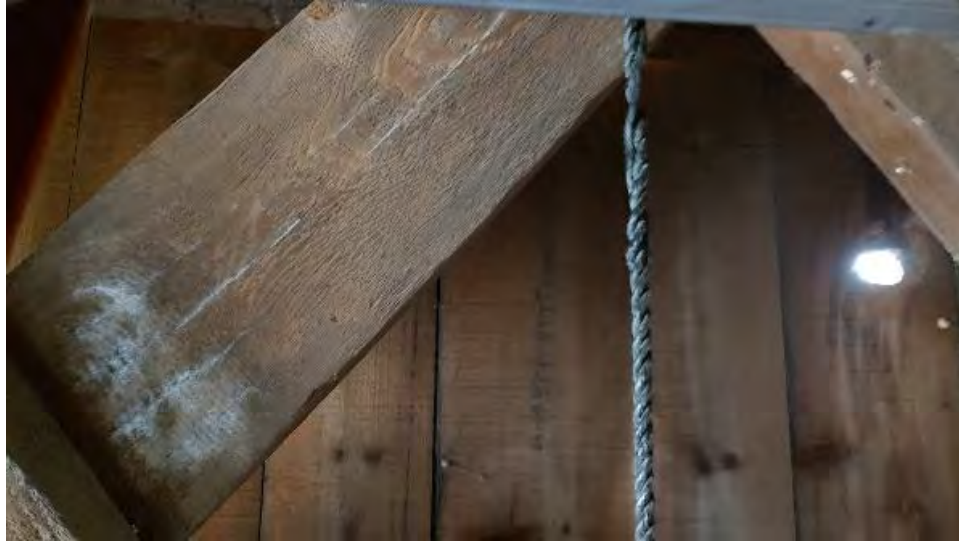
Figure 8-99: L4-7 is cracked through a row of dowels at the connection to L3-7. White surface fungi is seen on L3-7 above this connection. The top dowel does not penetrate through L4-7.

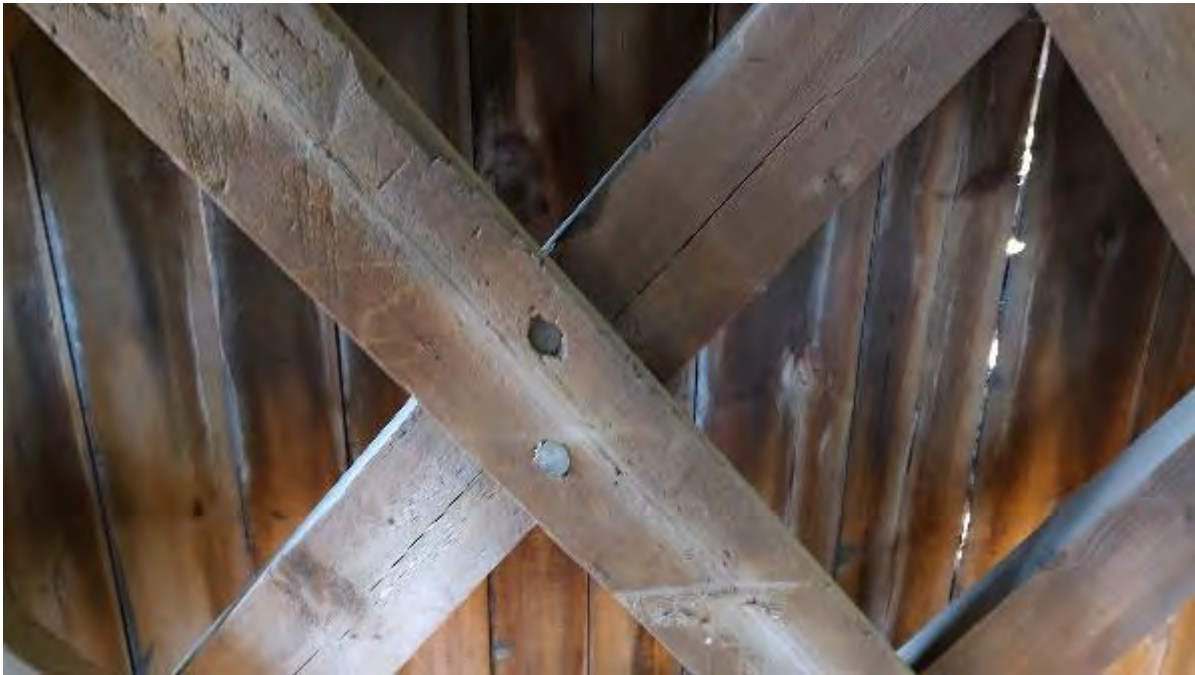
Figure 8-100: L4-12 is cracked through the bottom dowel at L3-11.

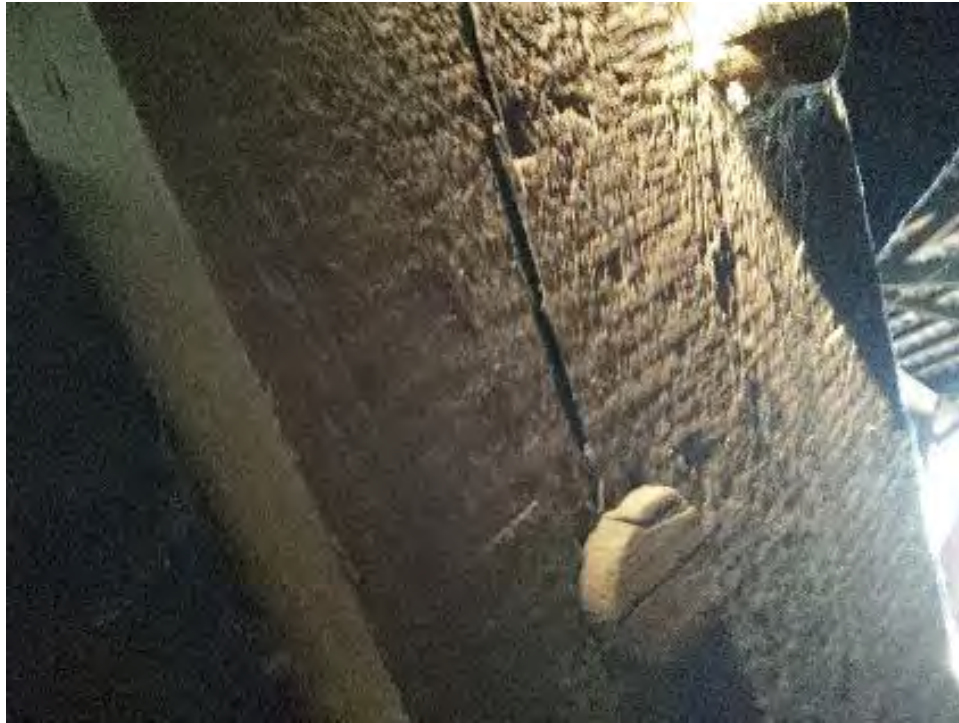
Figure 8-101: L4-12 is cracked through the bottom dowel at L3-11.

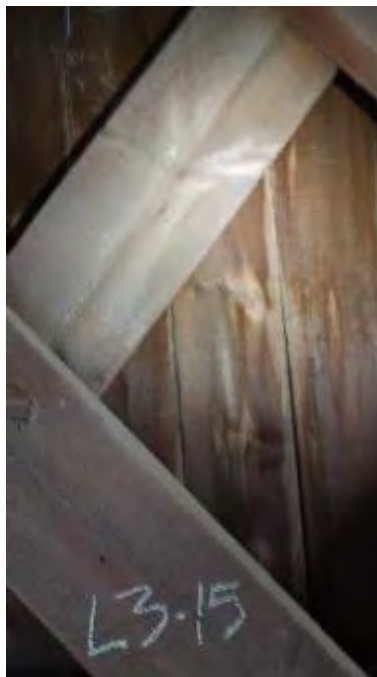
Figure 8-102: L4-14 has pith at mid depth on the inside face.

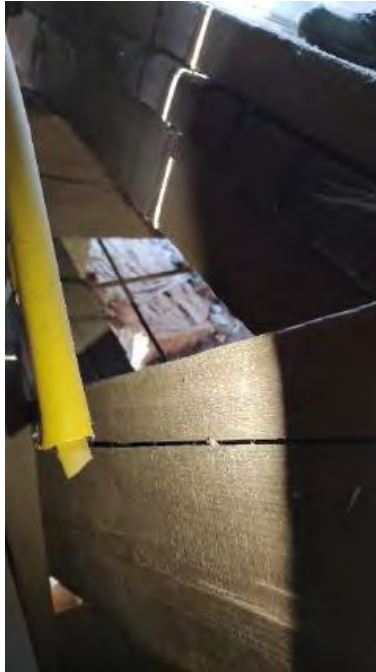
Figure 8-109: L4-22 is broken at the deck level.

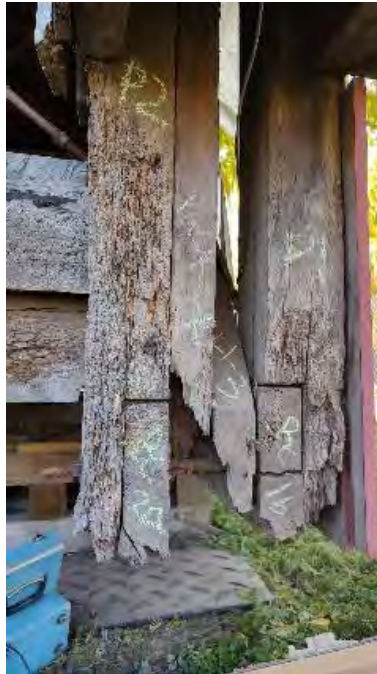
Figure 8-110: Post P1 is decayed and with termite damage for bottom 2-feet. P2 is decayed and with insect damage and section loss for bottom 3-feet. The packer between P2 and the lattice member has decayed and section loss.

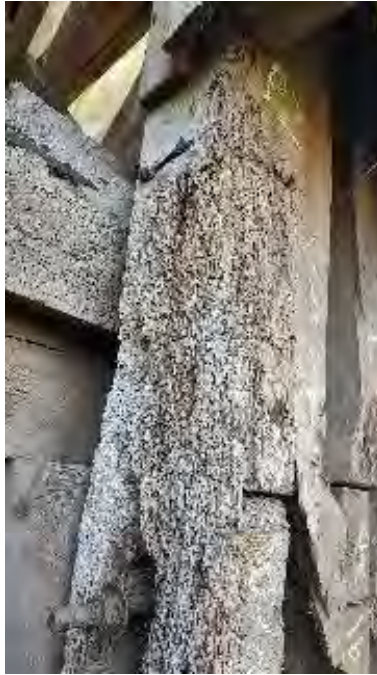
Figure 8-111: P2 is decayed with insect damage and section loss for bottom 3-feet.

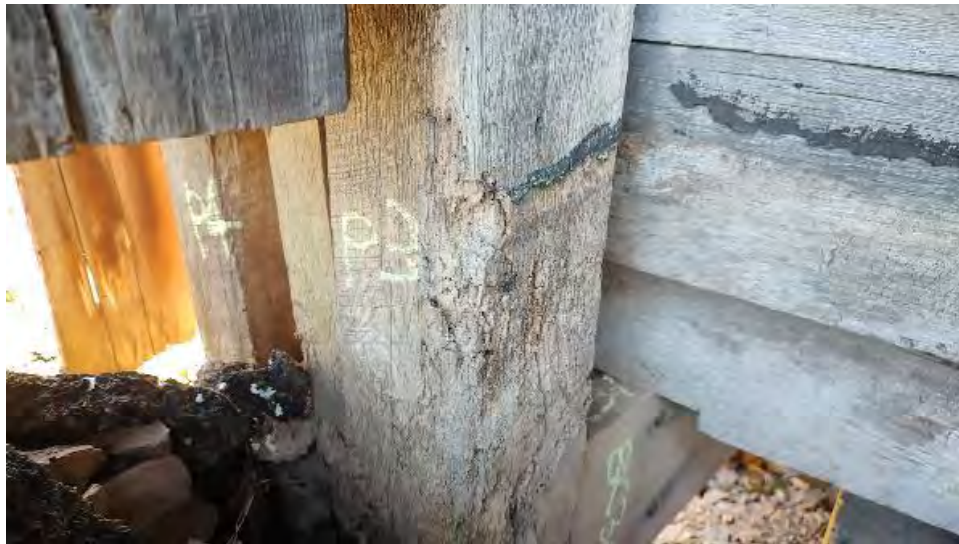
Figure 8-112: P3 is in very poor condition with decay extending 30-inches from the bottom.

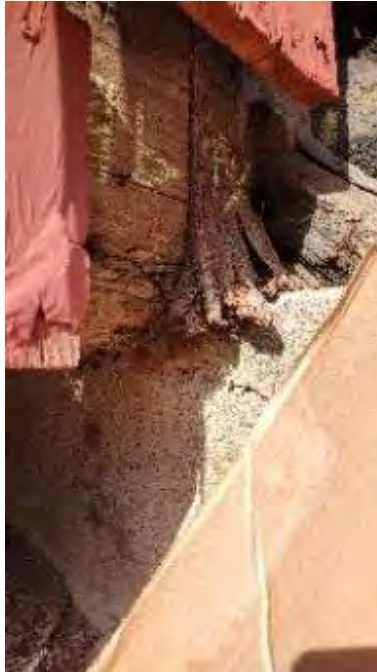
Figure 8-113: P4 is crushed for 6-inches from bottom.

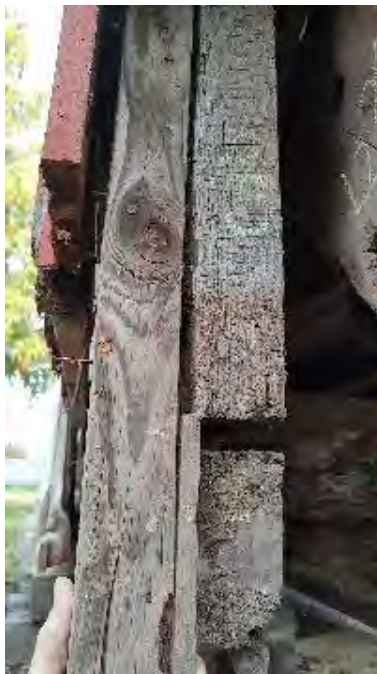
Figure 8-114: P5 has a 2x2 1/2" notch on the BC1A alignment. The bottom 12-inches are missing and the next 16-18- inches are decayed.

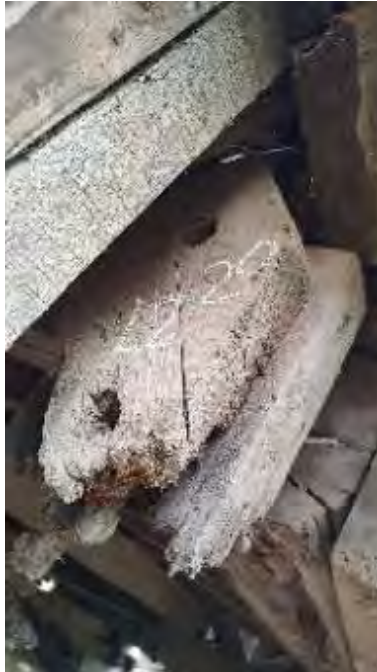
Figure 8-115: The bottom 16-inches of P6 are missing and the next 10-inches are decayed.

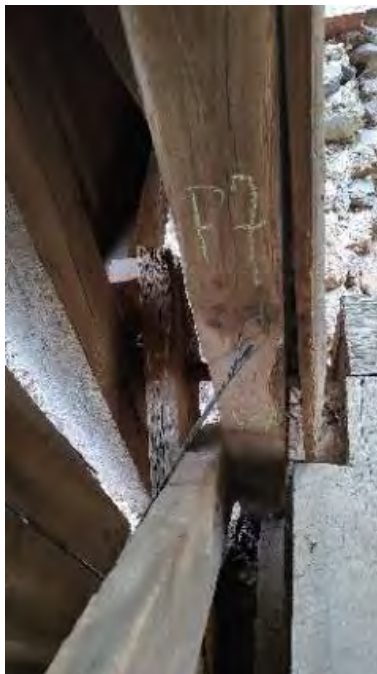
Figure 8-116: The bottom 16-inches of P7 are in very poor condition with decay.

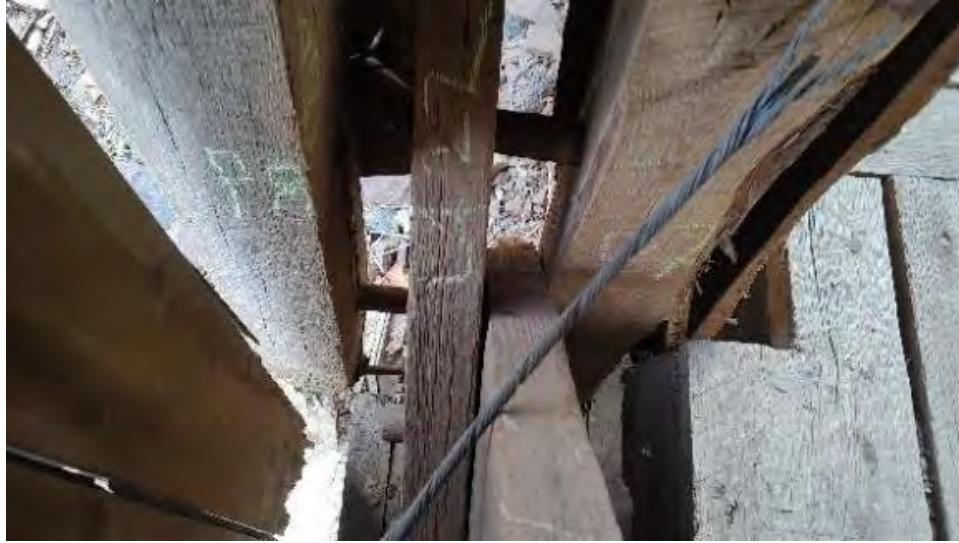
Figure 8-117: The bottom 12-inches of P8 are broken. There is a split up to 3-feet from the bottom and has disconnected from 2 dowels. The dowels are broken.

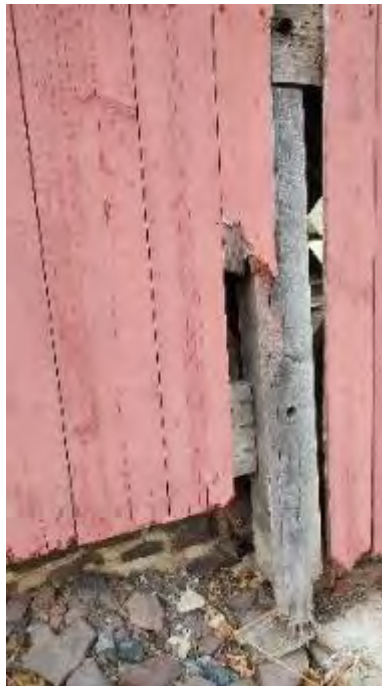
Figure 8-118: The bottom 12-inches of P8 are broken. There is a split up to 3-feet from the bottom and has disconnected from 2 dowels. The dowels are broken.

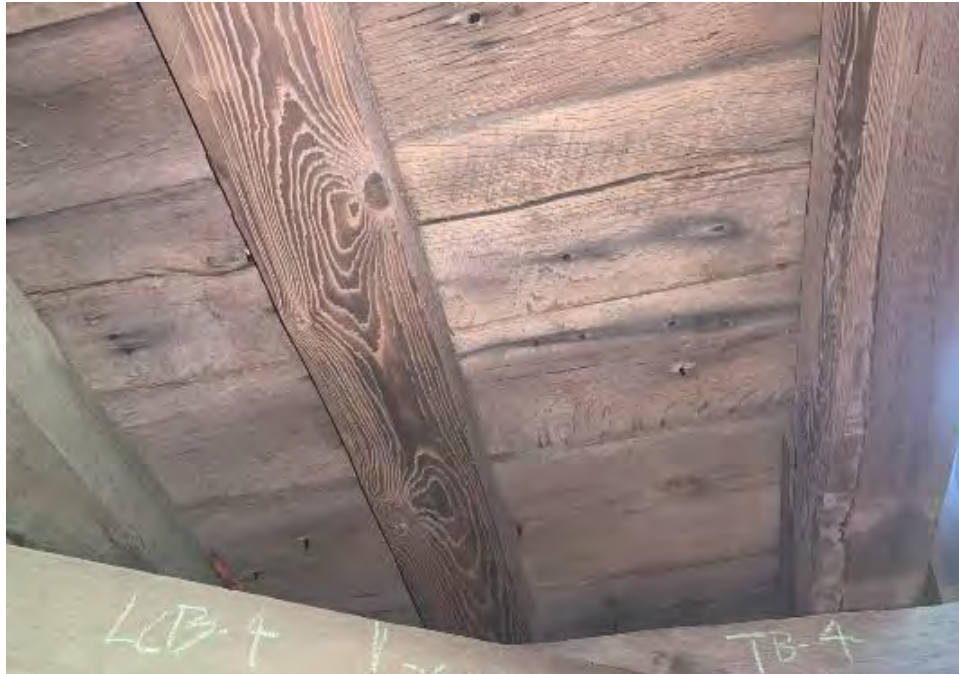
Figure 9-7: Lower layer of decking of Span 3 with termite damage.

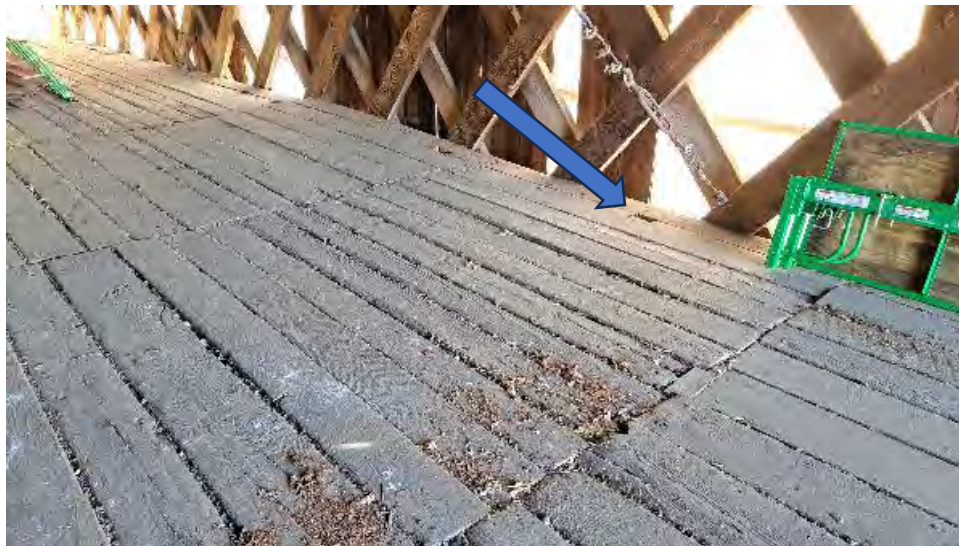
Figure 9-8: Floor decking Span 3, North side, with hole in Plank 2.

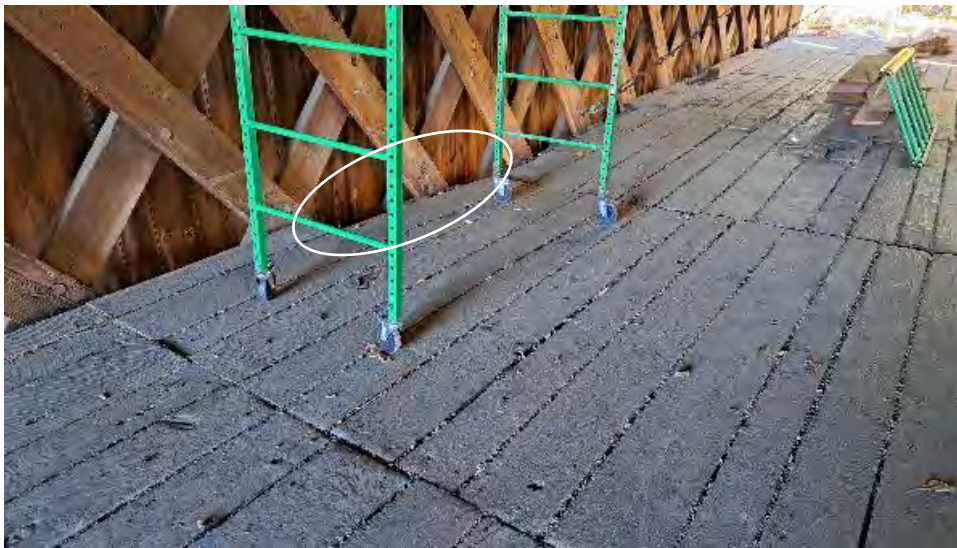
Figure 9-10: Floor decking Span 5, South side. Half of Plank is 18 missing.
