South Perkasio Covered Bridge Inspection Report

SUBMITTED TO:
Borough Of Perkasio
149 W Walnut St,
Perkasio, PA 18944
(Phone Number TBD); (Email TBD)

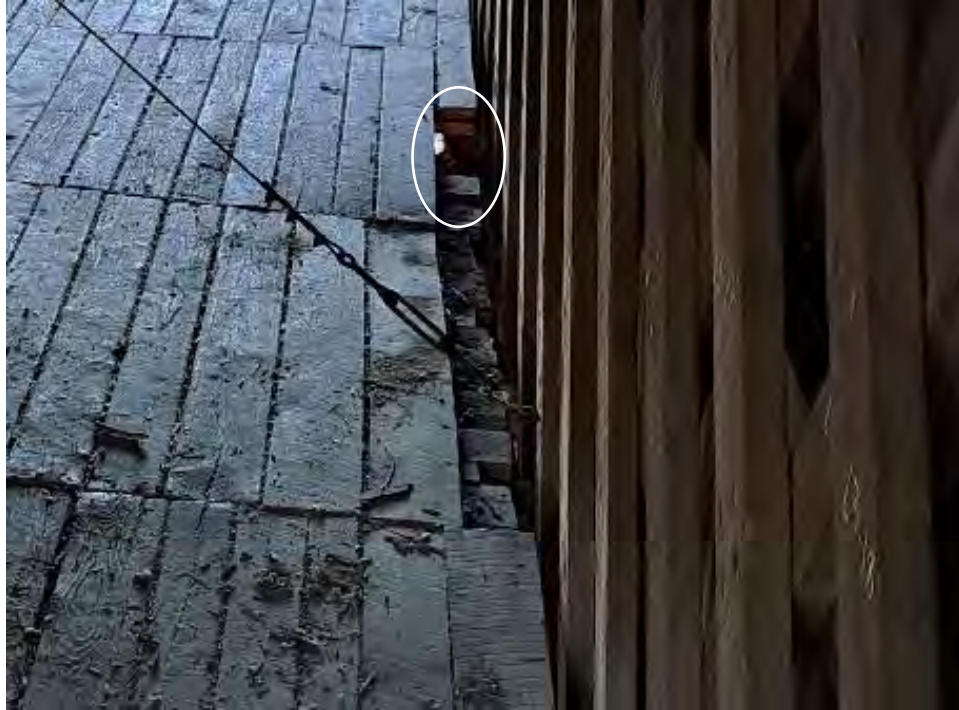
Figure 9-11: Floor decking Span 5, South side. Half of Plank 18 is missing.

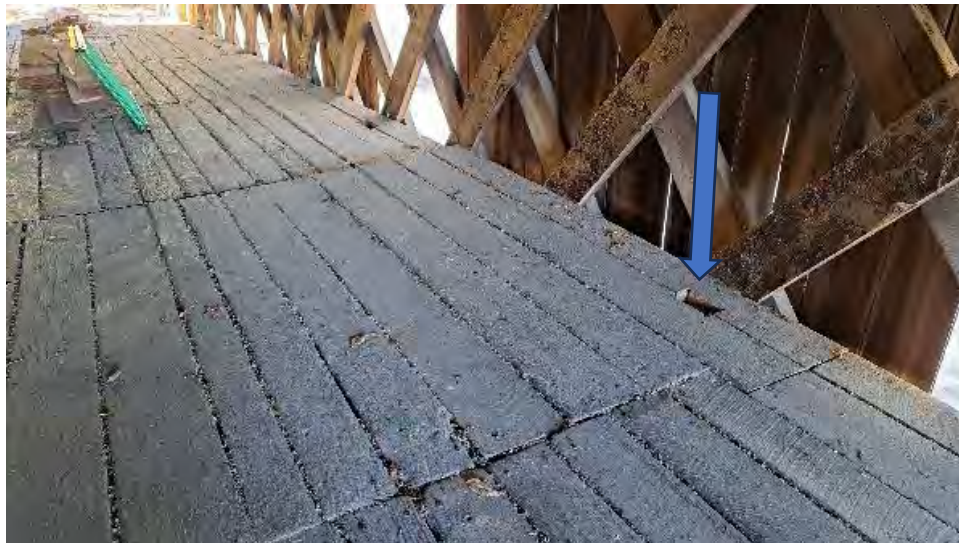
Figure 9-12: Floor decking Span 5, North side, with common hole in Planks 1 and 2.

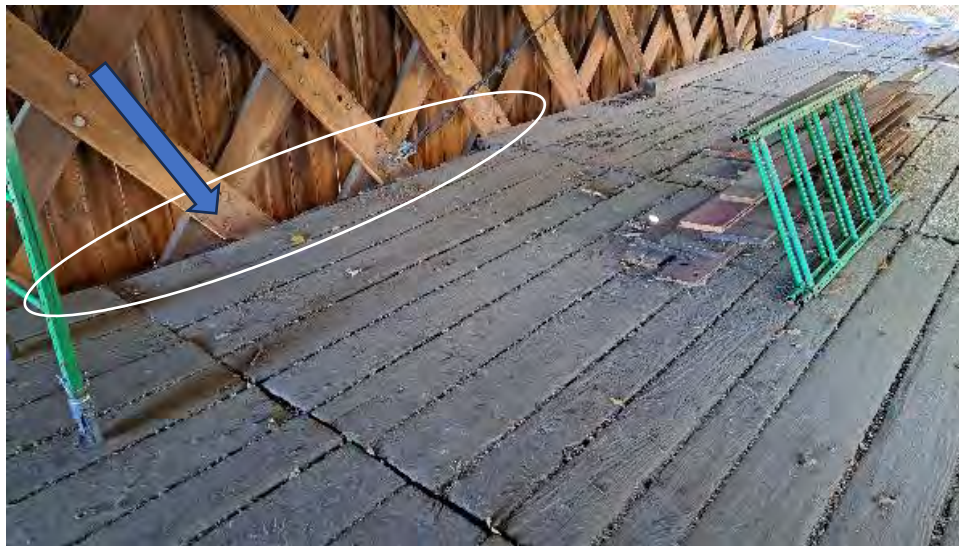
Figure 9-14: Floor decking Span 6, South side, where Plank 18 is missing.

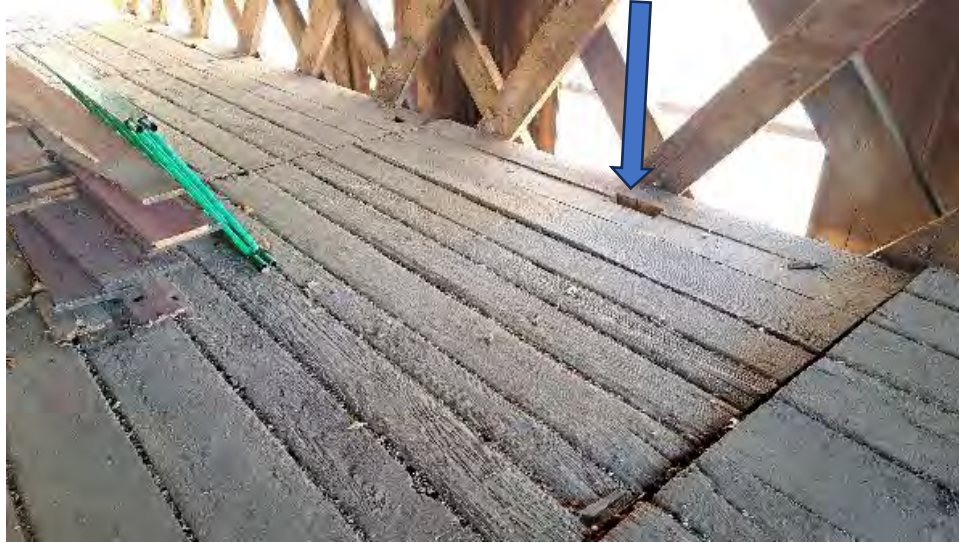
Figure 9-15: Floor decking Span 6, North side, with common hole in Planks 1 and 2.

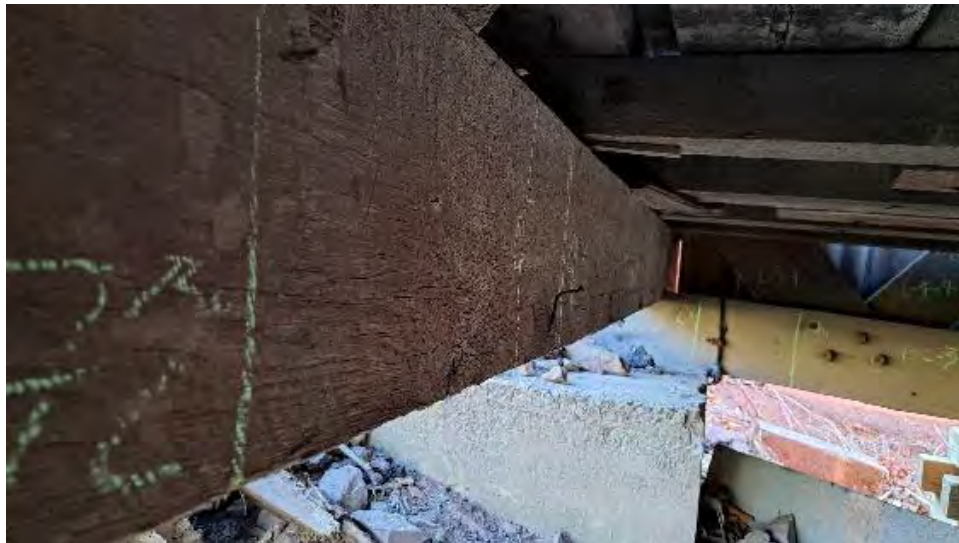
Figure 9-23: TB1 has some section loss (old split) on Abutment 2 side, North end on bottom corner for 12-inches.

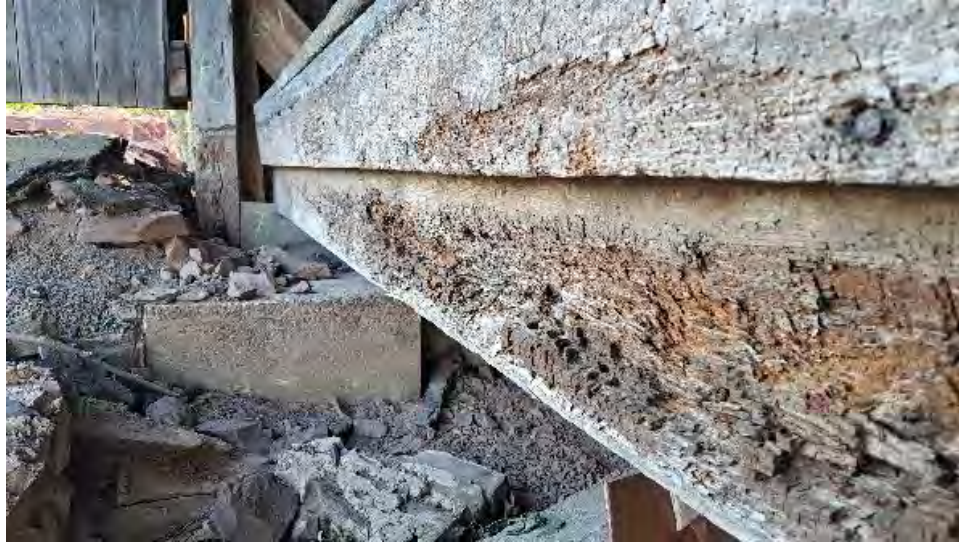
Figure 9-24: TB1 on Abutment 1 side is decayed and section loss up to 2-inches deep.

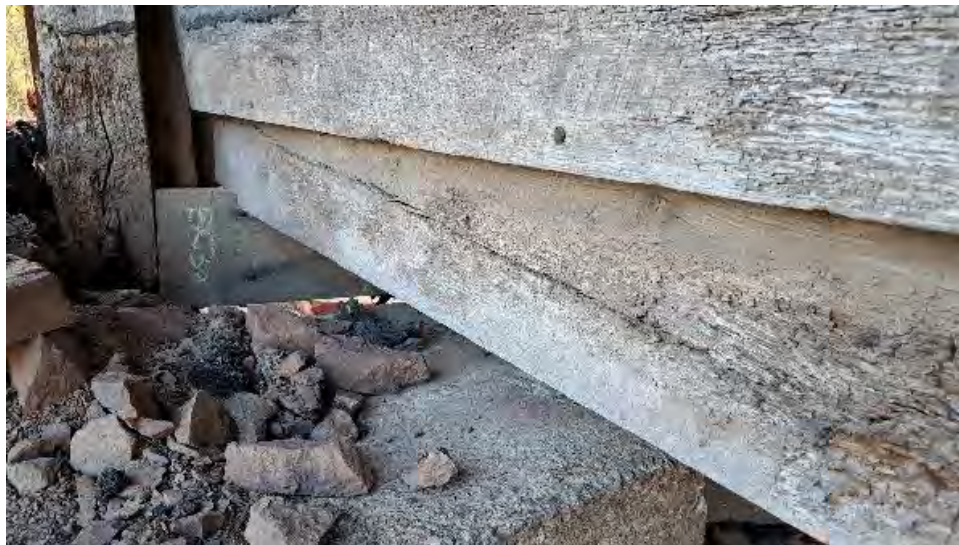
Figure 9-25: TB1 has a large shrinkage check originating from the South end, on Abutment 1 side which extends for 5 to 6 feet.

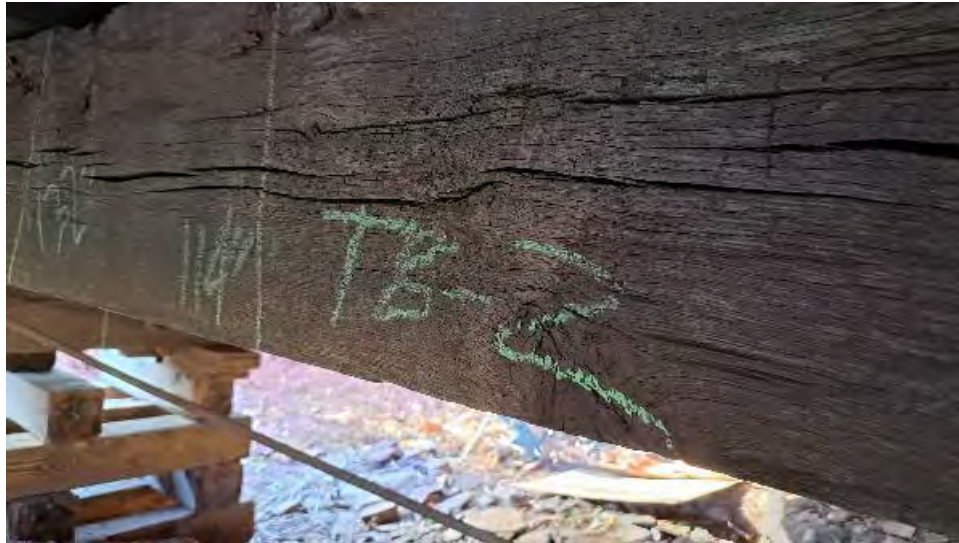
Figure 9-27: Significant shrinkage checking exists to TB2.

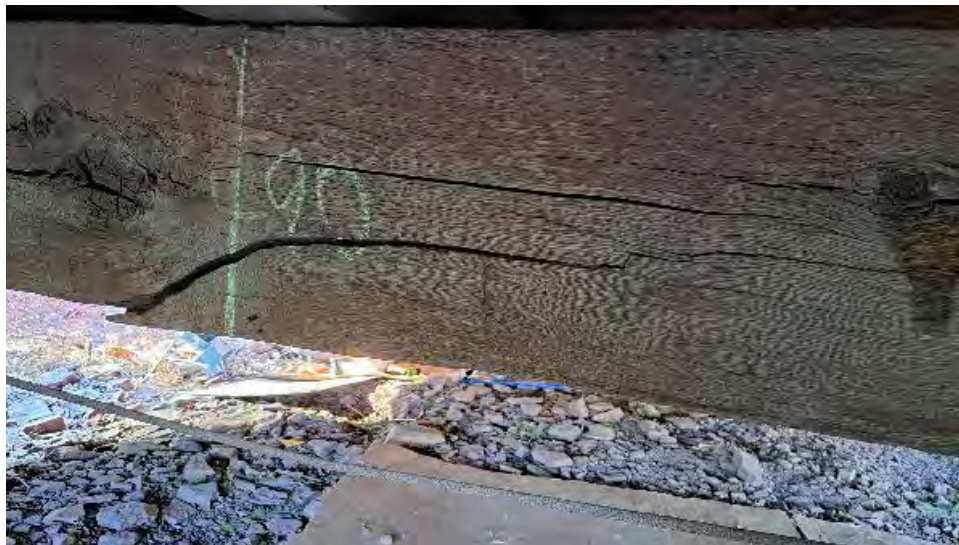
Figure 9-28: TB2 is broken, extending from the bottom face at mid span and caused by extreme slope of grain around a large knot on the side face.

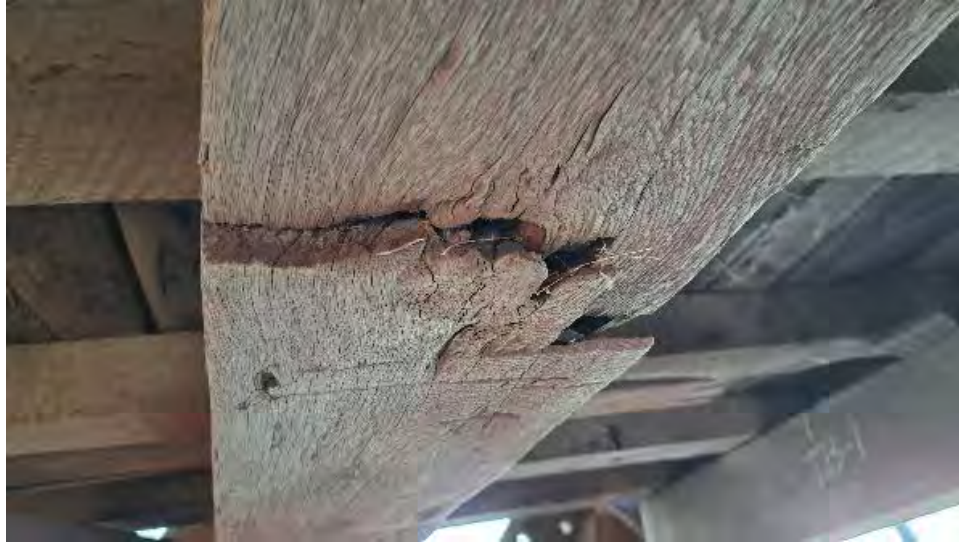
Figure 9-29: TB2 is broken, extending from the bottom face at mid span and caused by extreme slope of grain around a large knot on the side face.

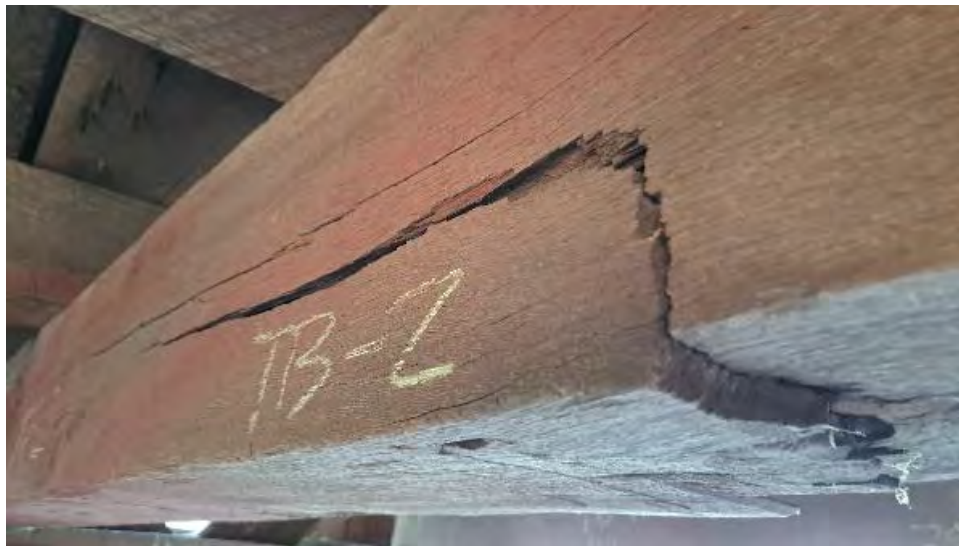
Figure 9-30: TB2 is broken, extending from the bottom face at mid span and caused by extreme slope of grain around a large knot on the side face.

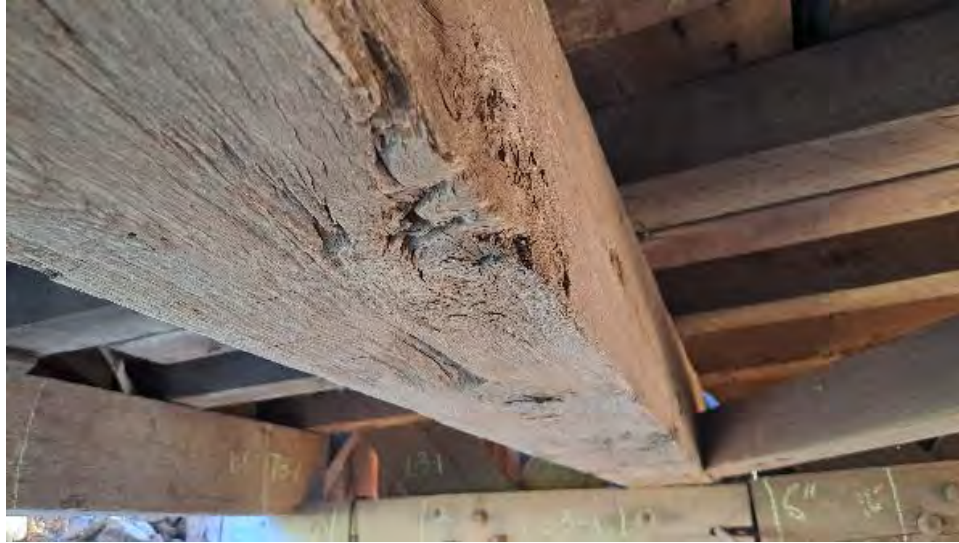
Figure 9-31: TB2 has another large knot on the bottom AB2 edge near the northern end.

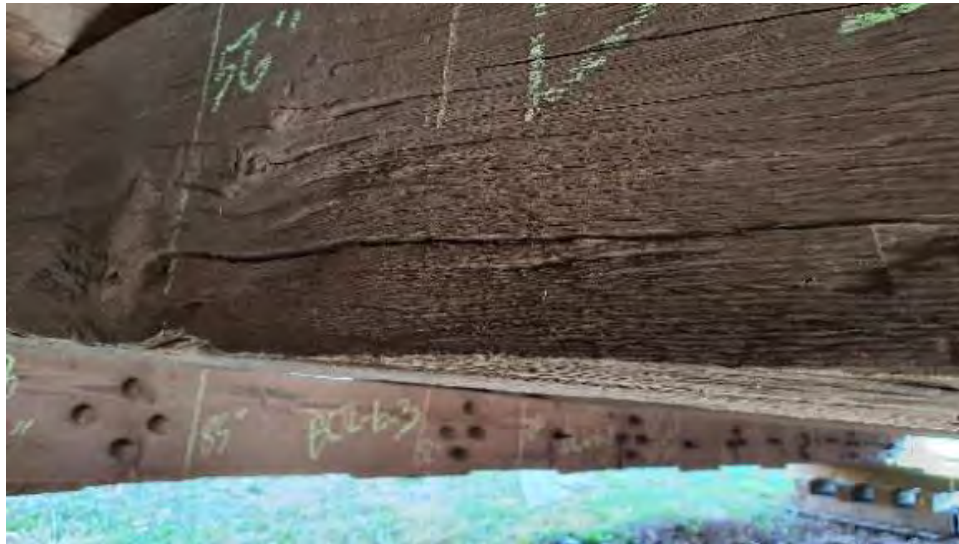
Figure 9-39: TB5 has a slope of grain crack on the AB2 side at 1/3 span from the North end with some section loss in bottom face.

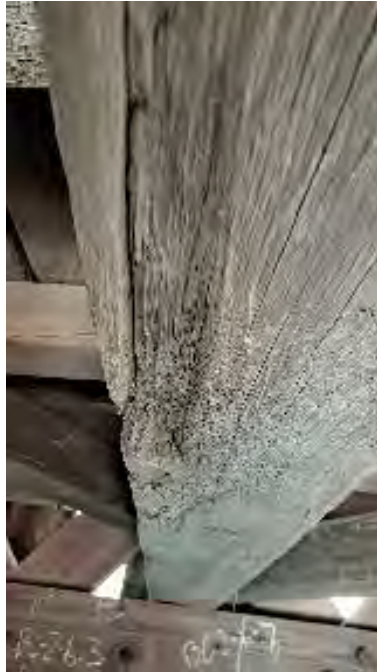
Figure 9-40: TB5 has a slope of grain crack on the AB2 side at 1/3 span from the North end with some section loss in bottom face. Planer skips and chisel scars are on all visible sides.

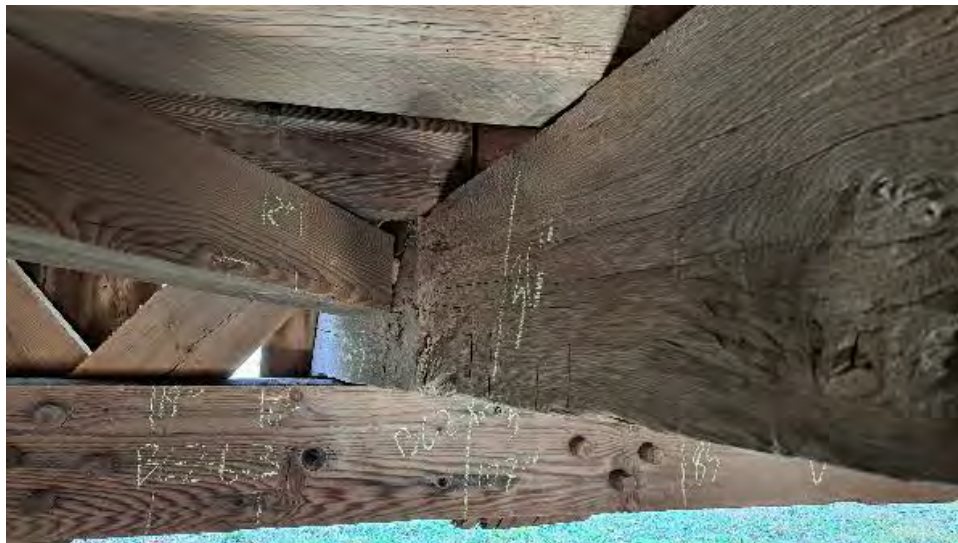
Figure 9-41: TB5 has planer skips and chisel scars on all visible sides. The North end is twisted 4 degrees and is lifting on the AB1 side from BC2.

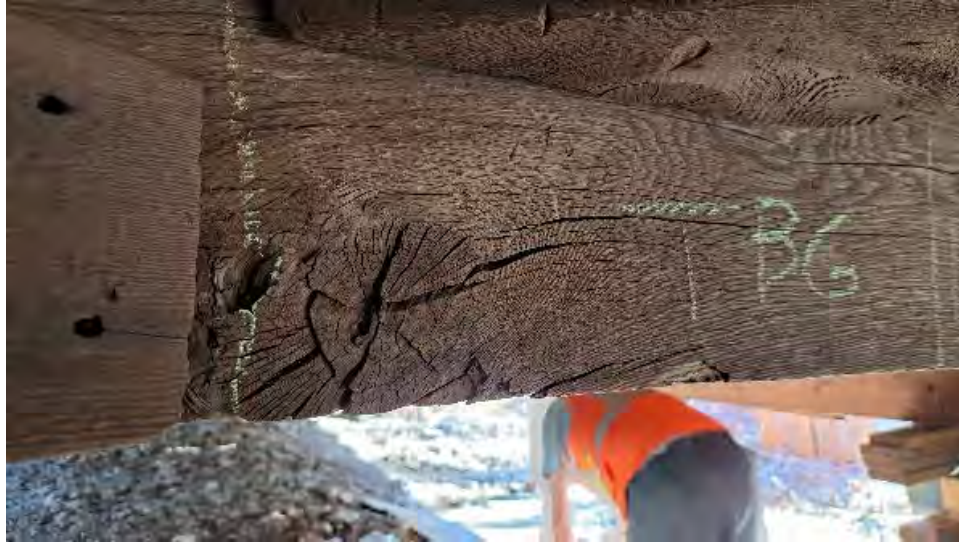
Figure 9-43: TB6 has a large knot on the AB2 side and a vertical crack approximately 20-inches from the North end.

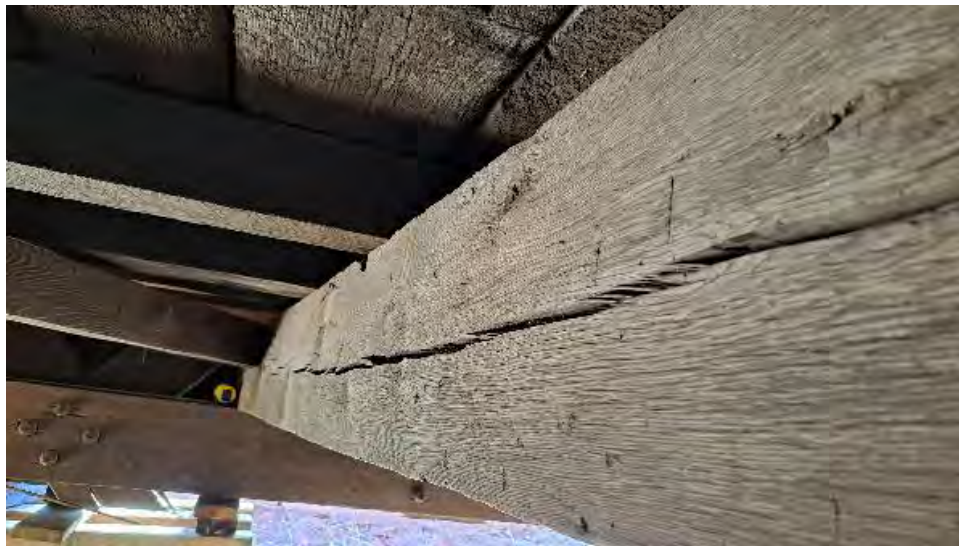
Figure 9-44: TB6 has large shrinkage checks on AB1 side, up to 2-inches deep and 1/2-inch wide.

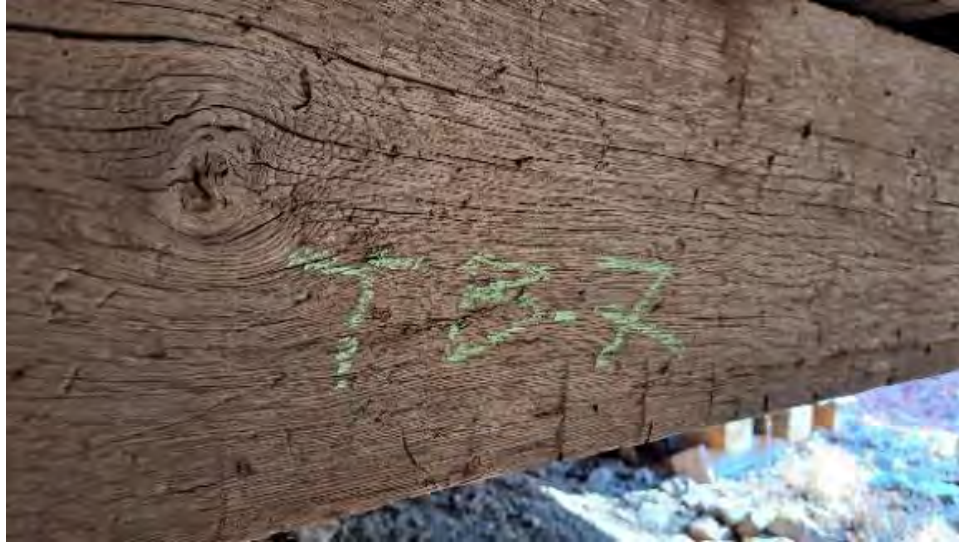
Figure 9-46: TB7 has planer skips and chisel scars on the AB1 side.

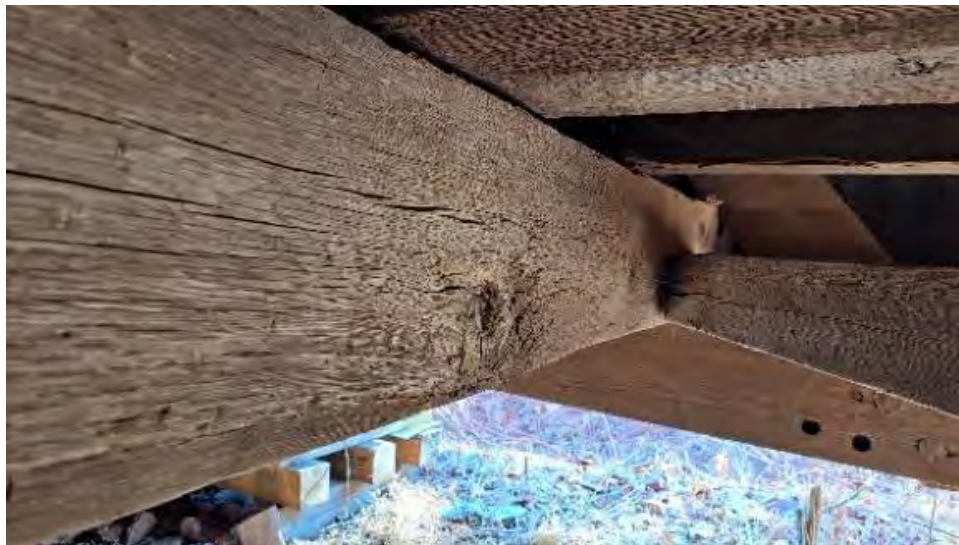
Figure 9-47: TB7 has a large knot on the AB1 side. Section loss exists above BC3A resulting from the old slope of grain cracks.

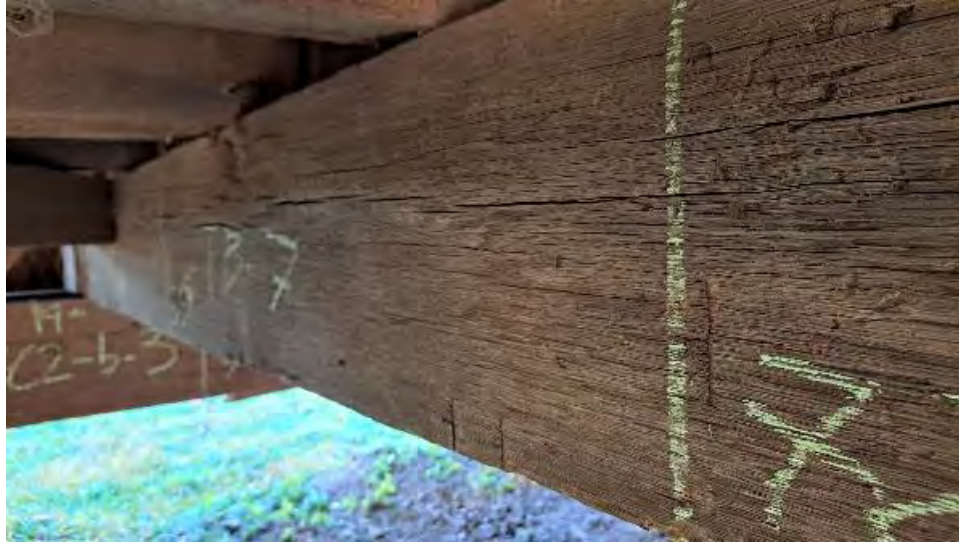
Figure 9-48: TB7 has planer skips, chisel scars and a large knot on the AB2 side, to the lower edge at 1/3 span location from the North end.

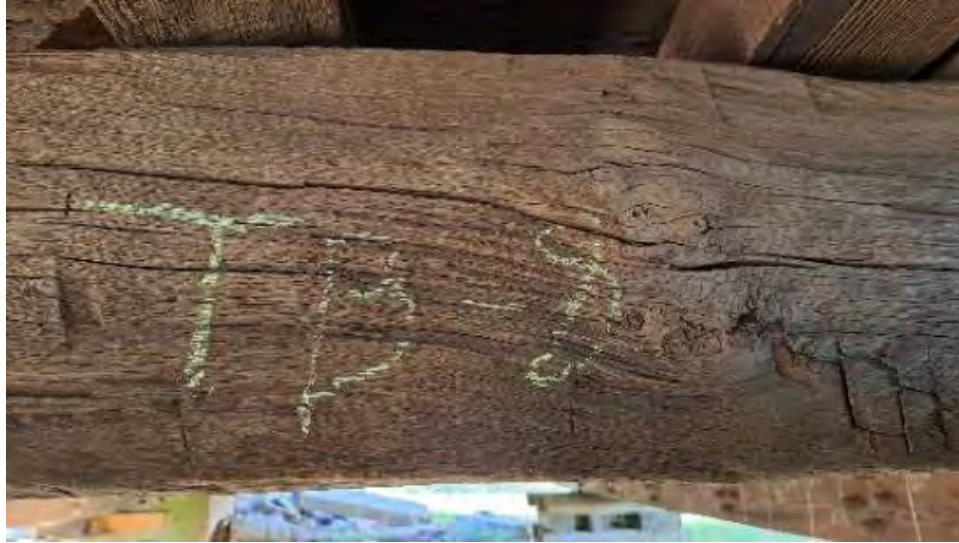
Figure 9-49: TB8 has planer skips and chisel scars on all visible sides with some minor shrinkage checking.

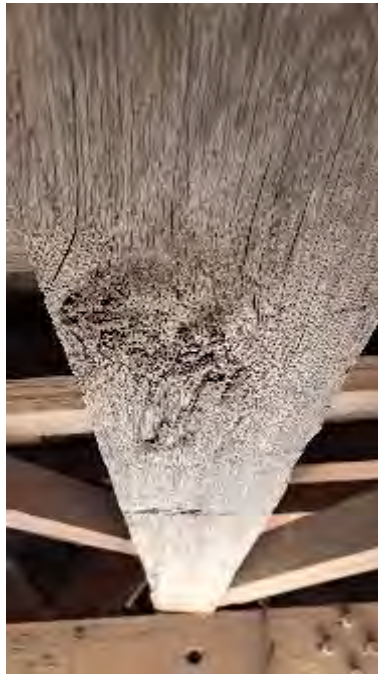
Figure 9-52: A small knot with minor section loss due to old slope of grain cracks exist on the bottom face at mid span.

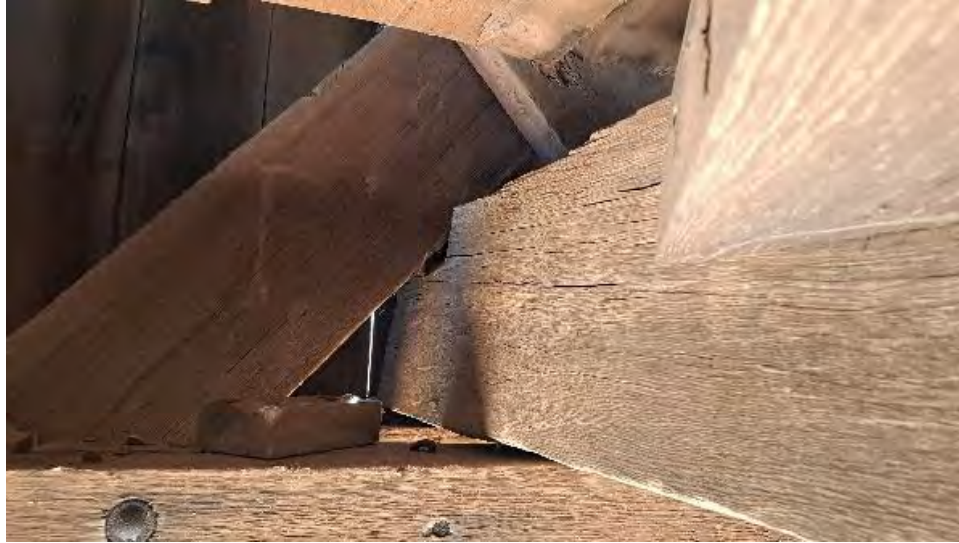
Figure 9-53: TB8 is twisted at the North end by 2-inches and has lifted off BC2 on the AB2 side.

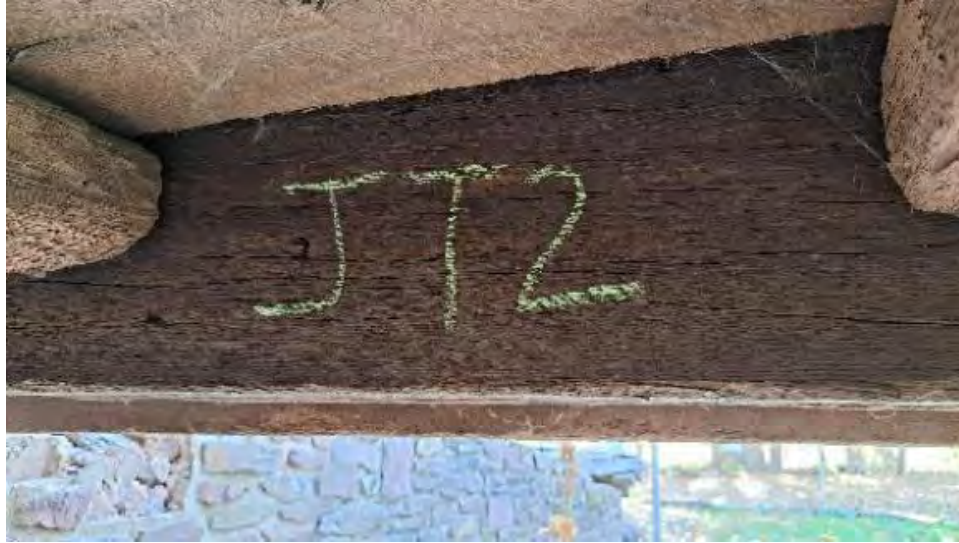
Figure 9-66: JT2 has wane at the mid span on the lower AB2 edge.

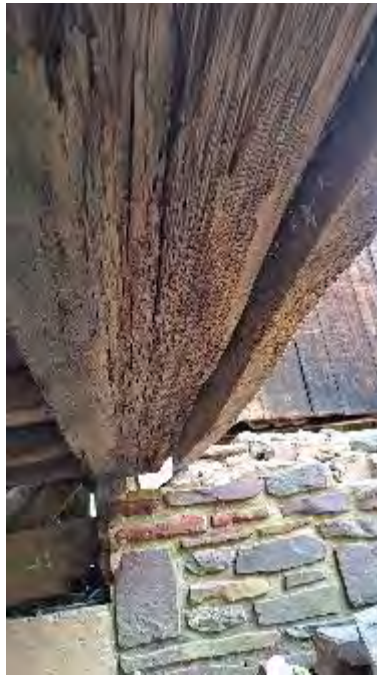
Figure 9-67: JT2 is severely decayed and with section loss on bottom face. A 3-inch-deep cavity exists on the bottom face. JT2 is not currently supported at either end.

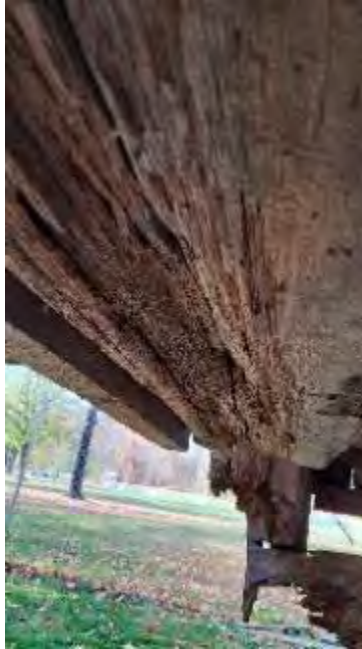
Figure 9-68: JT2 is severely decayed and with section loss on bottom face. A 3-inch-deep cavity exists on the bottom face. JT2 is not currently supported at either end.

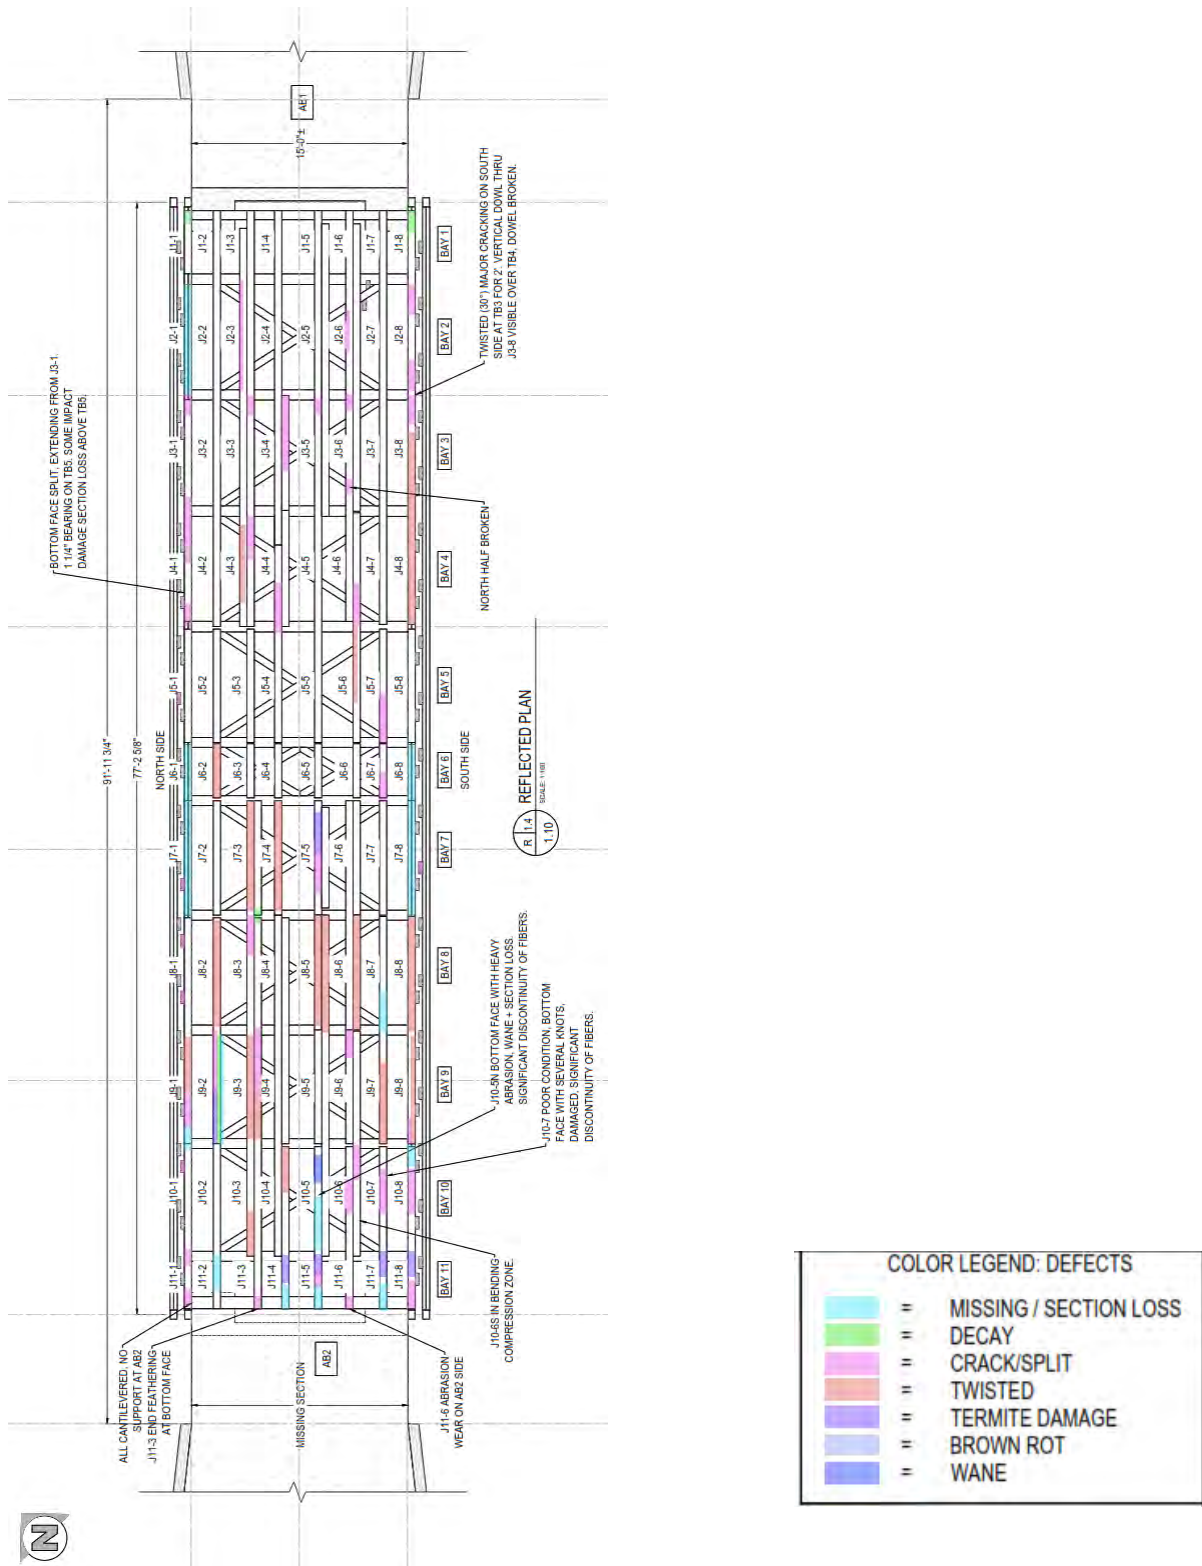
Figure 9-69: Summary of visual inspection on the joists.

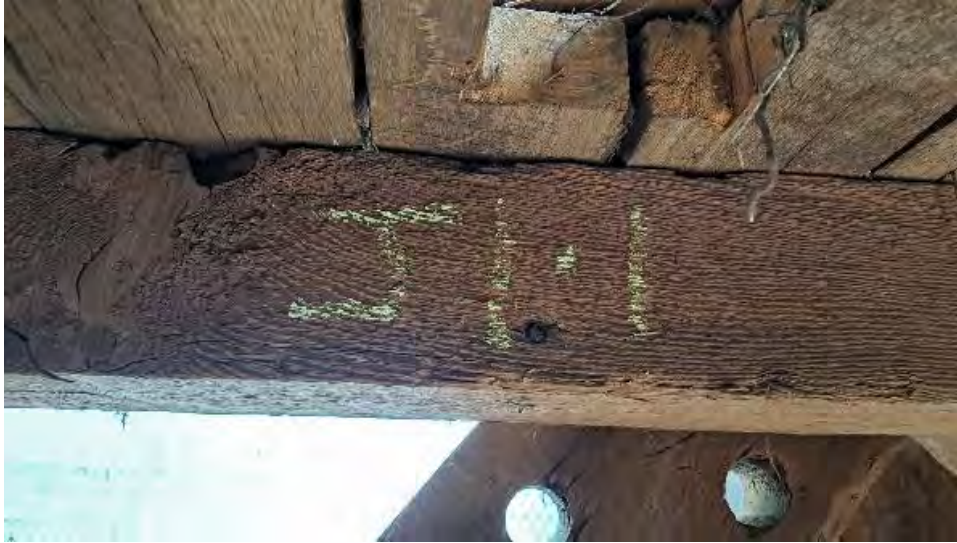
Figure 9-70: Joist J1-1 has some large knots.

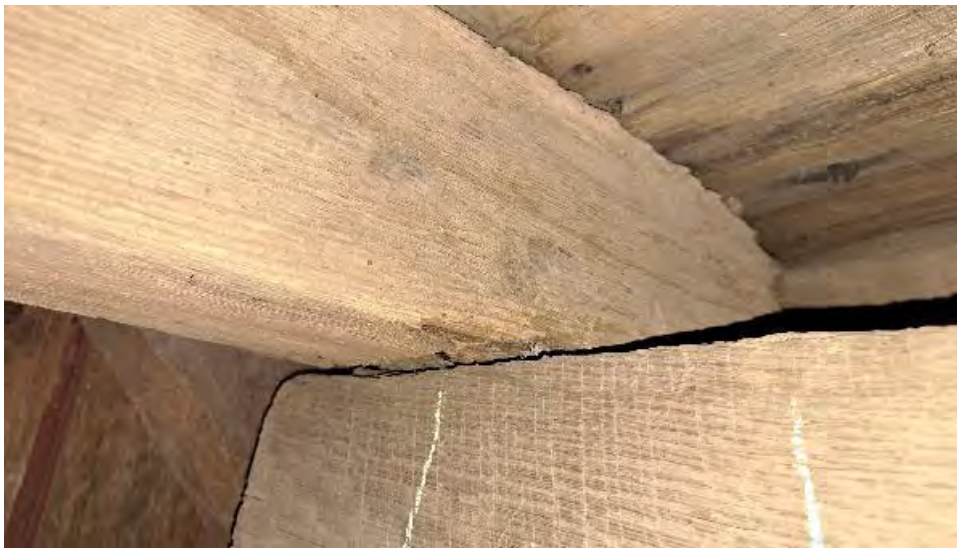
Figure 9-71: J1-1 is decayed on the bottom face at the bearing over TB1.

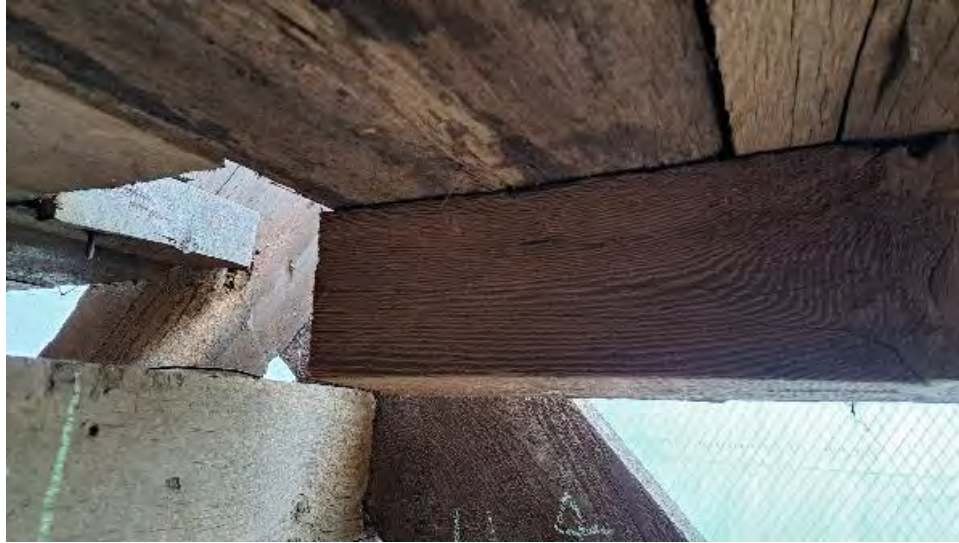
Figure 9-72: J1-1 has reduced bearing over TB2.

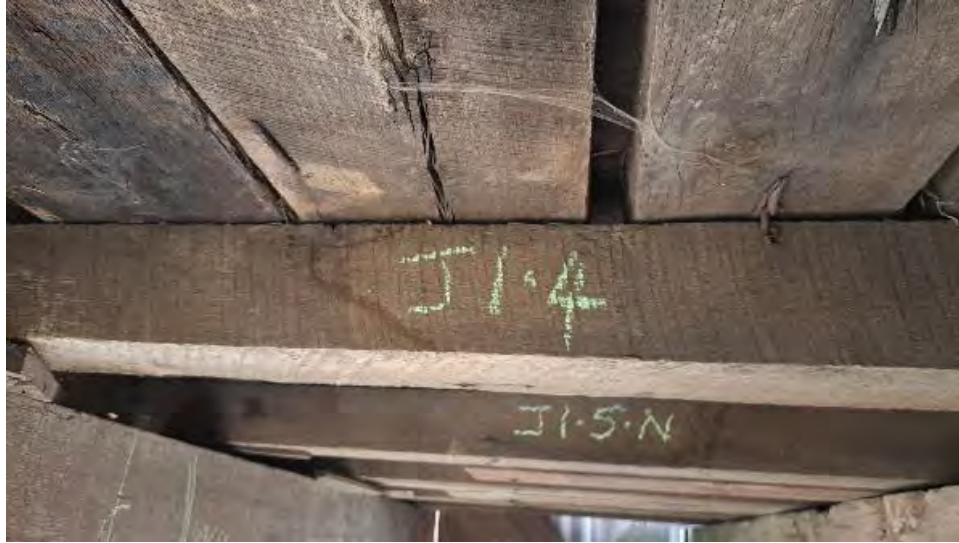
Figure 9-76: J1-4 is in fair condition.

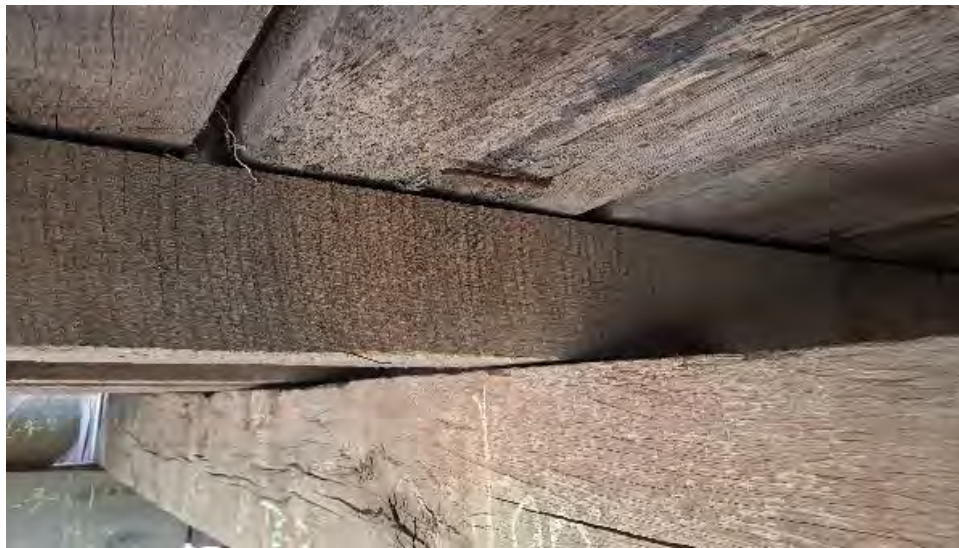
Figure 9-77: J1-4 is in fair condition.

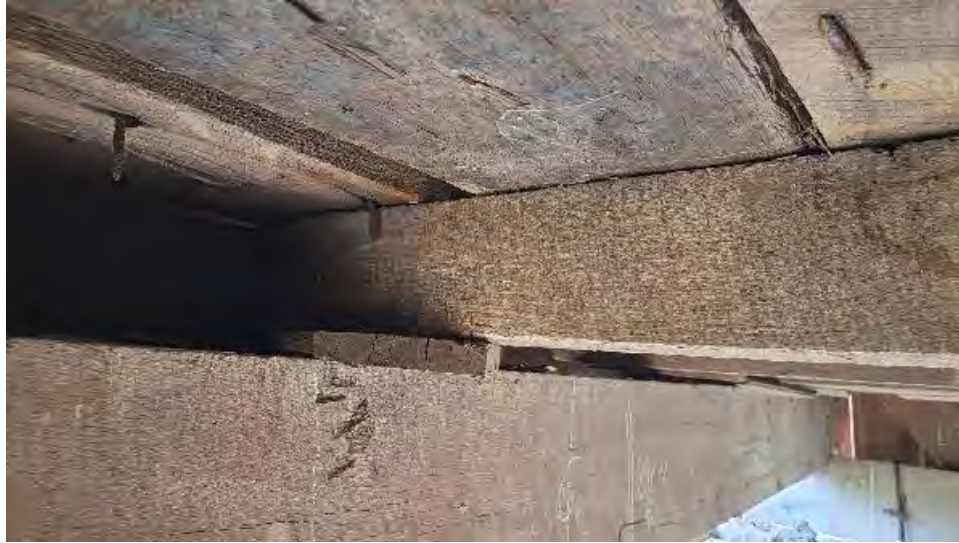
Figure 9-78: J1-4 is packed above TB1.

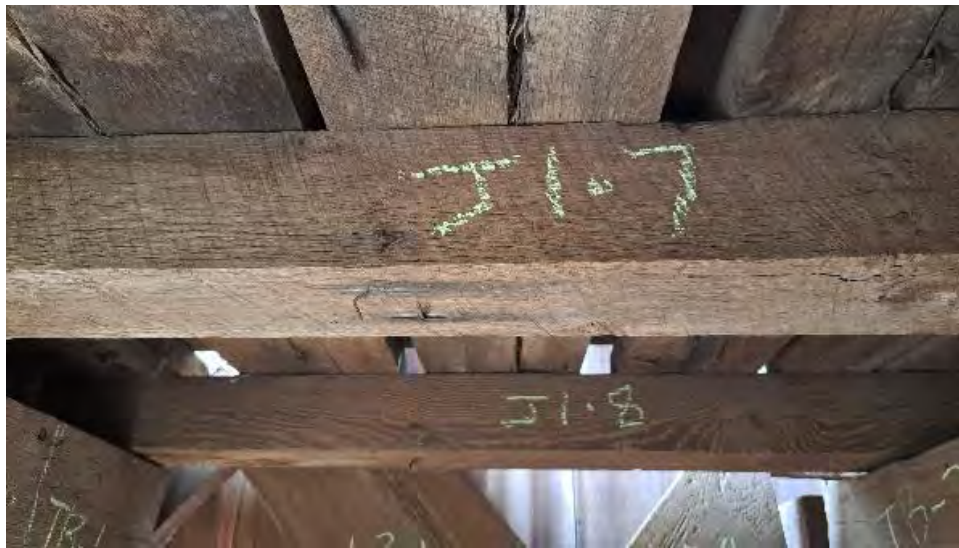
Figure 9-85: J1-7 is in fair condition and is continuous with J2-7.

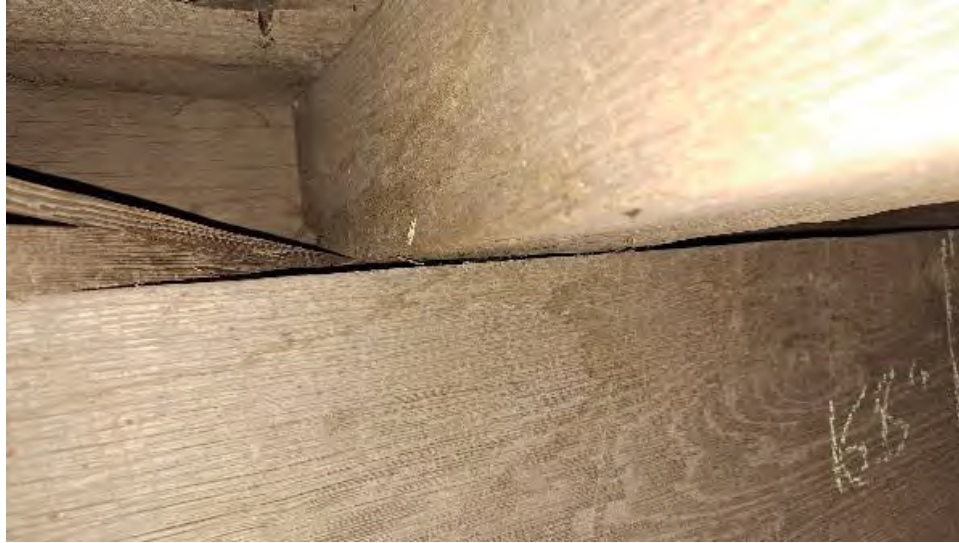
Figure 9-86: J1-7 only bears on South edge over TB1.

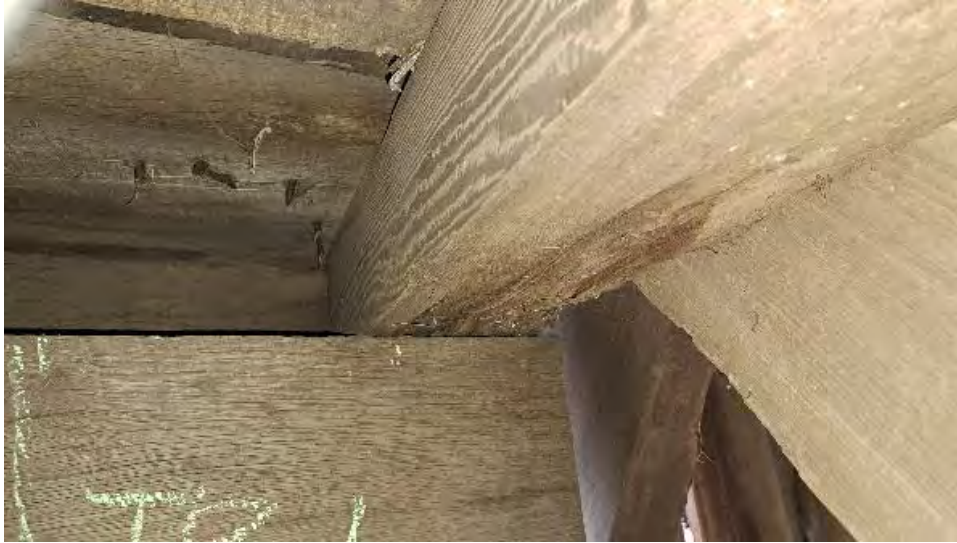
Figure 9-88: J1-8 has decay and section loss to the bottom face for 18-inches from the AB1 end.

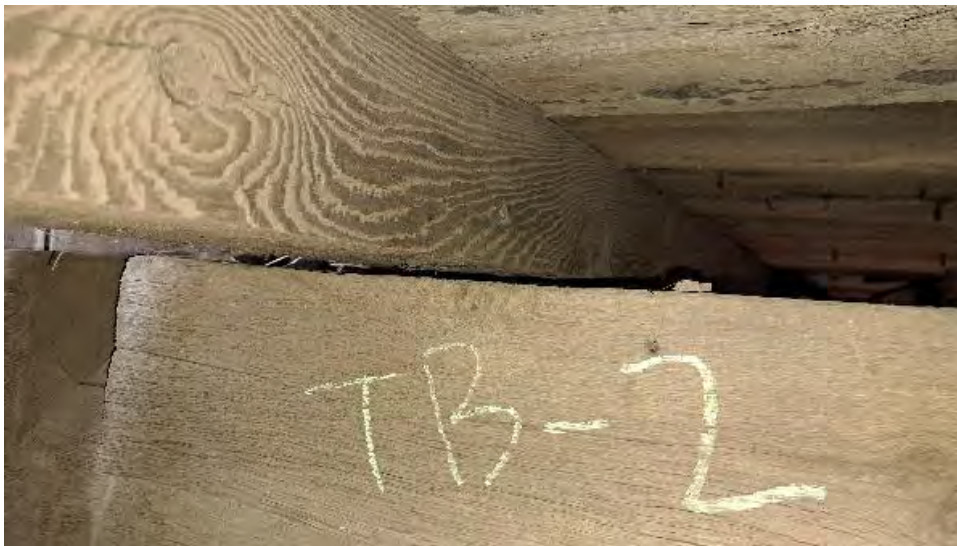
Figure 9-89: J1-8 is continuous with J2-8 but is not bearing on TB2.

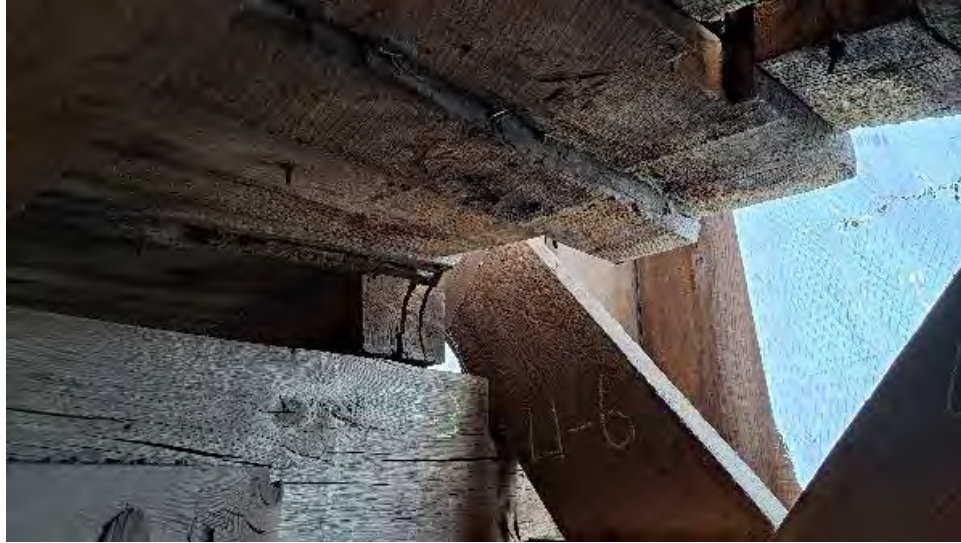
Figure 9-90: J2-1 is missing.

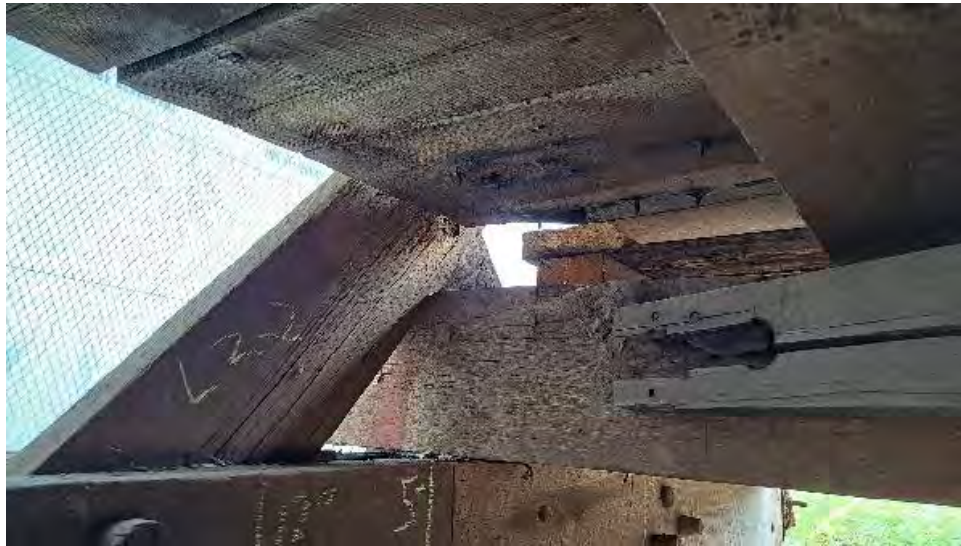
Figure 9-91: J2-1 is missing.

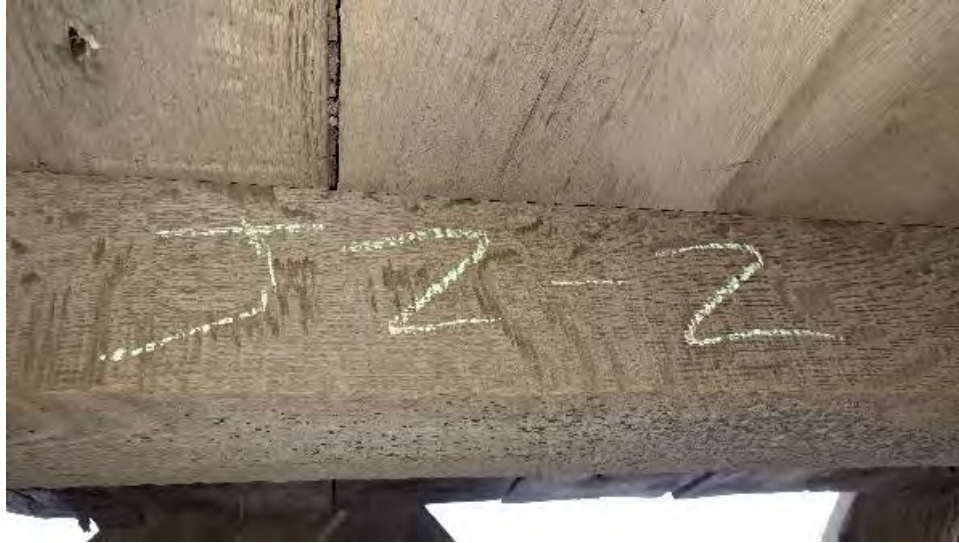
Figure 9-92: J2-2 is in fair condition.

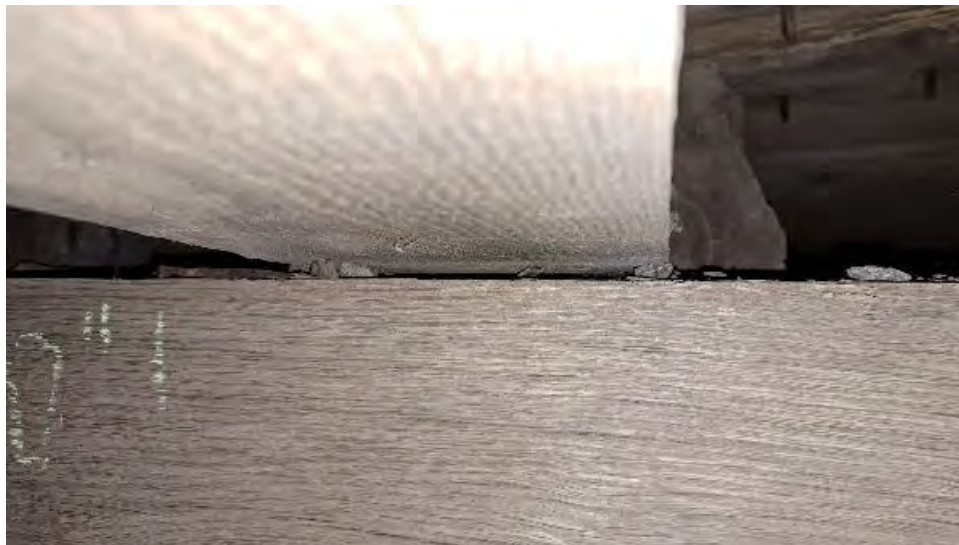
Figure 9-93: J2-2 is not bearing on TB3.
