South Perkasio Covered Bridge Inspection Report

SUBMITTED TO:
Borough Of Perkasio
149 W Walnut St,
Perkasio, PA 18944
(Phone Number TBD); (Email TBD)

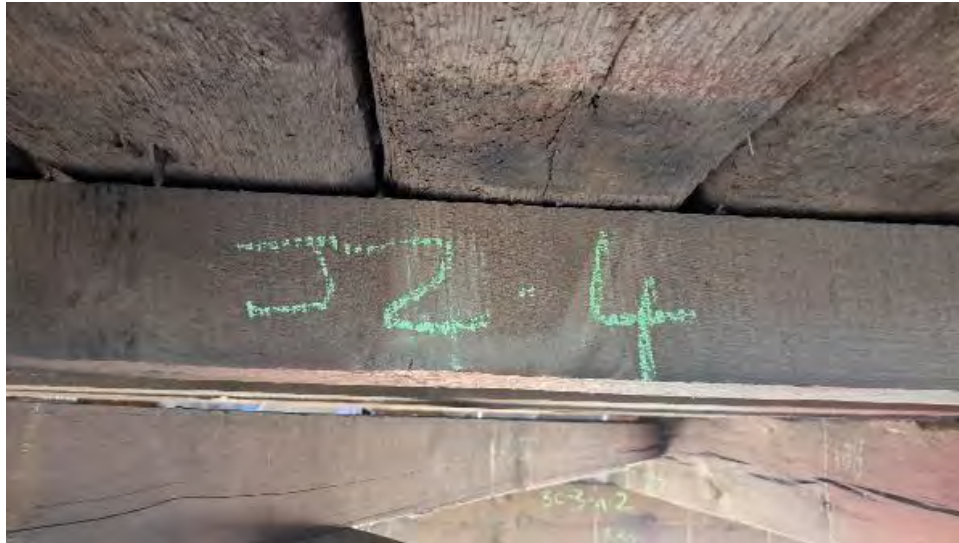
Figure 9-97: J2-4 is in fair condition.

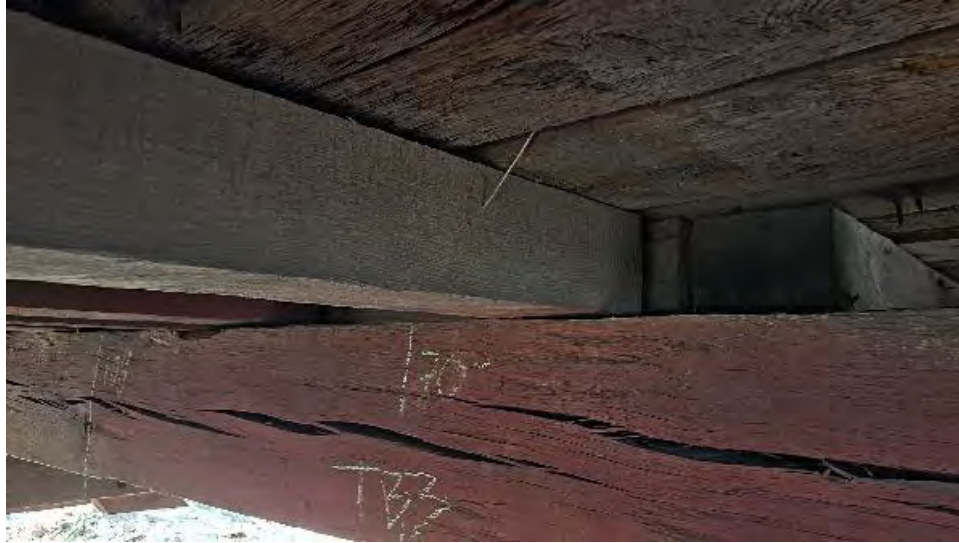
Figure 9-98: J2-4 bearing only on its South edge over TB3 with less than 1-inch twist.

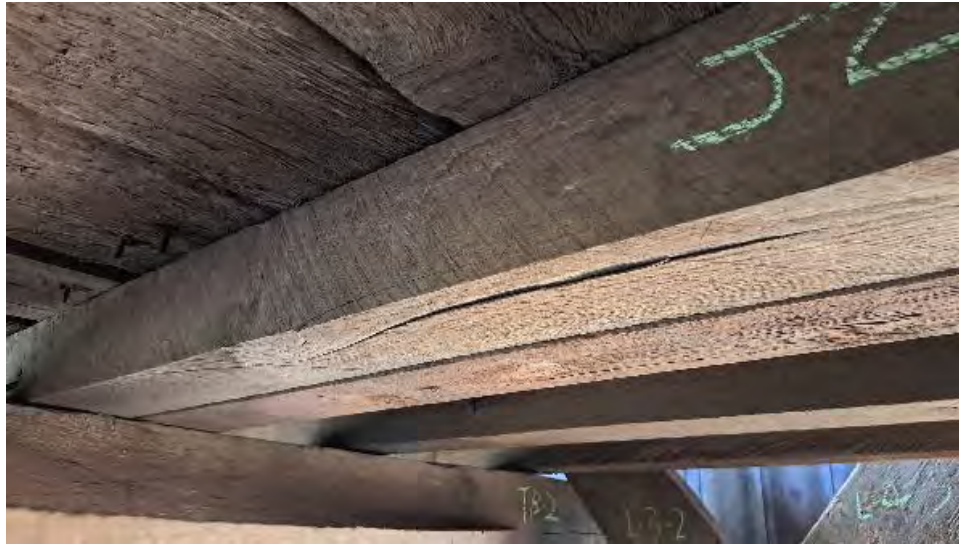
Figure 9-102: J2-6-N has a vertical slope of grain crack to bottom face around a knot.

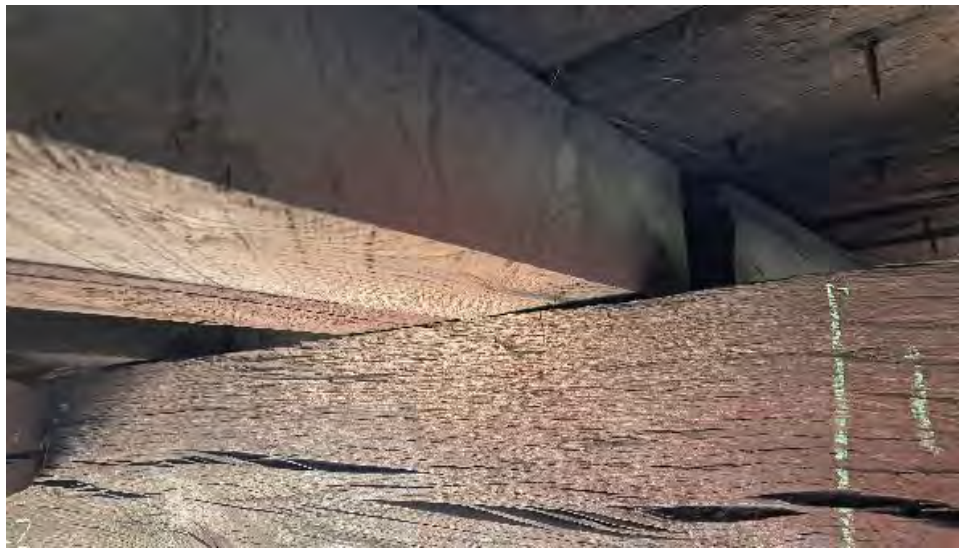
Figure 9-103: J2-6-N is bearing on TB3 on its South edge only. It is not twisted but is not a square section.

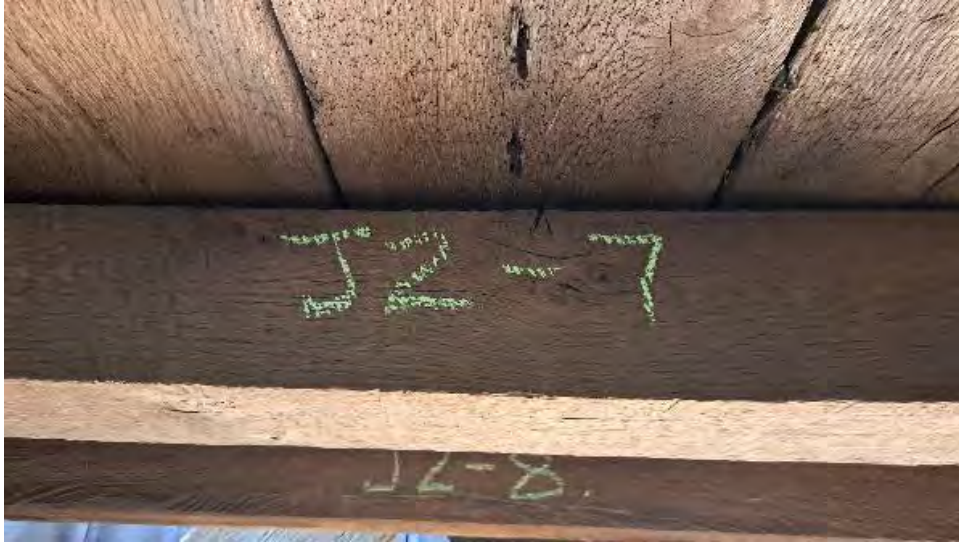
Figure 9-104: J2-7 is in fair condition.

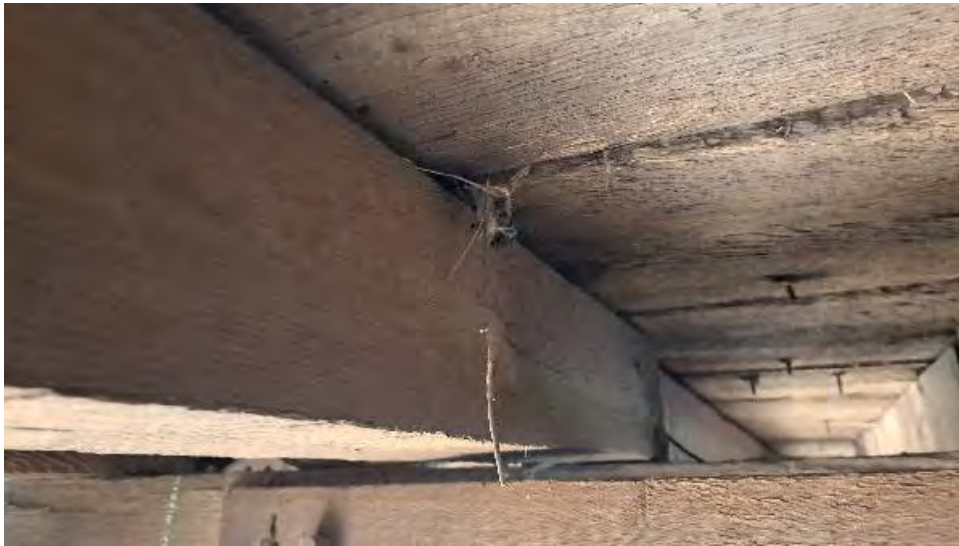
Figure 9-105: J2-7 is in fair condition.

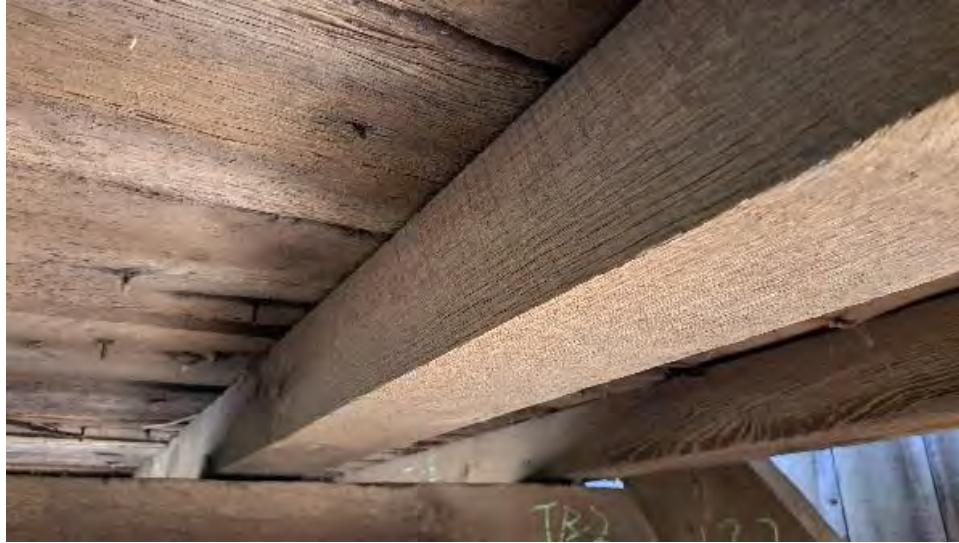
Figure 9-106: J2-7 is not bearing on TB2.

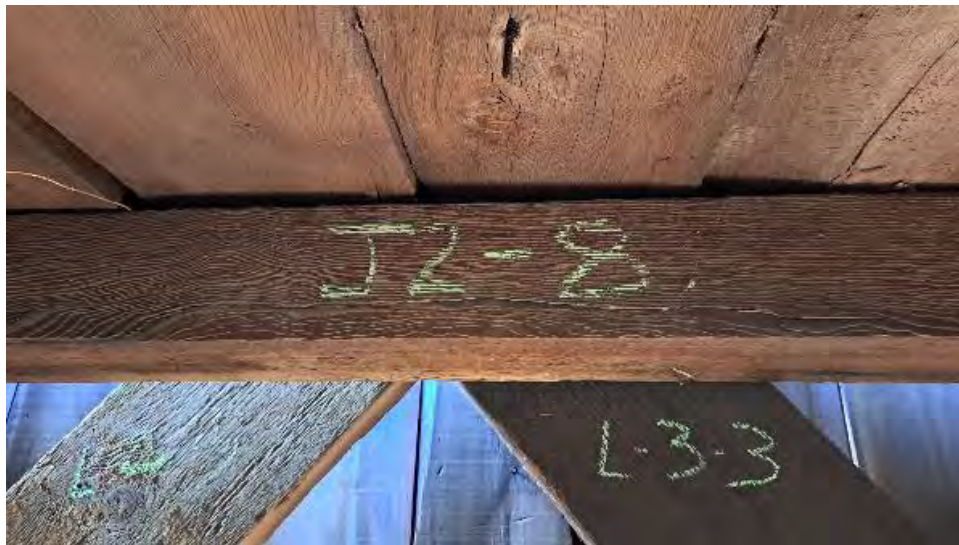
Figure 9-107: J2-8 has vertical cracks to the bottom face, extending to the North side.

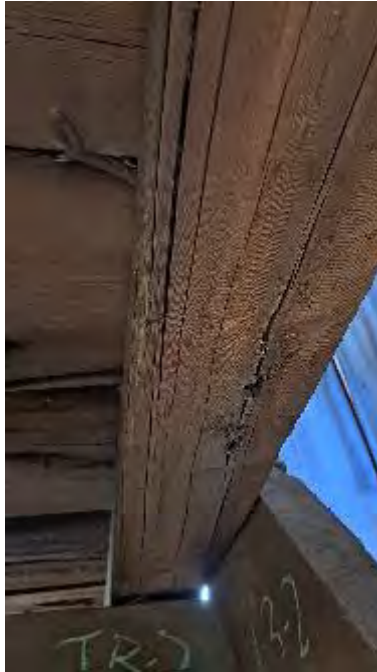
Figure 9-108: J2-8 has vertical cracks to the bottom face, extending to the North side.

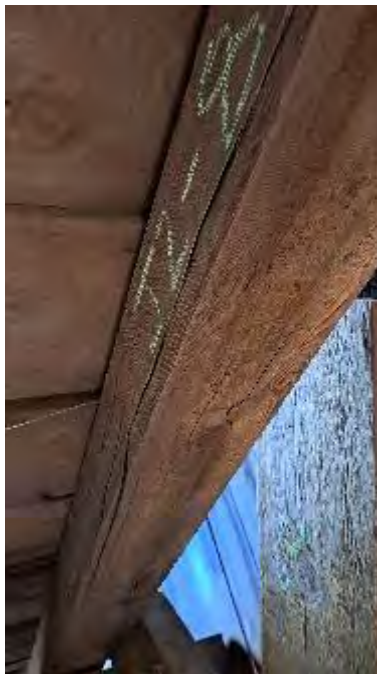
Figure 9-109: J2-8 has vertical cracks to the bottom face, extending to the North side.

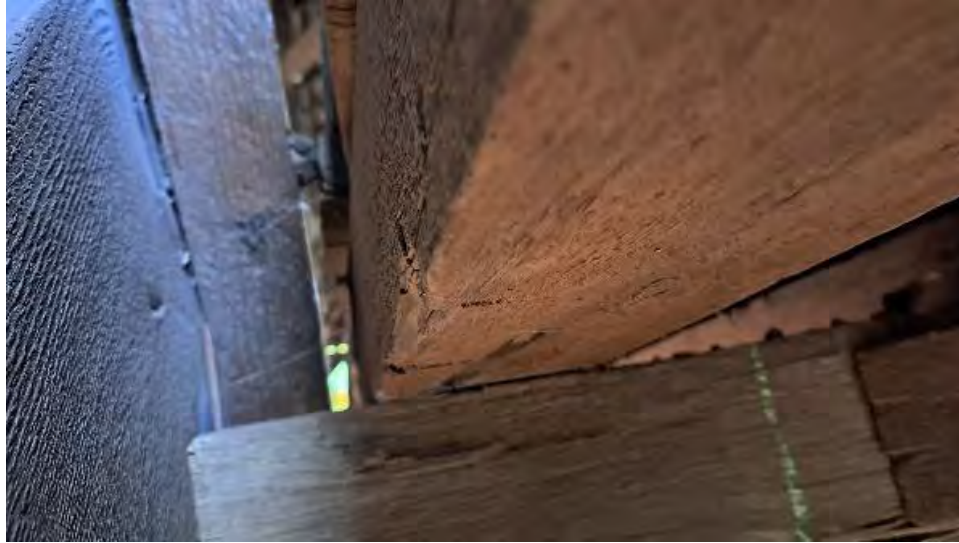
Figure 9-110: J2-8 has section loss and is split on the bottom South edge for 24-inches from TB3.

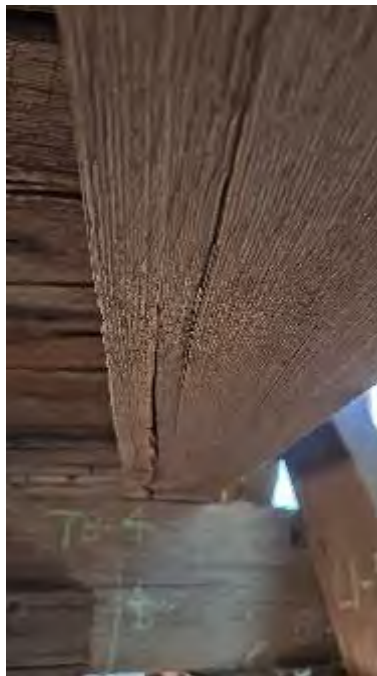
Figure 9-111: J3-1 has bottom face vertical splits.

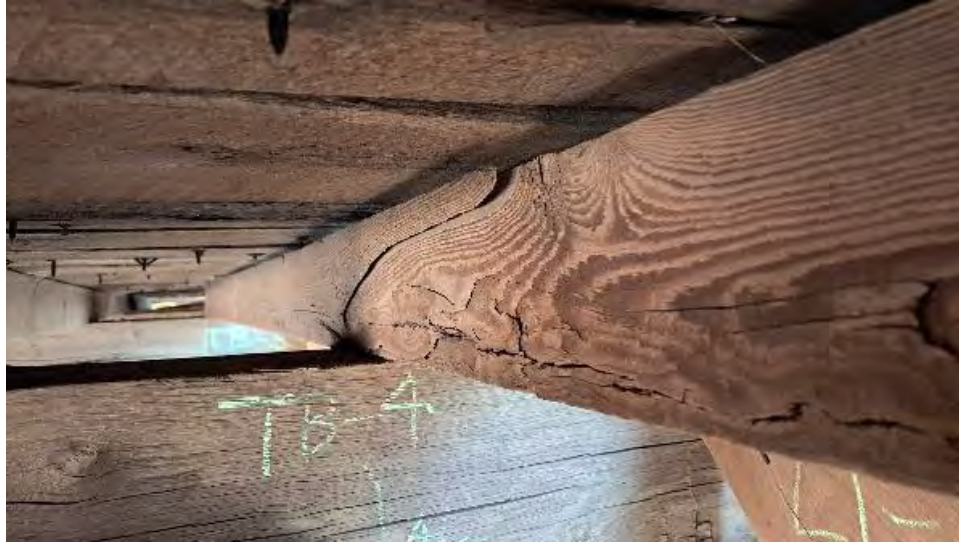
Figure 9-112: J3-1 has large cracks on the South side over TB4 and is continuous with J4-1.

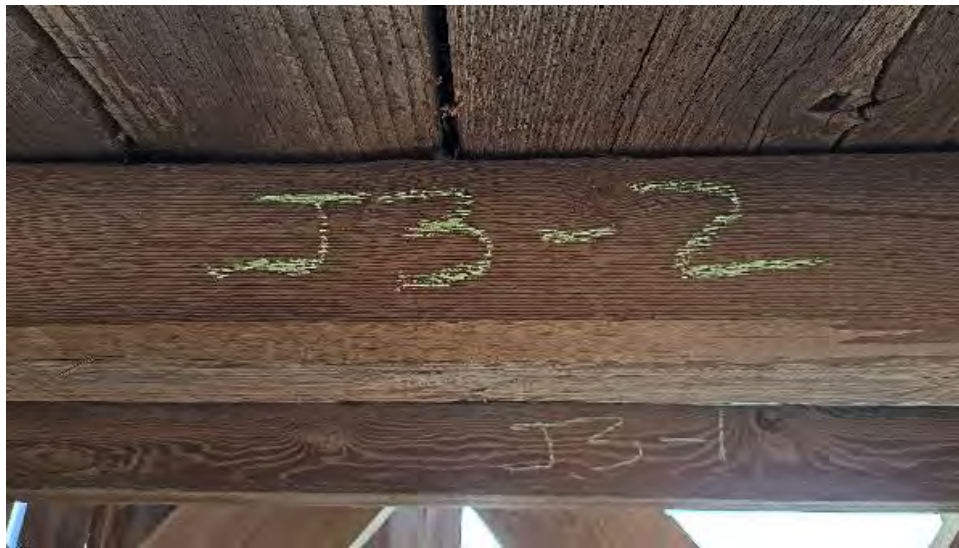
Figure 9-113: J3-2 has some wane on bottom South edge.

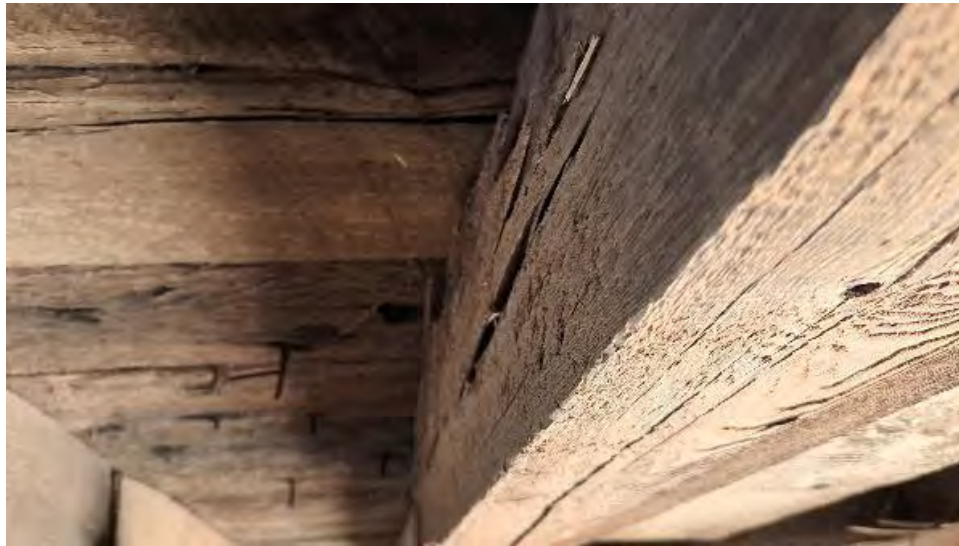
Figure 9-123: J3-6-N has a large end split at TB3 end. The North half is broken.

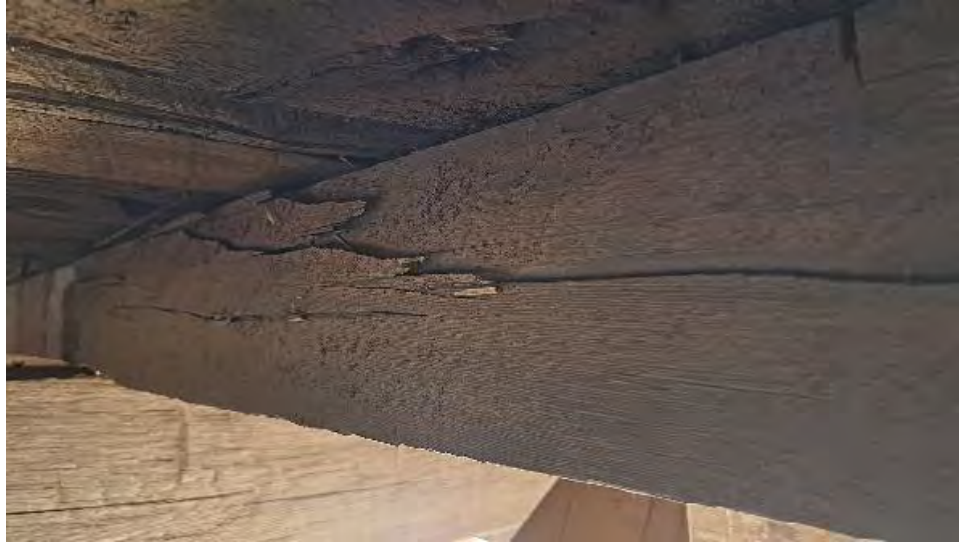
Figure 9-124: J3-6-N has a large end split at TB3 end. The North half is broken.

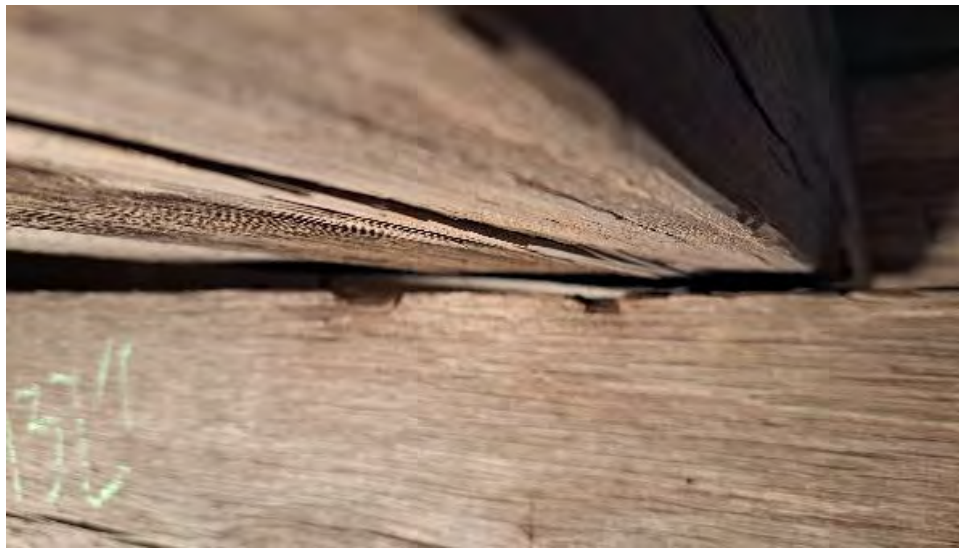
Figure 9-125: J3-6-N is not bearing on TB4.

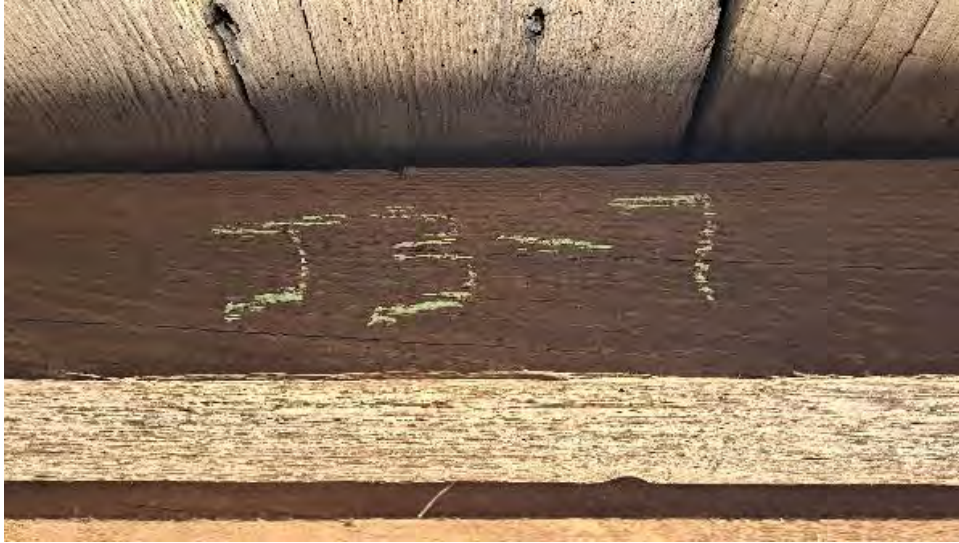
Figure 9-126: J3-7 is in fair condition.

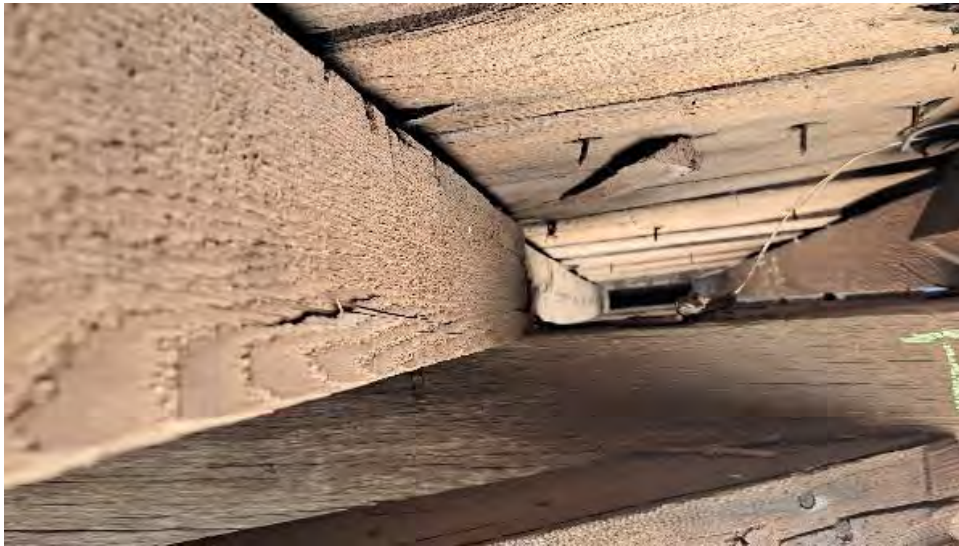
Figure 9-127: Joist J3-7 is continuous with J4-7.

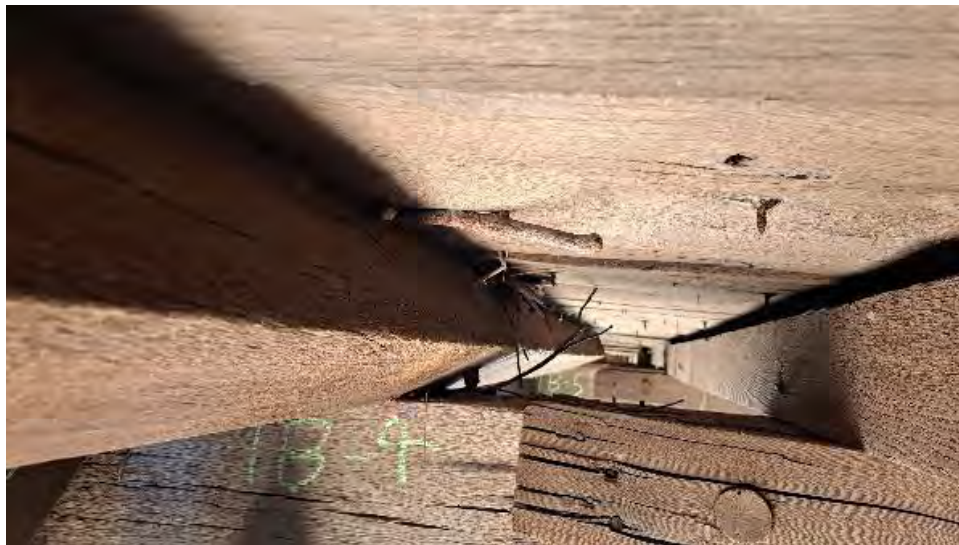
Figure 9-129: J3-8 is penetrated by a vertical broken dowel over TB4.

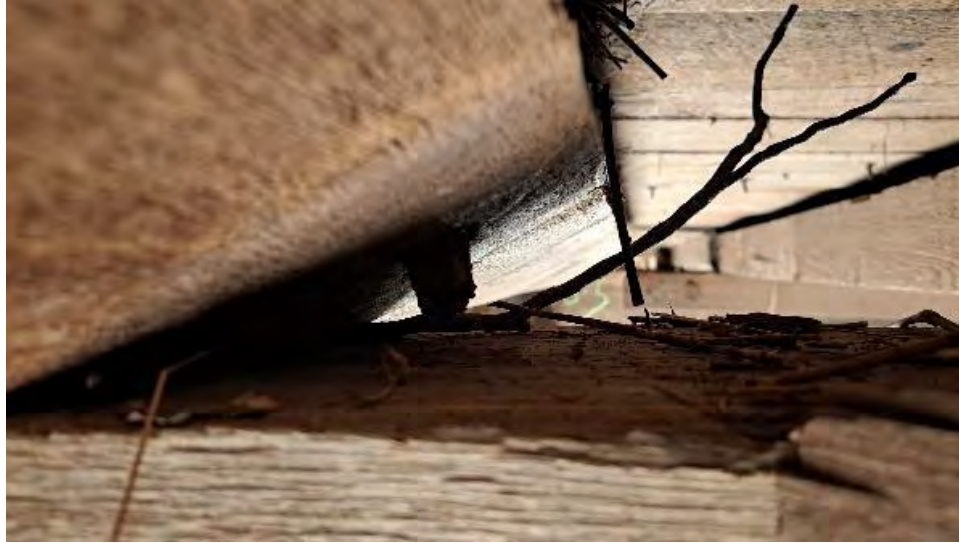
Figure 9-130: J3-8 is penetrated by a vertical broken dowel over TB4.

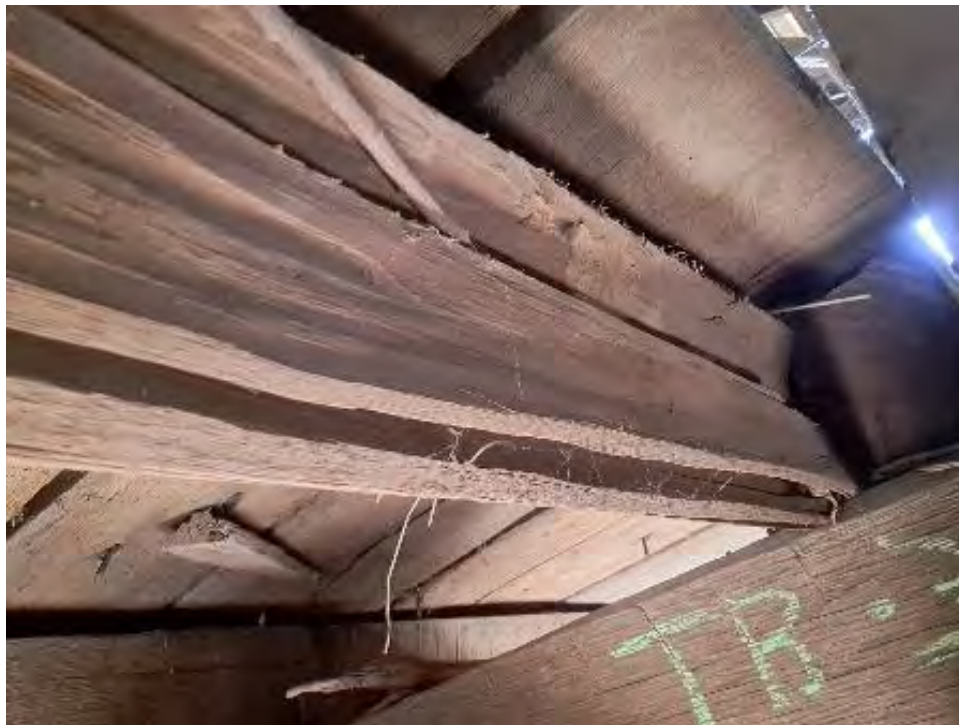
Figure 9-131: J3-8 has major cracking on the South side at TB3 for 2-foot length.

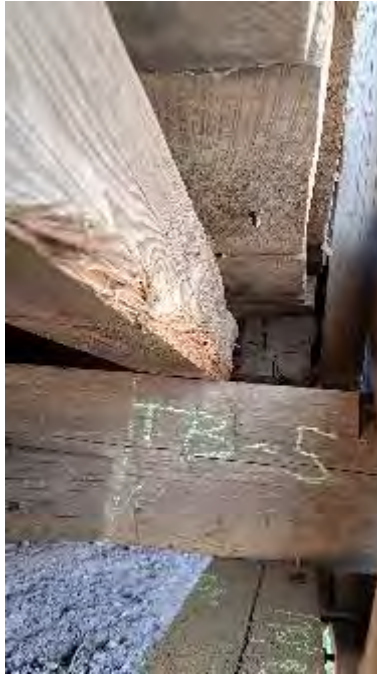
Figure 9-134: J4-1 has 1.25-inch bearing on TB5. Some impact damage and section loss exist above TB5.

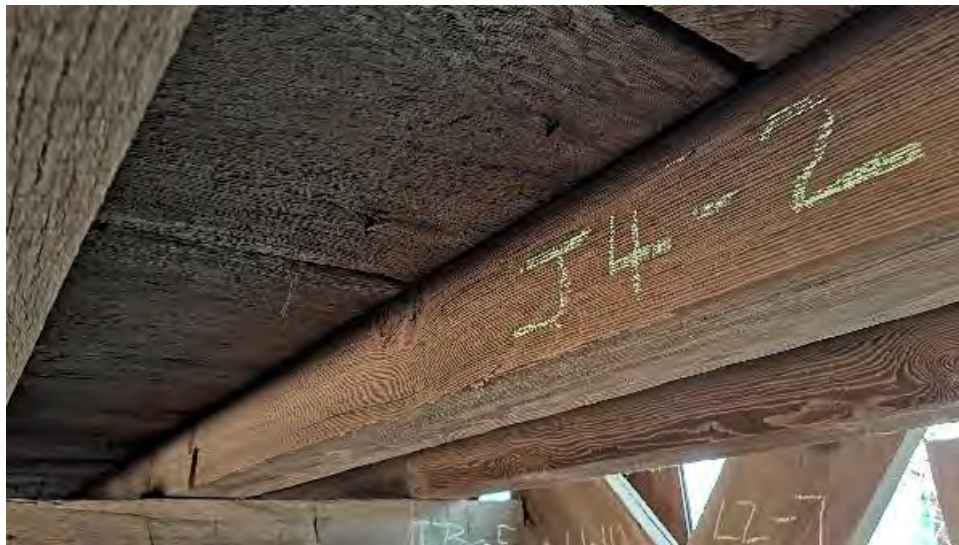
Figure 9-135: J4-2 only bears on the North edge at TB5.

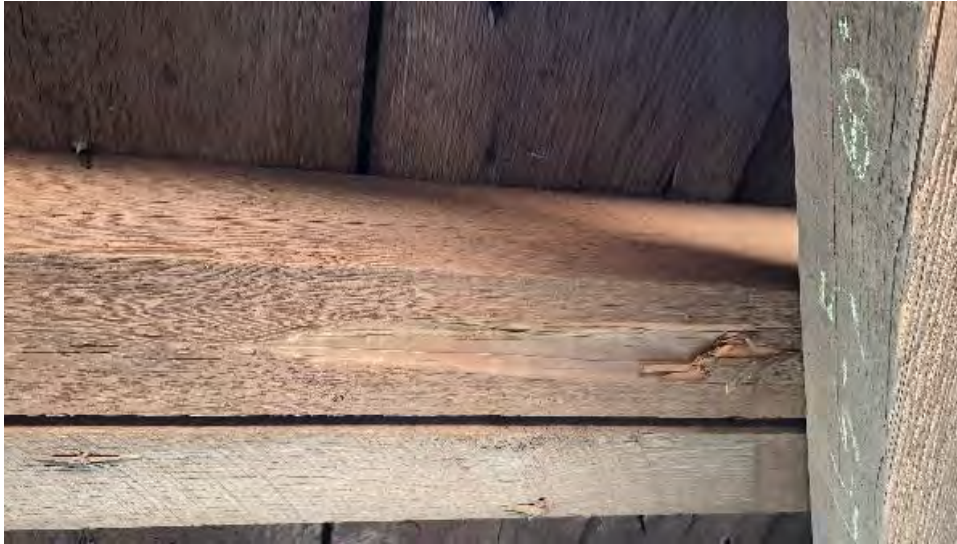
Figure 9-139: J4-3-S has a vertical crack on the bottom face extending from TB4 for 3-feet.

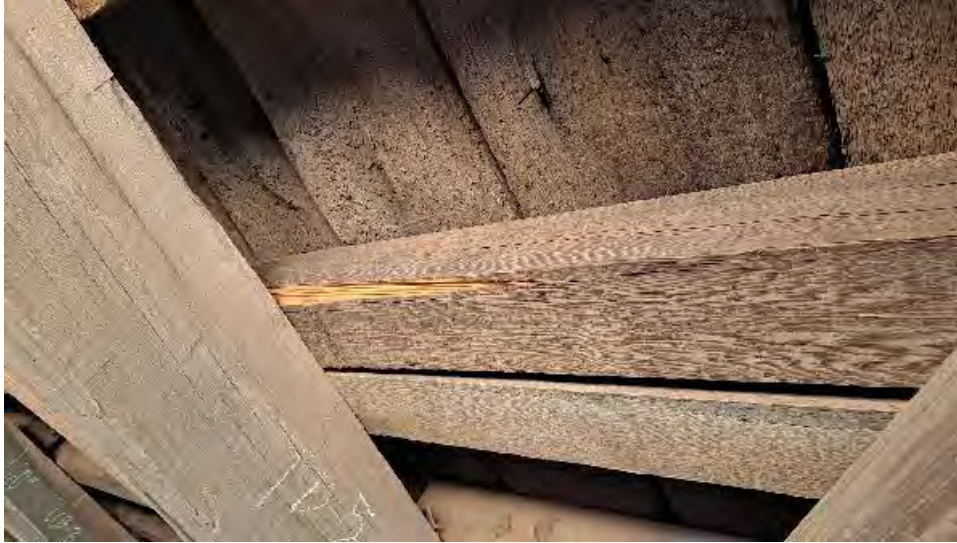
Figure 9-140: J4-4-S has section loss on the bottom edge and does not bear onto TB5.

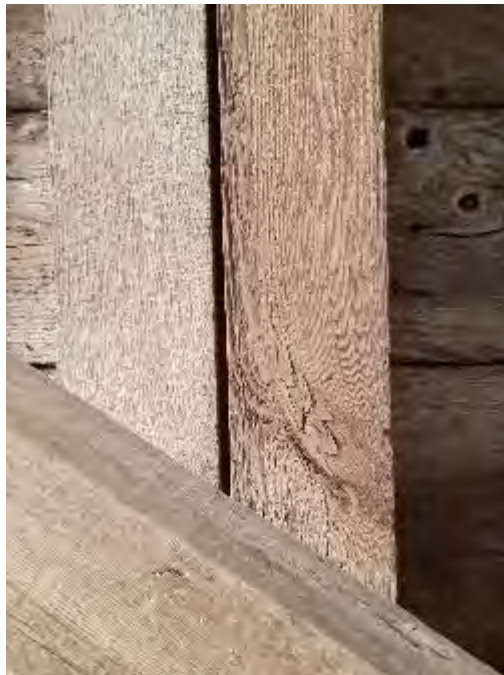
Figure 9-141: J4-5-N has a large on the bottom face at mid span but with no associated damage.

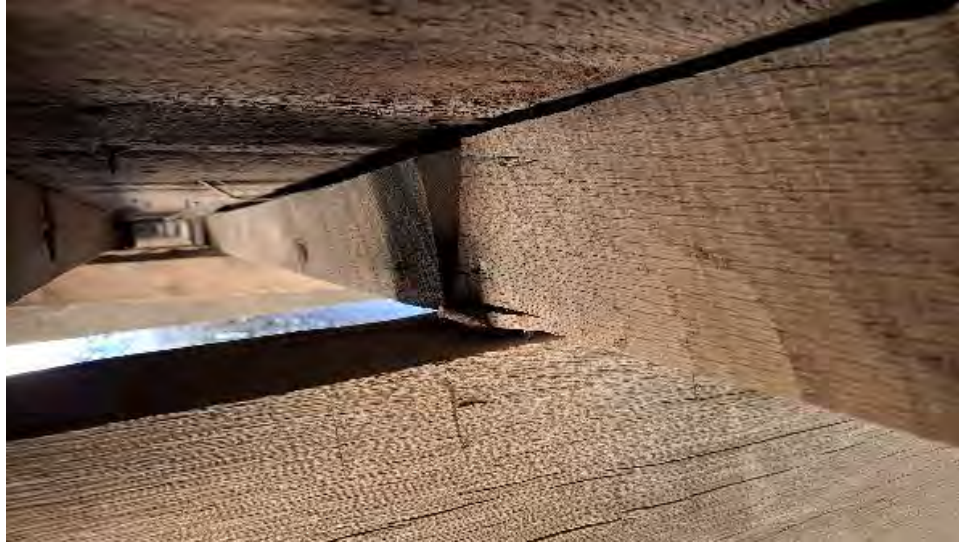
Figure 9-142: J4-6-S has a short end split due to cleaving of skew nail to TB5.

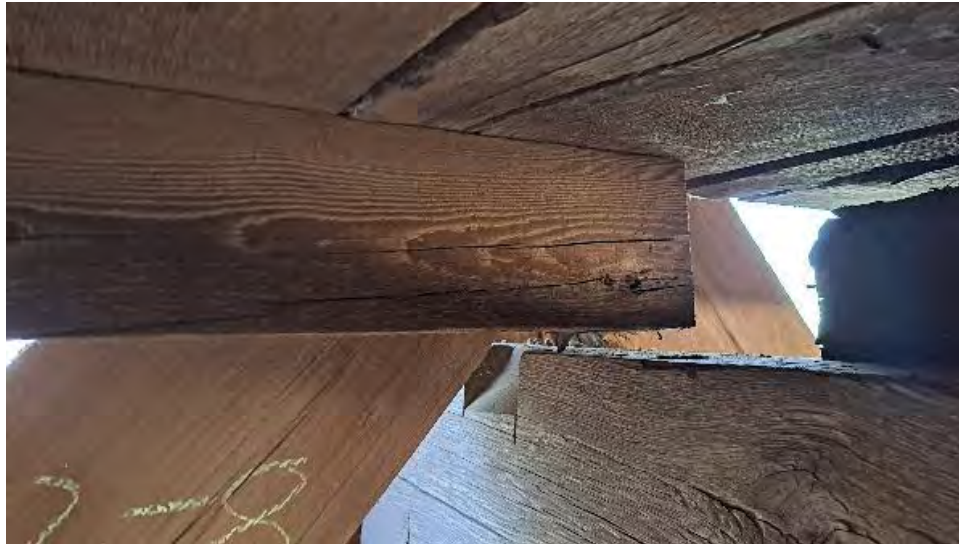
Figure 9-147: J5-1 is not bearing on TB4.

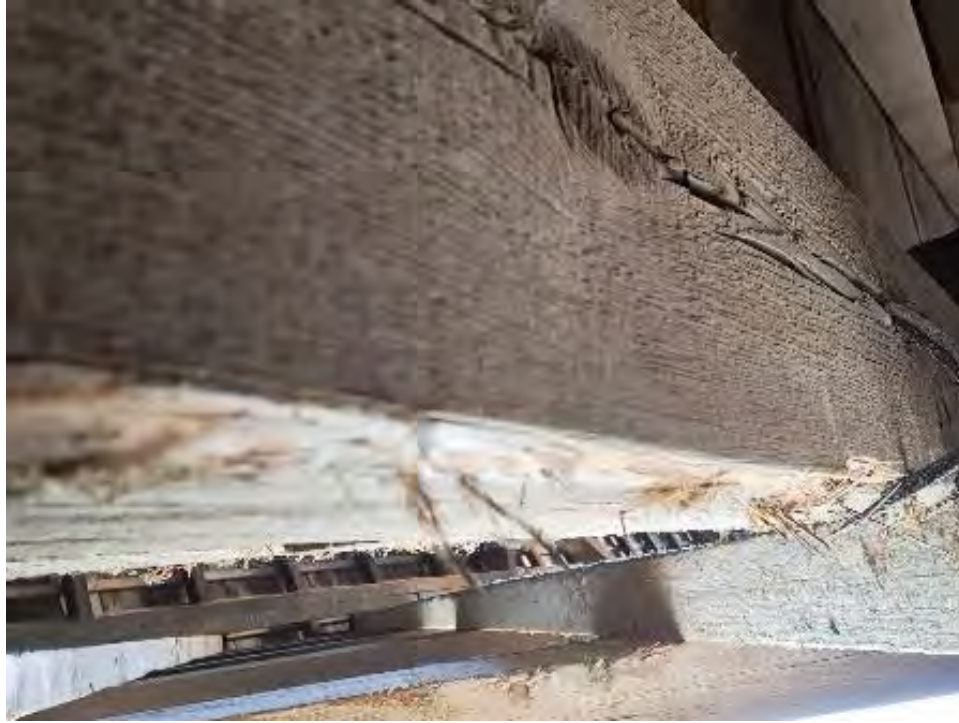
Figure 9-149: J5-1 has abrasion damage to its North edge.

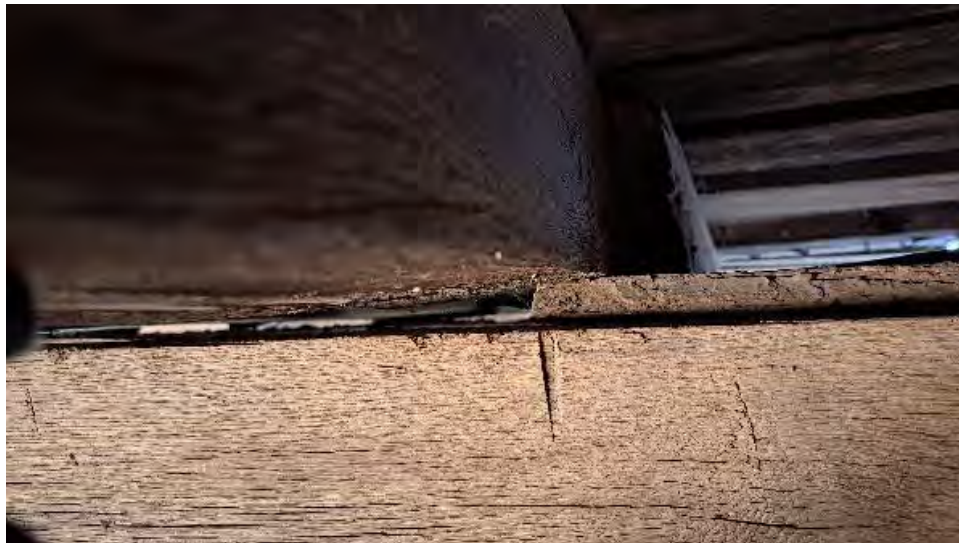
Figure 9-150: J5-2 has partial bearing on a packer over TB6.

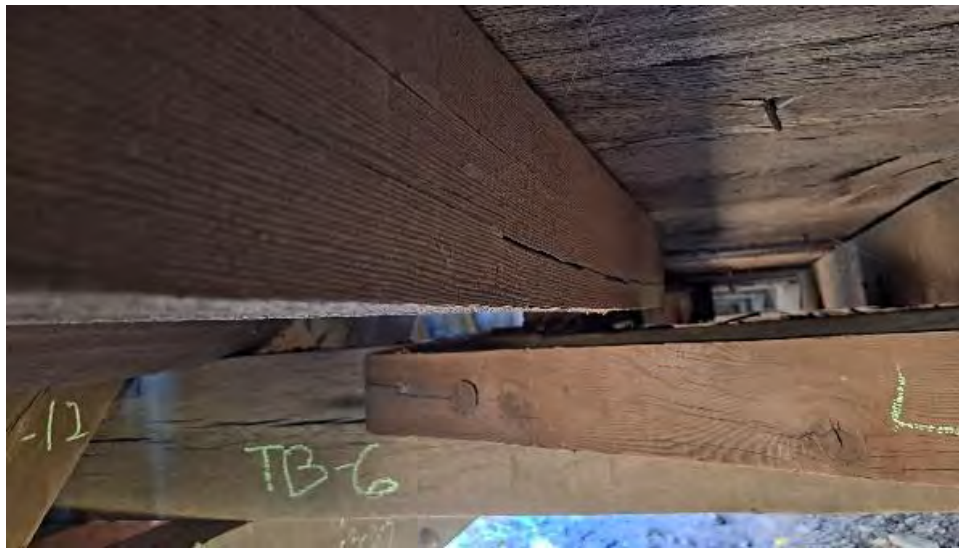
Figure 9-162: J5-7 is cracked for 3-feet length on the North side from TB6. J5-7 is not bearing on TB6.

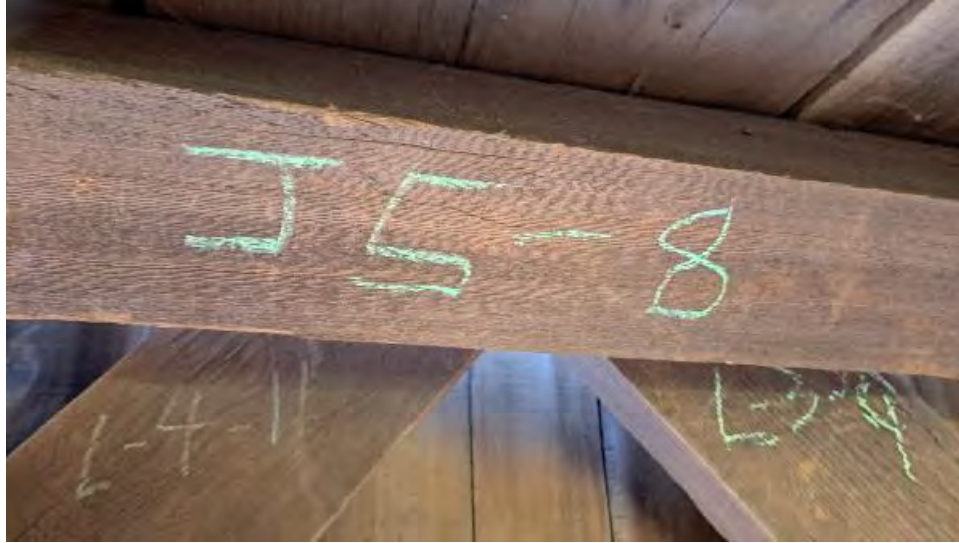
Figure 9-163: J5-8 is twisted 27 degrees.

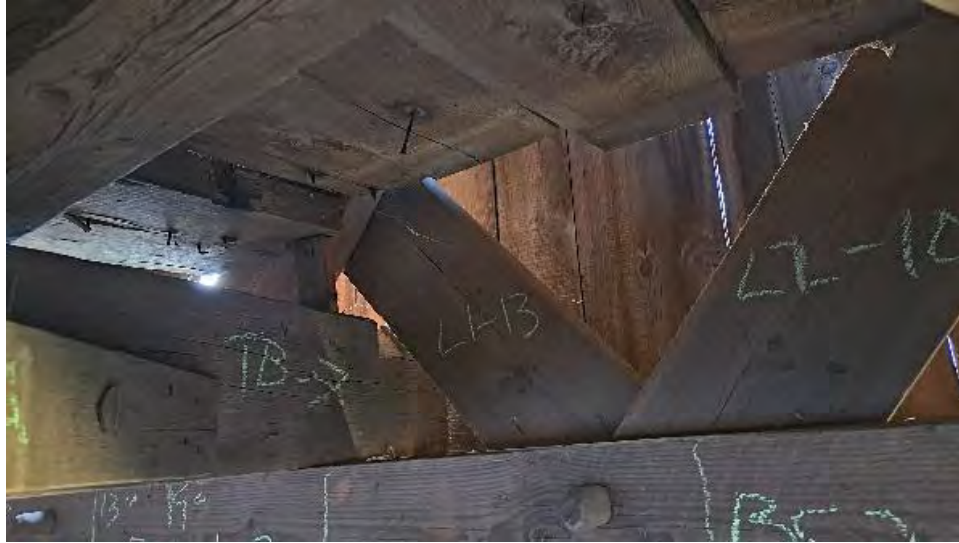
Figure 9-166: J6-1 is missing.

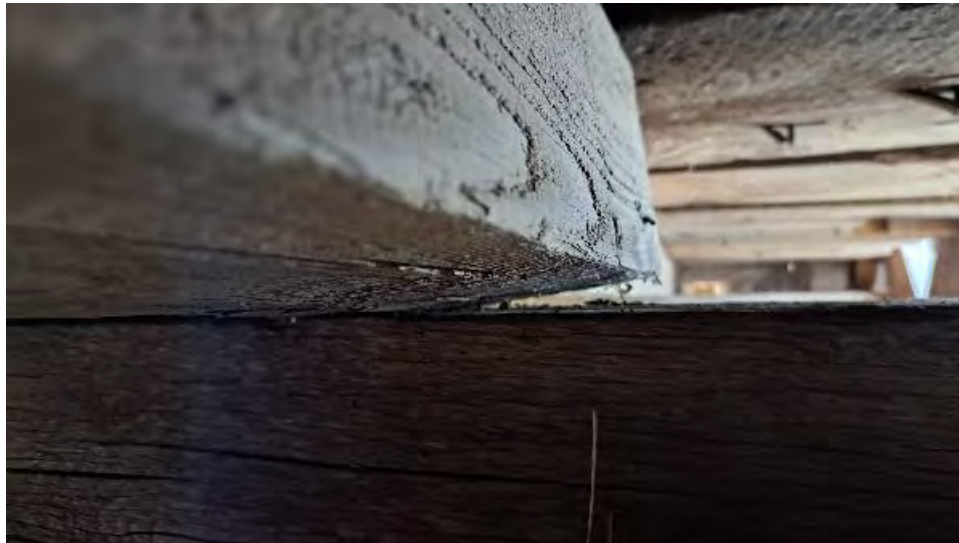
Figure 9-167: J6-2 is partial bearing on its South edge at TB7. J6-2 is twisted by 8 degrees.

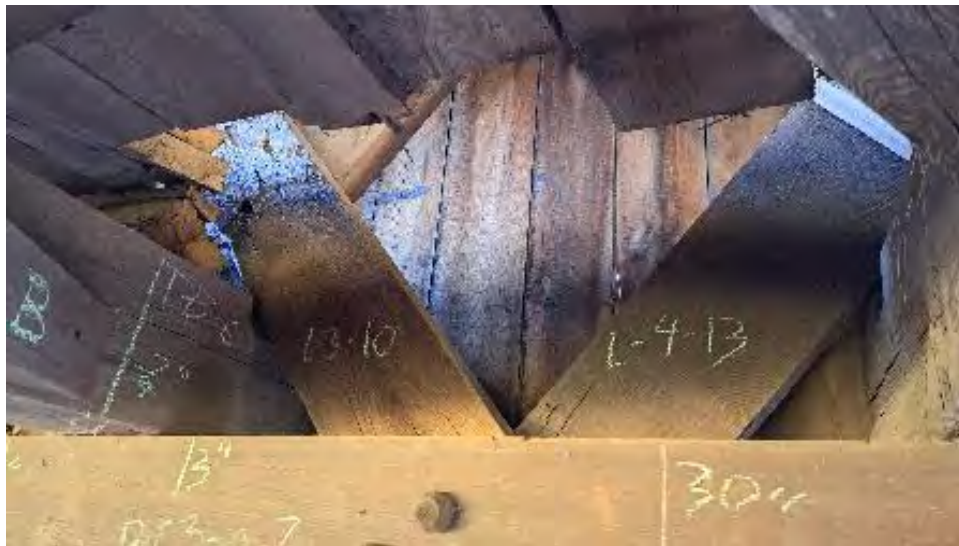
Figure 9-177: J6-8 is missing.

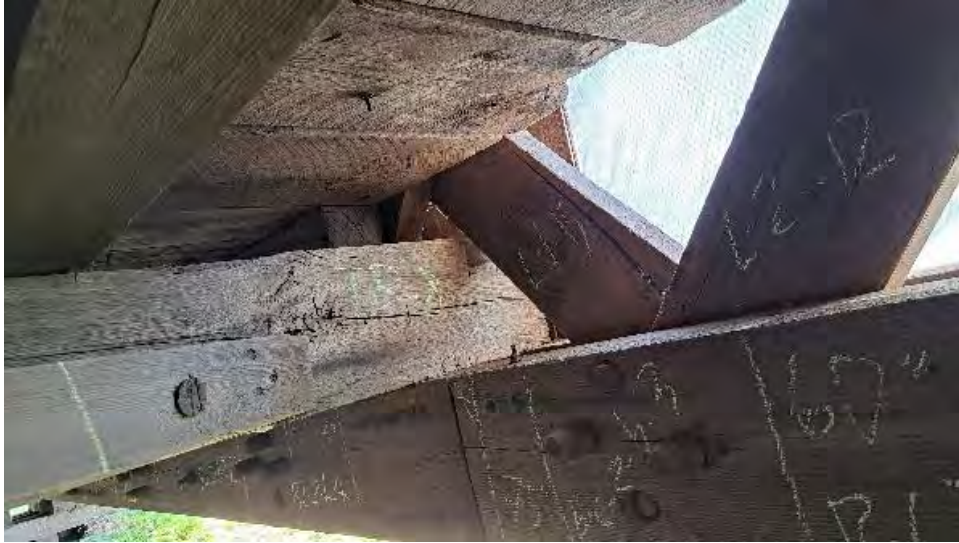
Figure 9-178: J7-1 is missing.

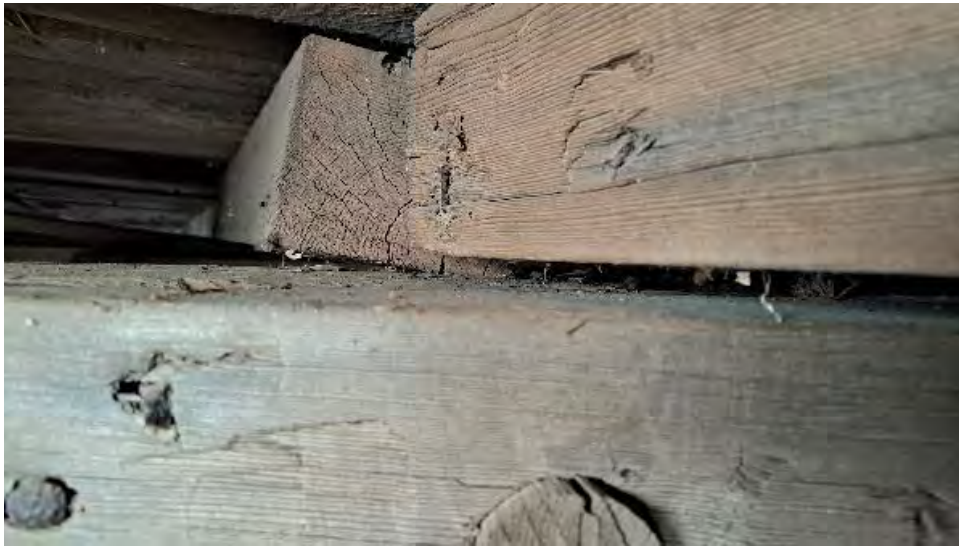
Figure 9-179: J7-2 is not bearing on TB7.

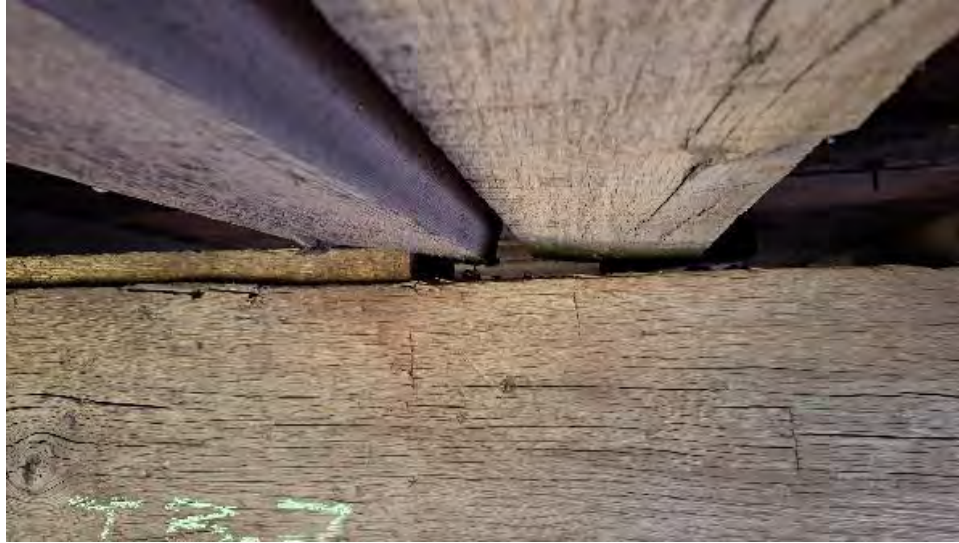
Figure 9-188: J7-5-N partial bearing on packer at TB7 & TB8. J7-5-S is not supported at TB7 or TB8. Old termite damage exists with pockets that have led to cracking at mid span.

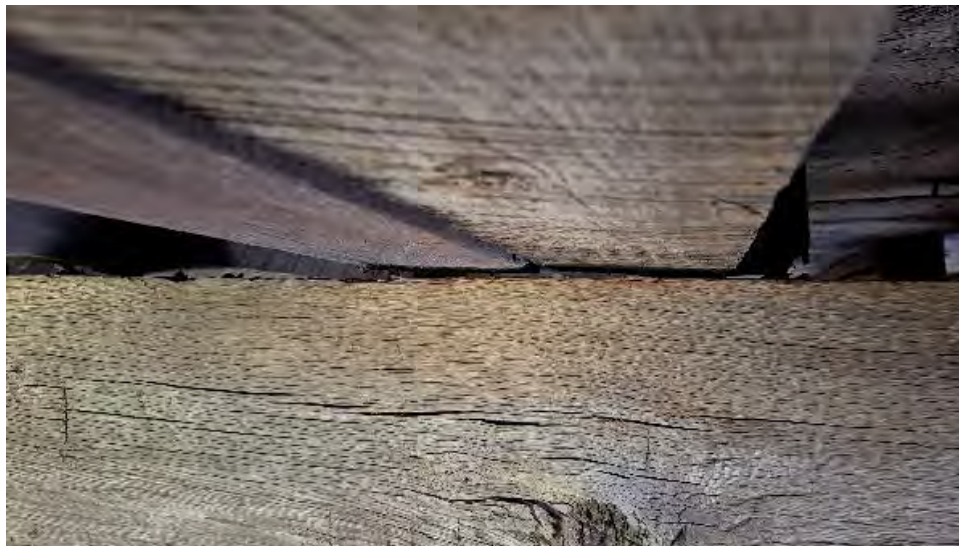
Figure 9-189: J7-6-S is not bearing over TB7.

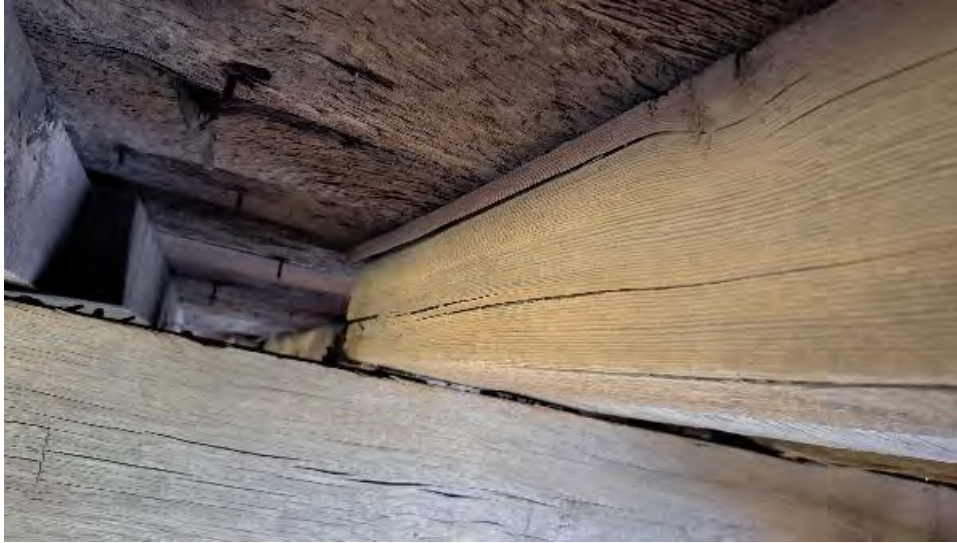
Figure 9-190: J7-6-S has some cracking on the South side near TB7 and is not bearing on TB7.

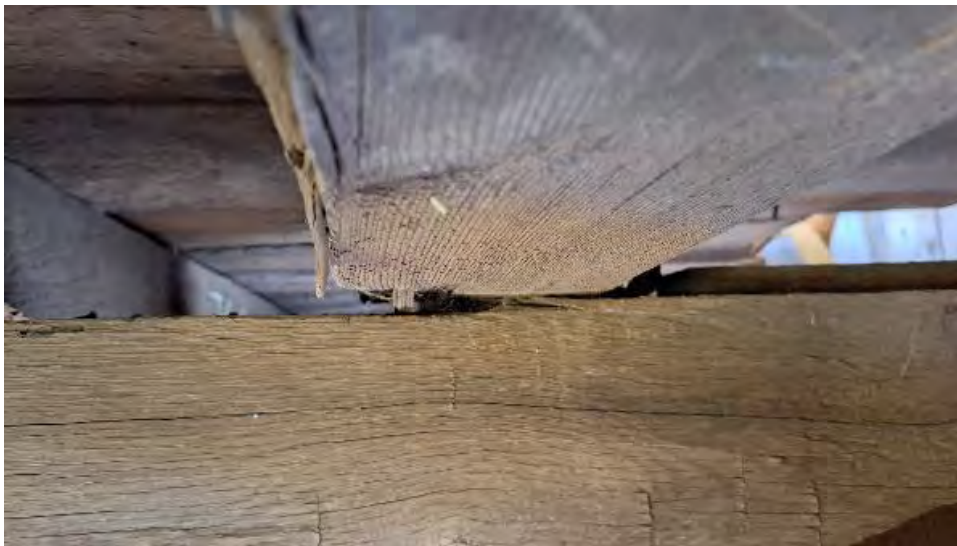
Figure 9-191: J7-7 does not bear onto transverse beams at either end.

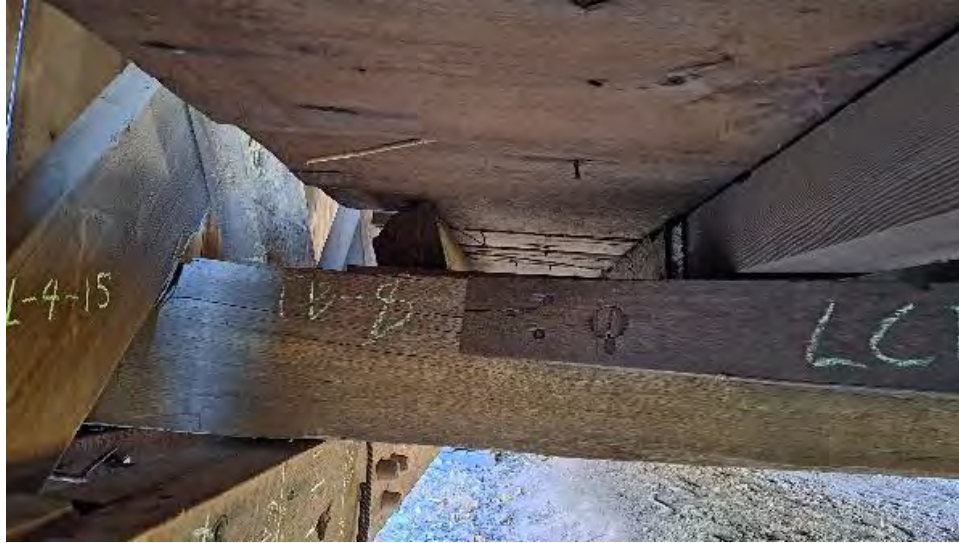
Figure 9-192: J7-8 is missing.

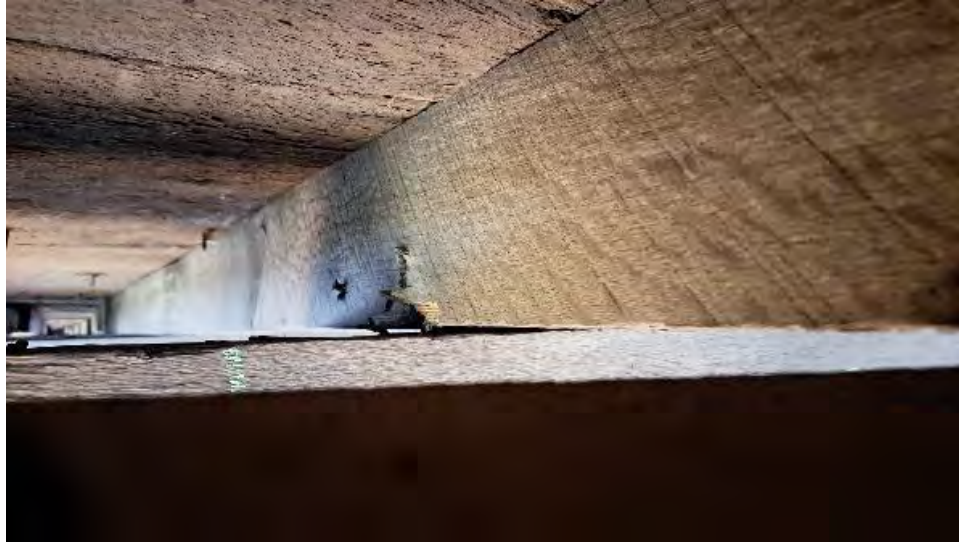
Figure 9-198: J8-3S has decay and section loss at its bearing over TB8.
