South Perkasio Covered Bridge Inspection Report

SUBMITTED TO:
Borough Of Perkasio
149 W Walnut St,
Perkasio, PA 18944
(Phone Number TBD); (Email TBD)

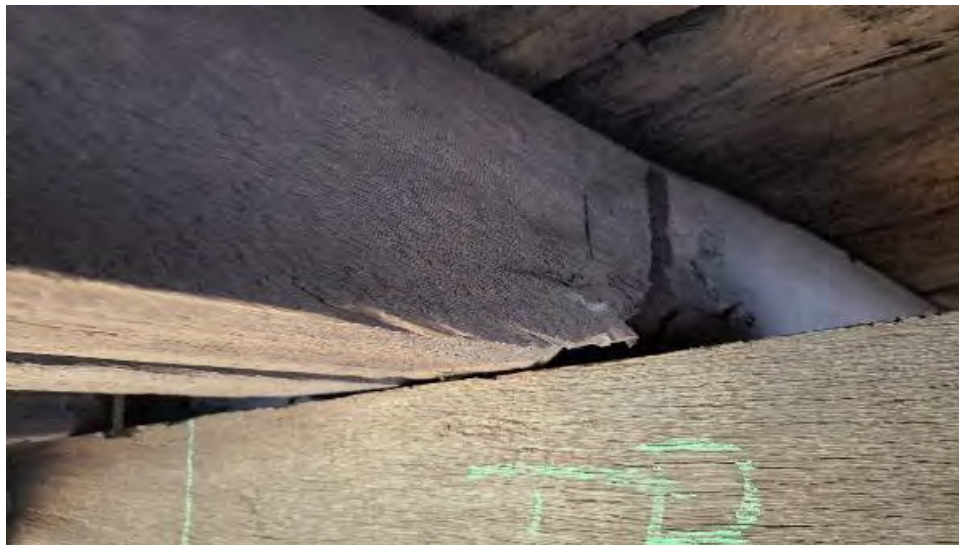
Figure 9-199: J8-3S has decay and section loss at its bearing over TB8.

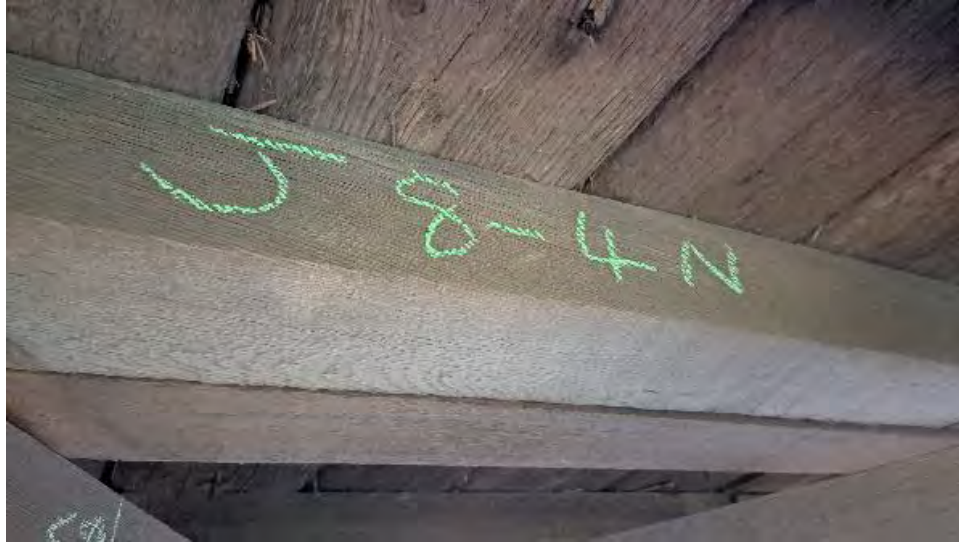
Figure 9-200: J8-4-N is continuous with J9-4-S.

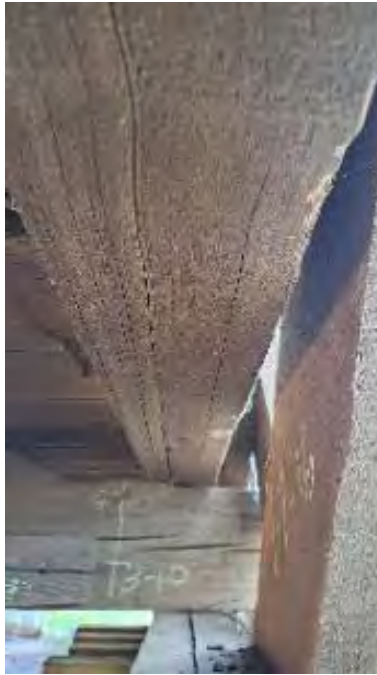
Figure 9-216: J9-1 has a vertical end split from TB10 (24-inches long) and is twisted 4 degrees at the TB10 end, possibly due to the end split and uneven bearing surface. Bearing only on the North edge at TB9.

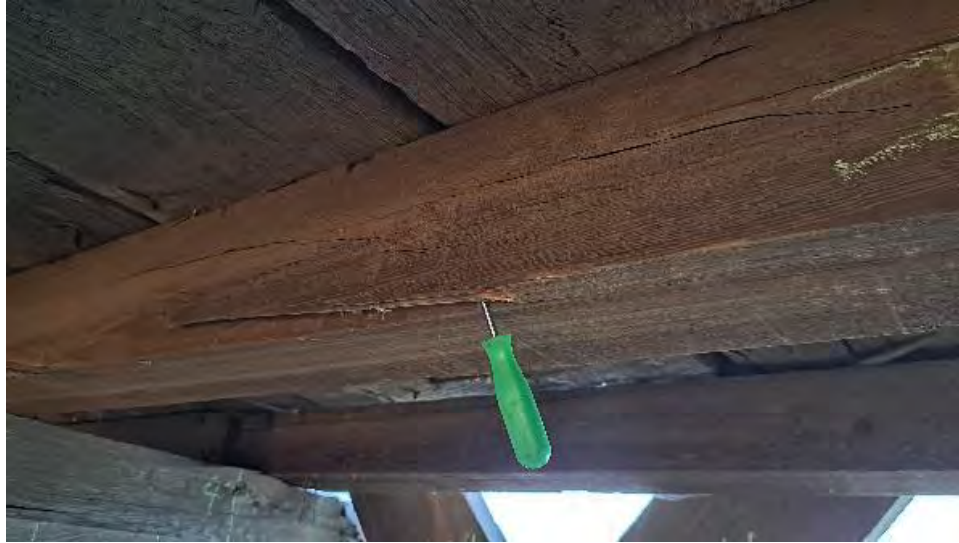
Figure 9-219: J9-2 is decayed on the South side face resulting in splits and section loss with possible internal termite damage for approximately 1/3 width, in very poor condition.

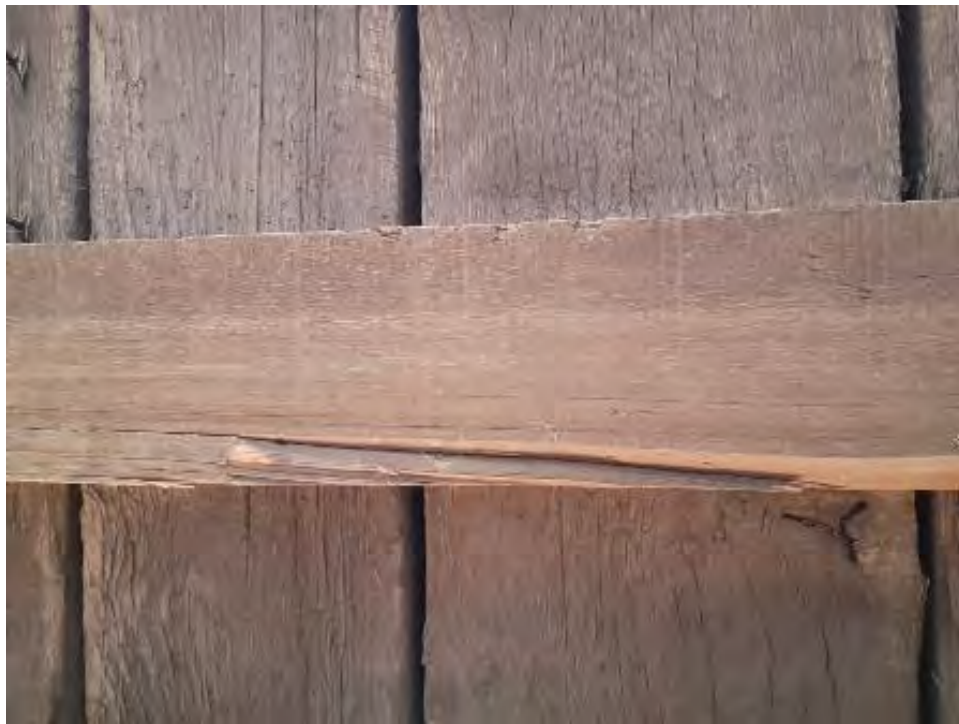
Figure 9-220: J9-2 is decayed on the South face resulting in splits and section loss with possible internal termite damage for approximately 1/3 width, in very poor condition.

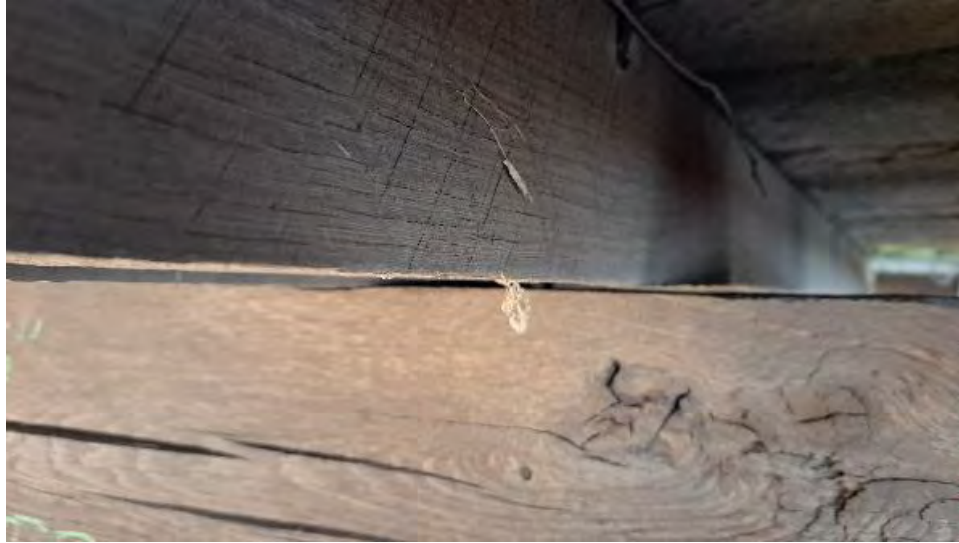
Figure 9-221: J9-3-N minor twisting with no bearing on TB10.

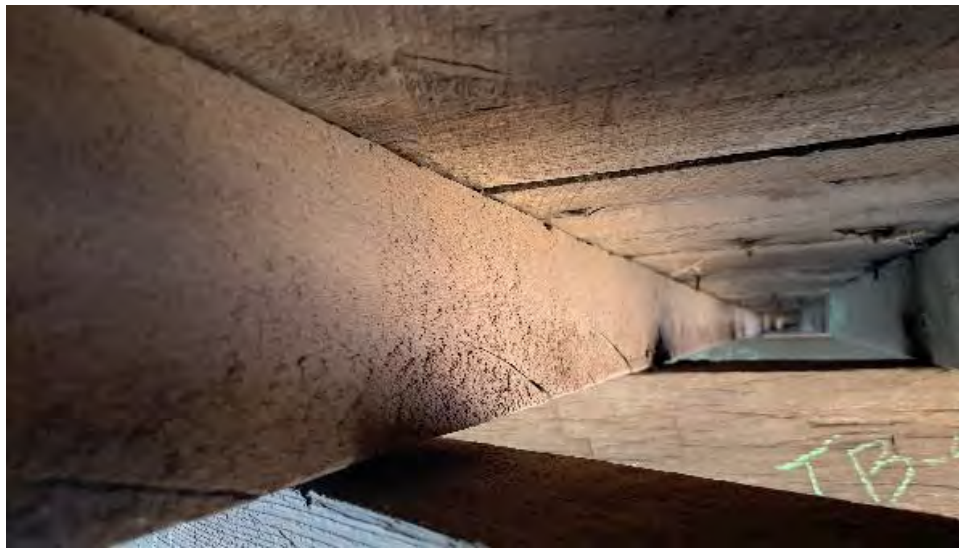
Figure 9-222: J9-3-S is cracked from the bearing over TB9 to 1/3 span.

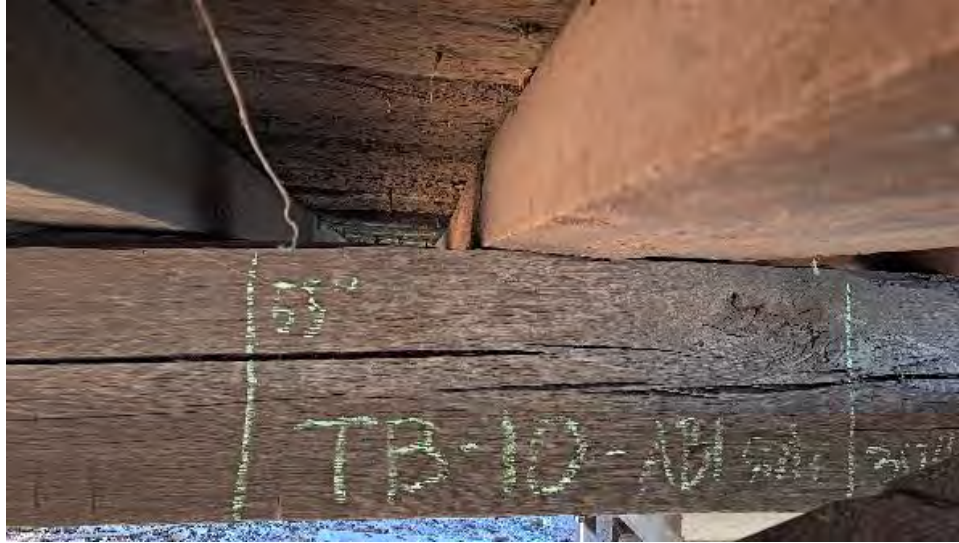
Figure 9-223: J9-3-S has minor twisting over TB10 due to sloped bearing surface of TB10.

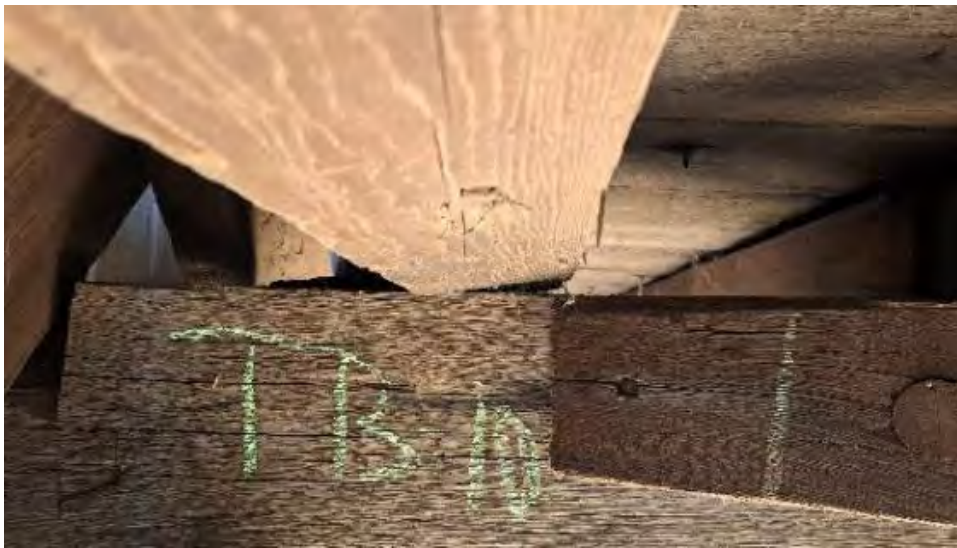
Figure 9-232: J9-8 has end splitting showing its South side only at TB10 end that is 4-feet long. J9-8 is likely cracked on its top surface. There is an end split 8-inches long on its North face from TB10.

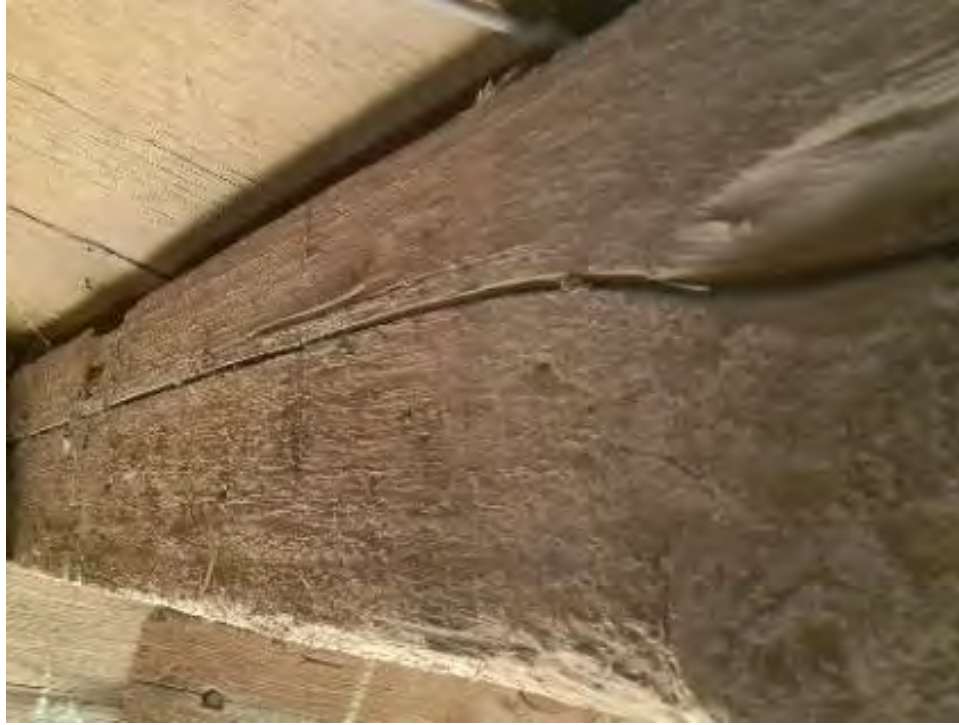
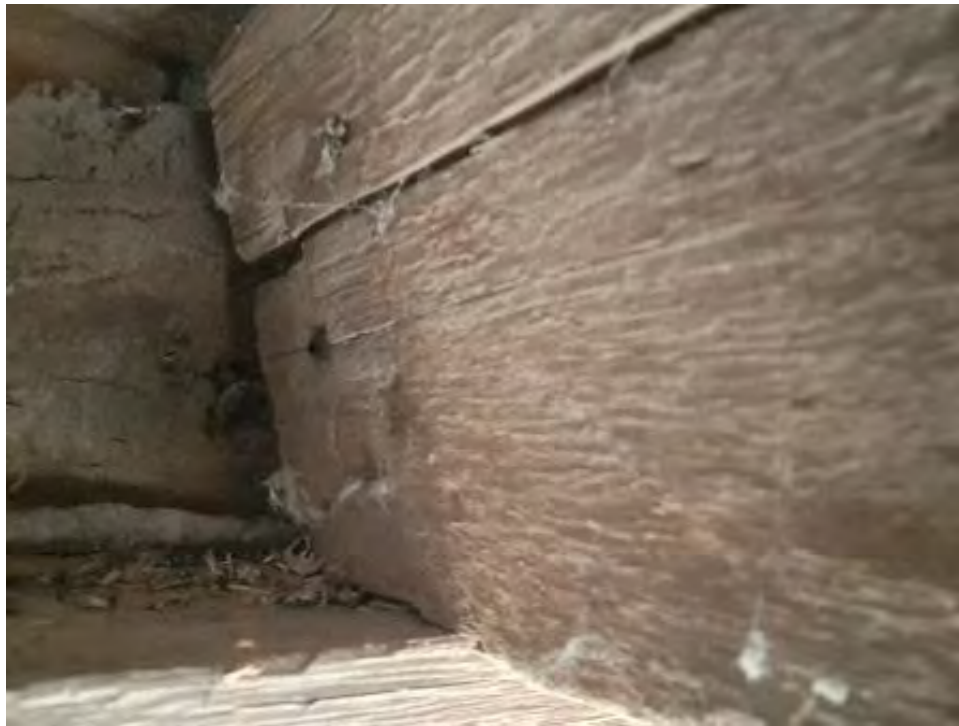
Figure 9-233: J9-8 has end splitting showing its South side only at TB10 end that is 4-feet long. J9-8 is likely cracked on its top surface. There is an end split 8-inches long on its North face from TB10.

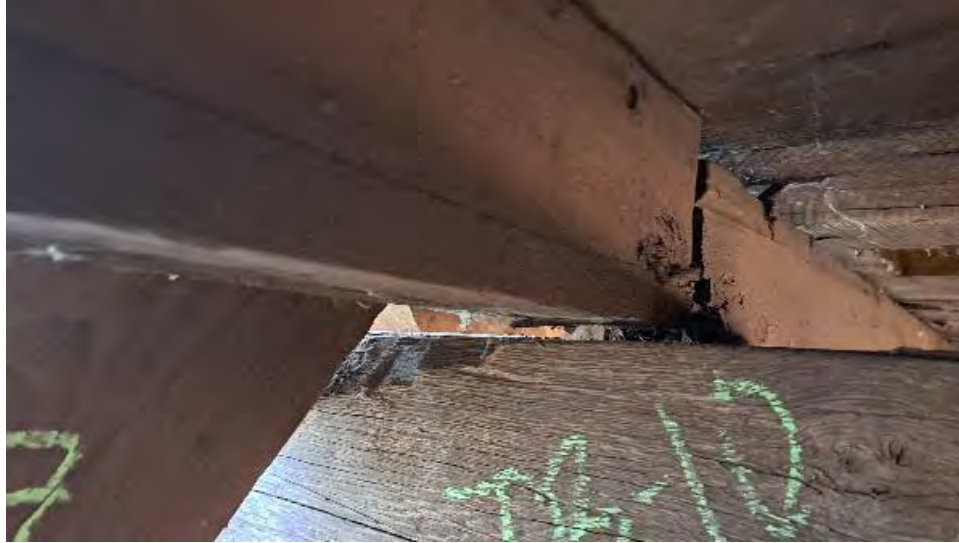
Figure 9-234: J10-1 is not bearing on TB10. Wane exists on its North bottom edge for 3-feet from TB11.

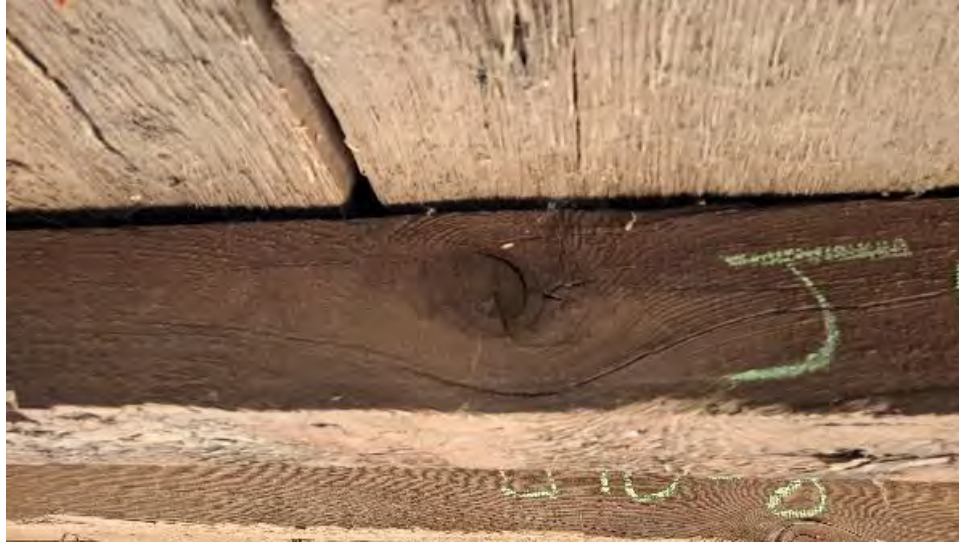
Figure 9-244: J10-7 has a large knot on its North side face near midspan which has led to slope of grain cracking.

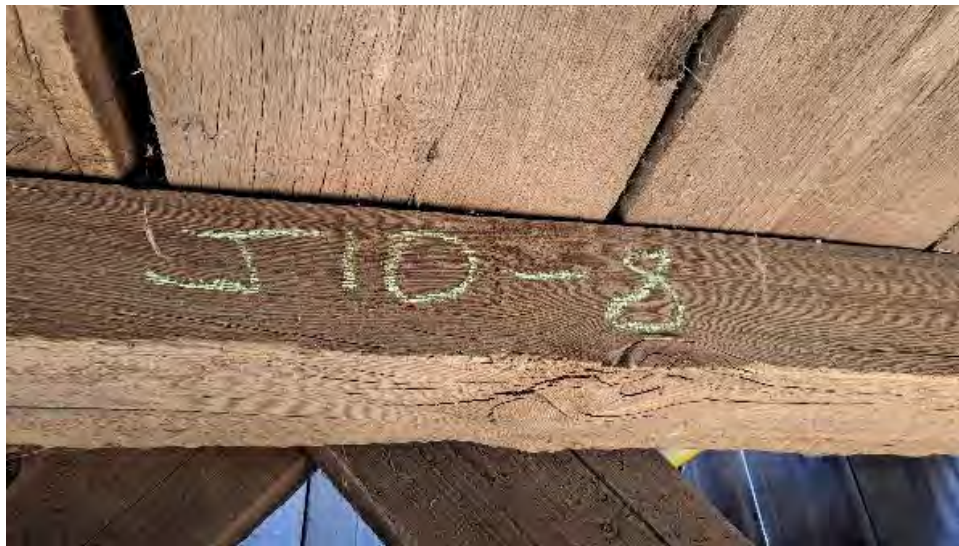
Figure 9-245: J10-8 has a large knot and cracks on its bottom and North side face at mid span.

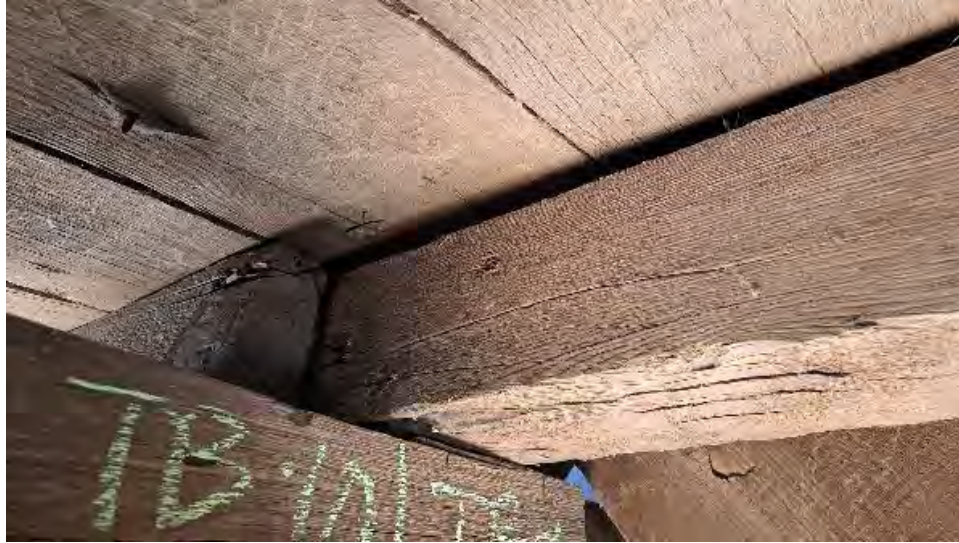
Figure 9-246: J10-8 has section loss at its bearing surface over TB10 and at the top South edge over TB10.

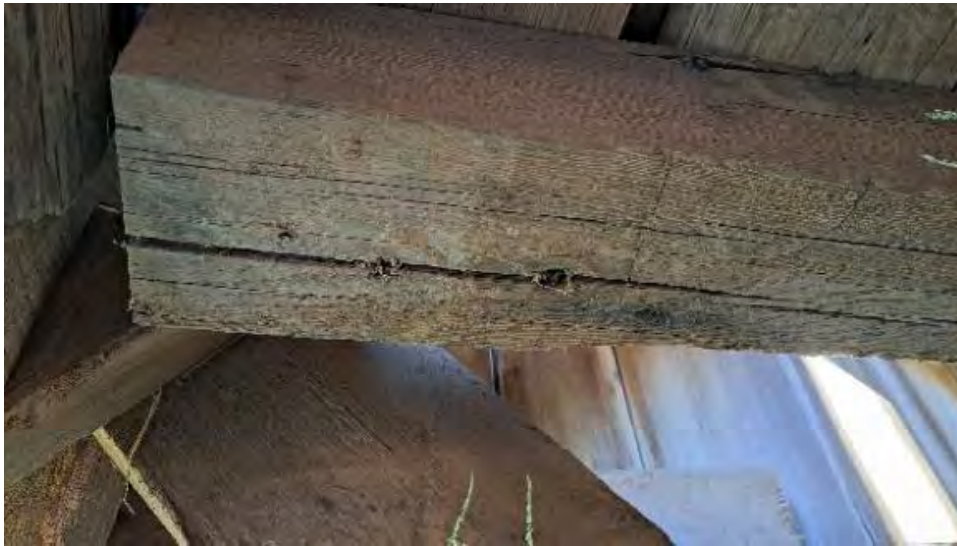
Figure 9-247: J11-1 has a vertical split 16-inches long at the AB2 end, with some additional minor splitting at its top South edge.

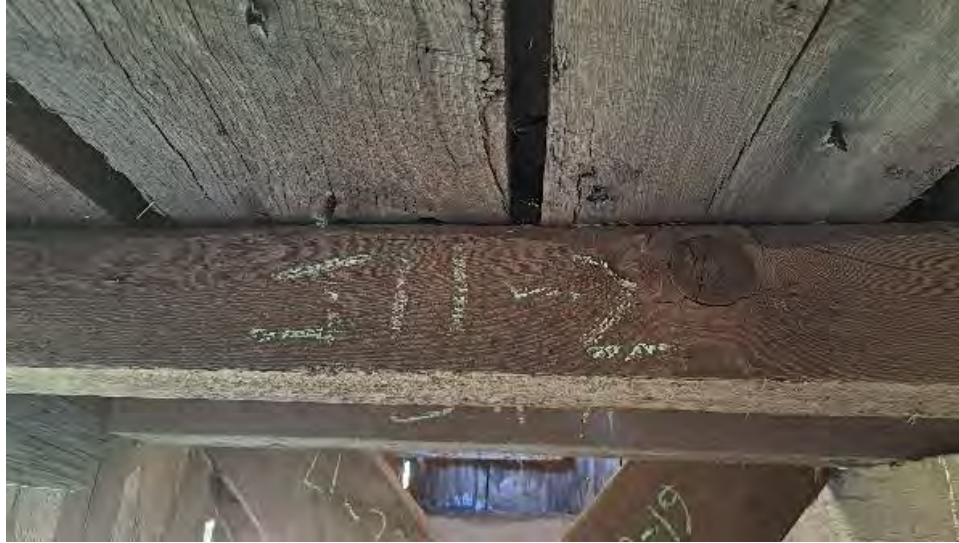
Figure 9-248: J11-2 has a large knot on the South face at mid span, likely extending to the top face with some section loss from slope of grain cracking and wane.

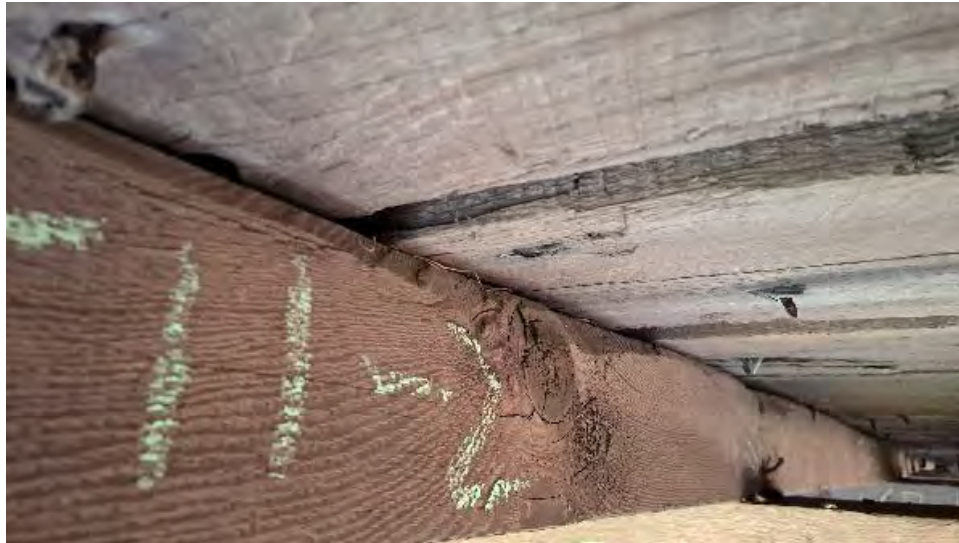
Figure 9-249: J11-2 has a large knot on the South face at mid span, likely extending to the top face with some section loss from slope of grain cracking and wane.

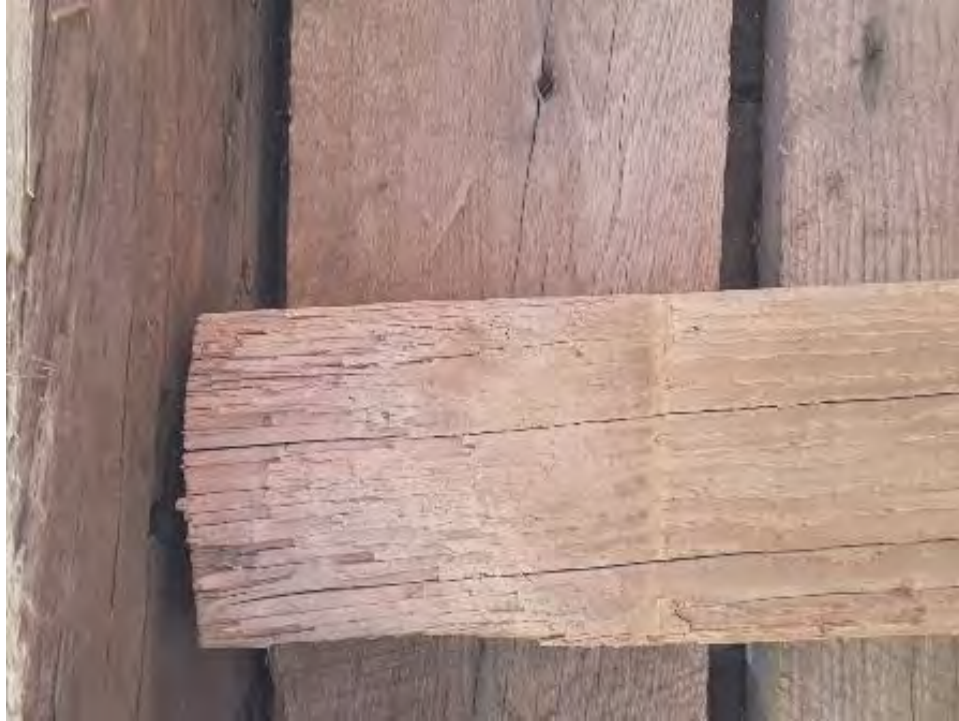
Figure 9-250: J11-3 has feathering at the bottom face at AB2 end.

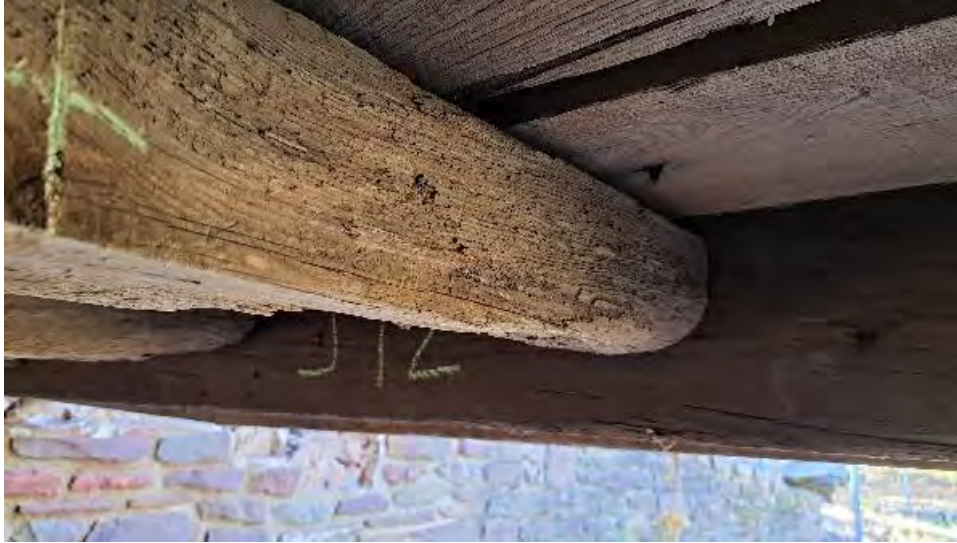
Figure 9-252: J11-4 has some termite damage with major section loss at the bottom face at the AB2 end.

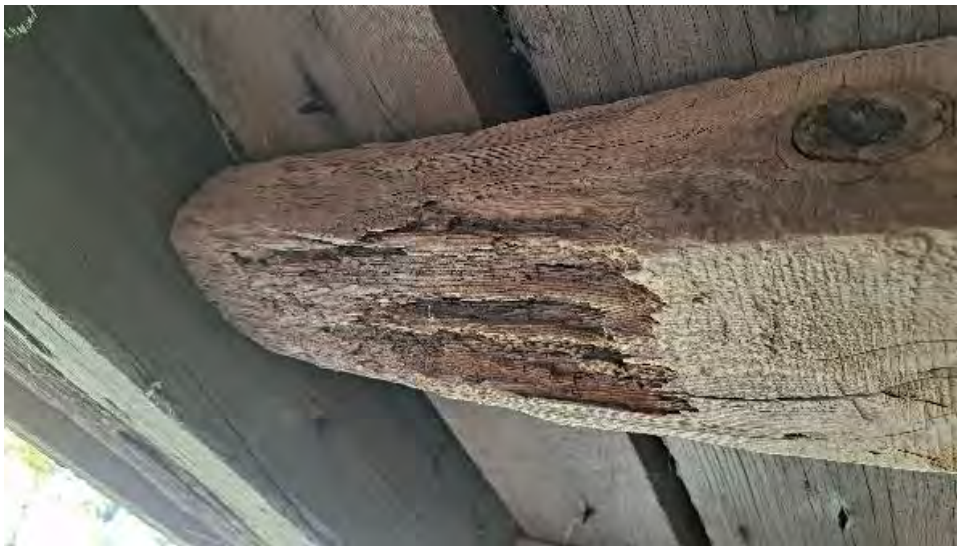
Figure 9-253: J11-4 has some termite damage with major section loss at the bottom face at the AB2 end.

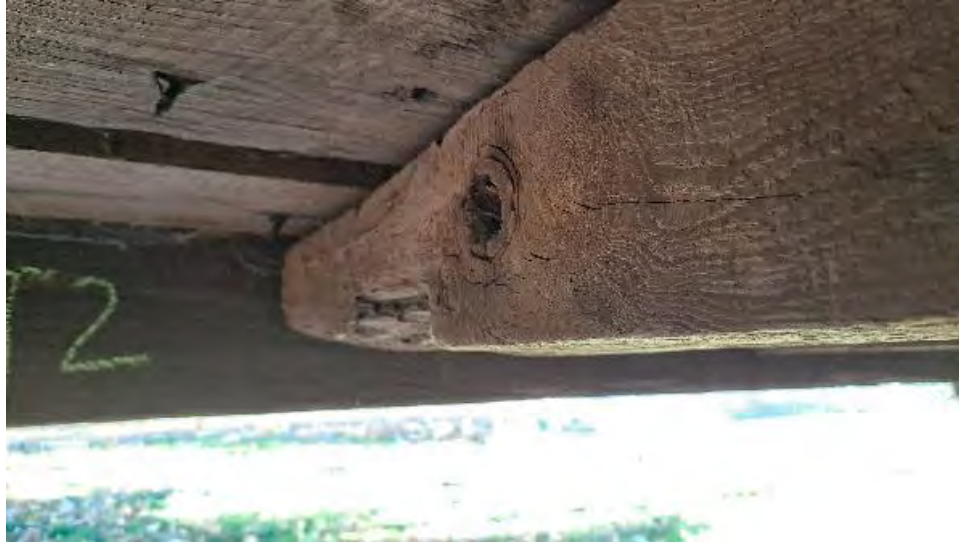
Figure 9-254: J11-4 has some termite damage with major section loss at the bottom face at the AB2 end.

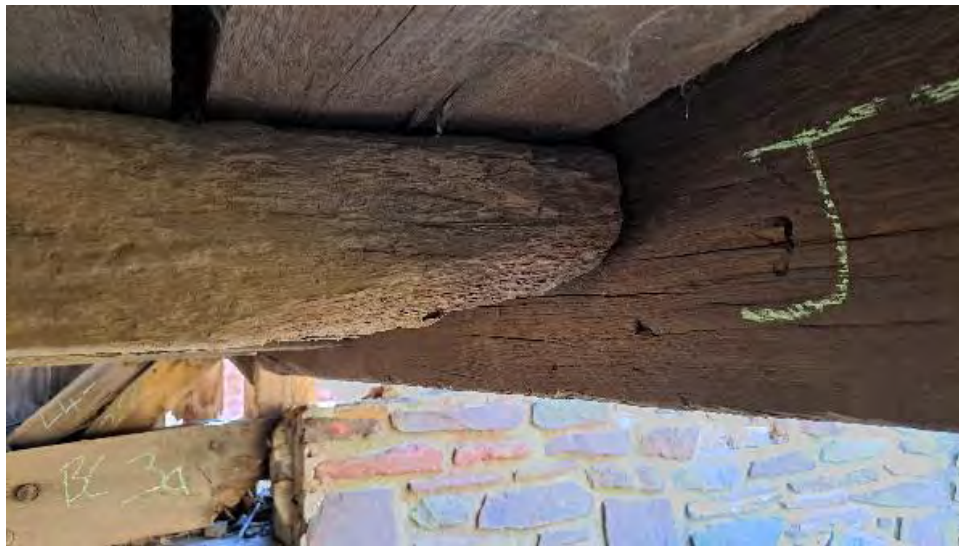
Figure 9-255: J11-5 has some termite damage and some section loss at bottom and South faces at the AB2 end.

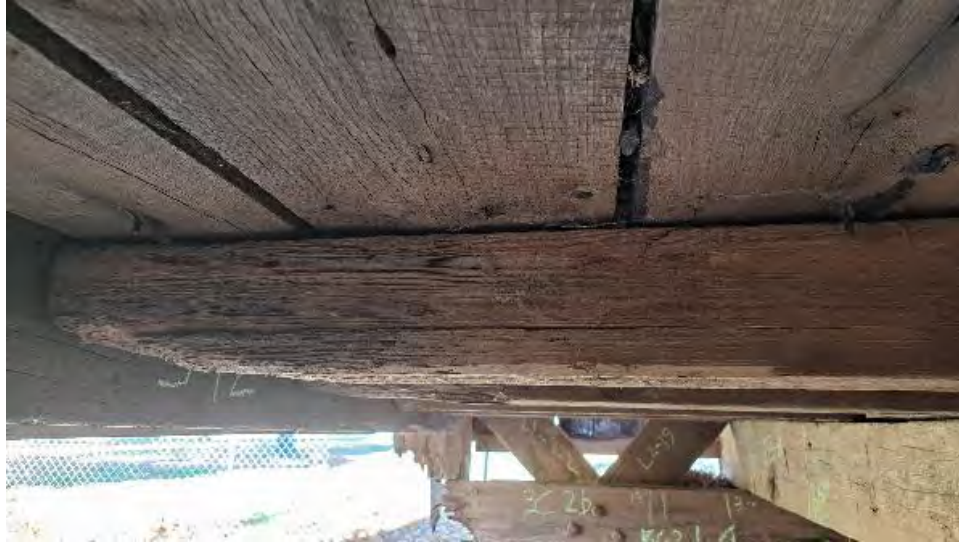
Figure 9-256: J11-5 has an end split on the South face that is 20-inches long.

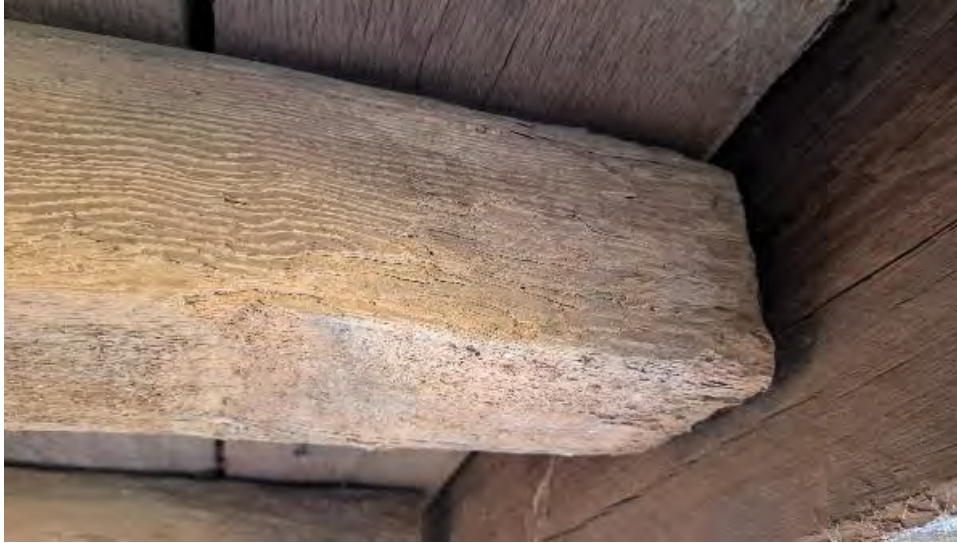
Figure 9-258: J11-6 has abrasion wear at the AB2 end.

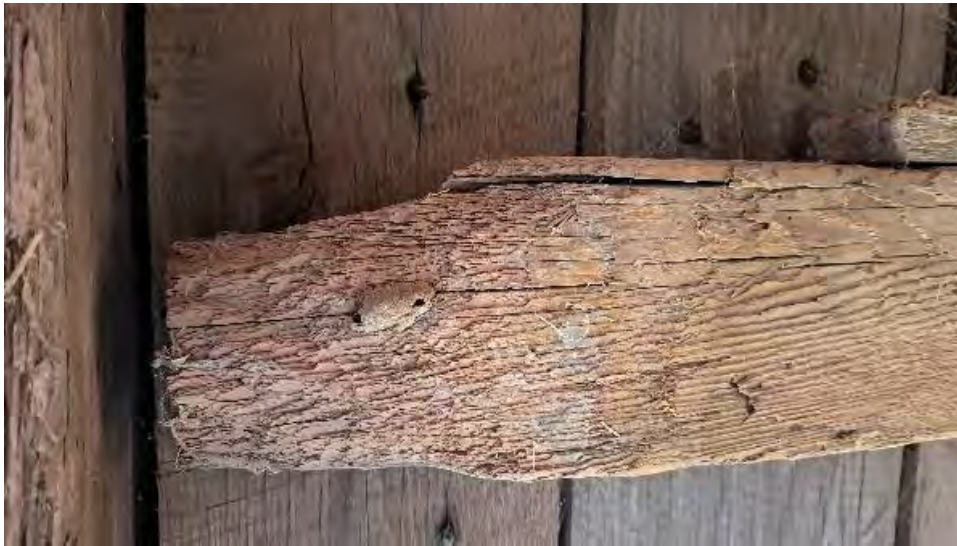
Figure 9-259: J11-7 has termite damage to the bottom and South faces with significant section loss.

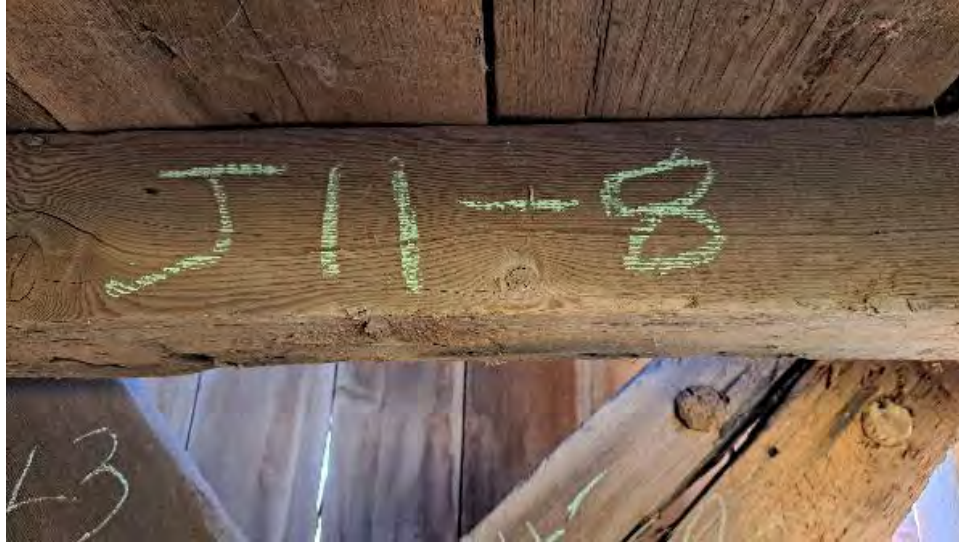
Figure 9-260: J11-8 termite damage to bottom and South faces for most of the length with some minor cracking and damage.

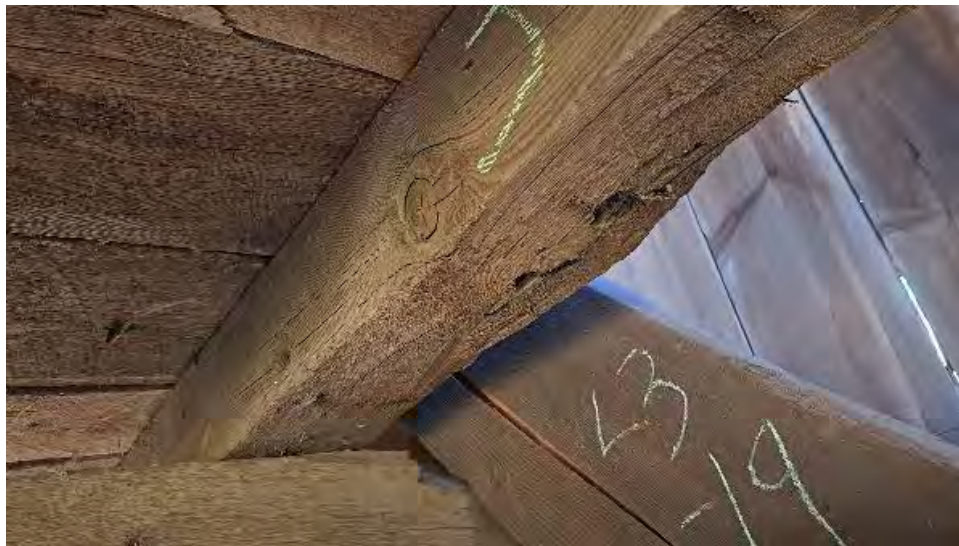
Figure 9-261: Joist J11-8 termite damage to bottom and South faces for most of the length with some minor cracking and damage.

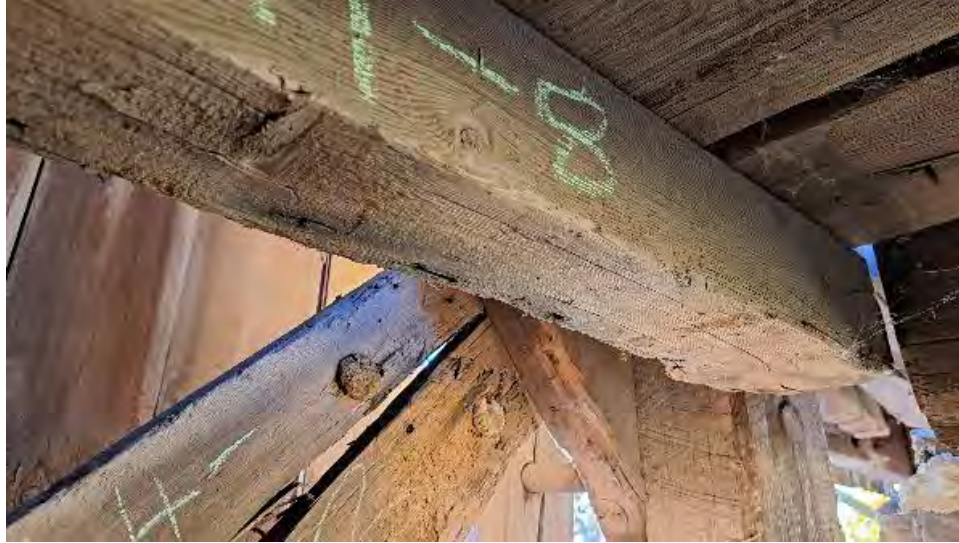
Figure 9-262: Joist J11-8 termite damage to bottom and South faces for most of the length with some minor cracking and damage.

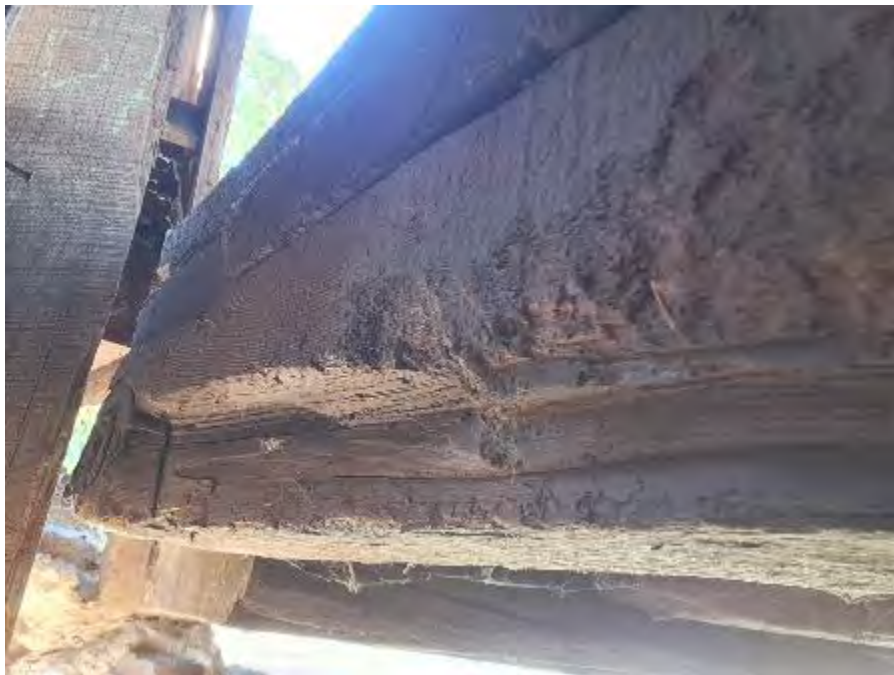
Figure 9-263: termite damage to bottom and South faces for most of the length with some minor cracking and damage.

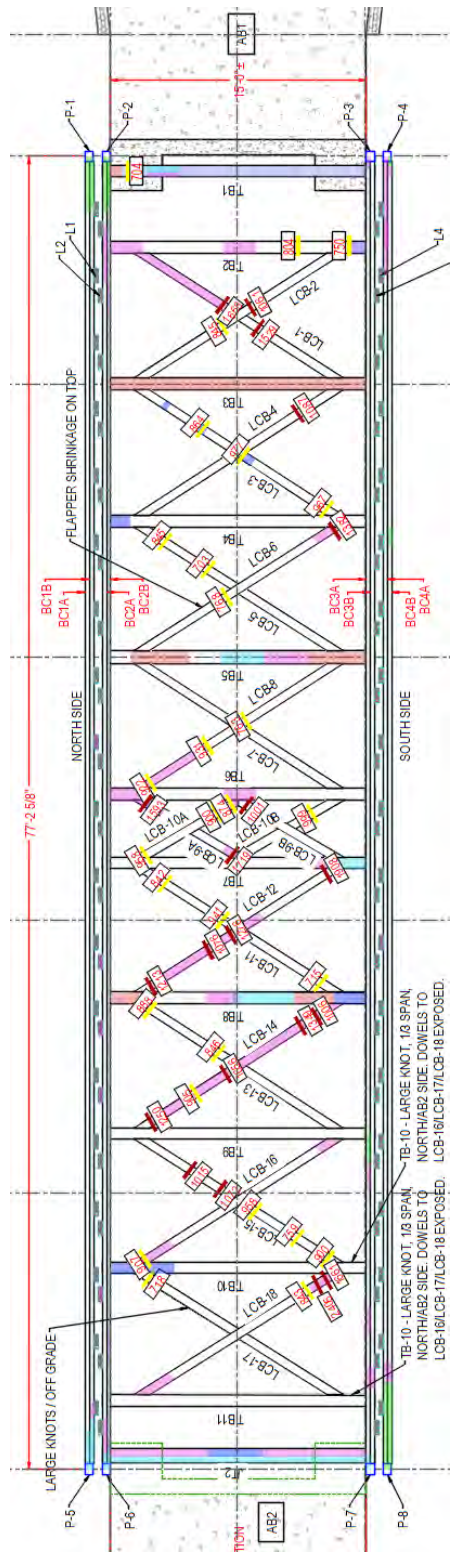
Figure 9-264: Summary of elevated SWT values on the lower cross braces.

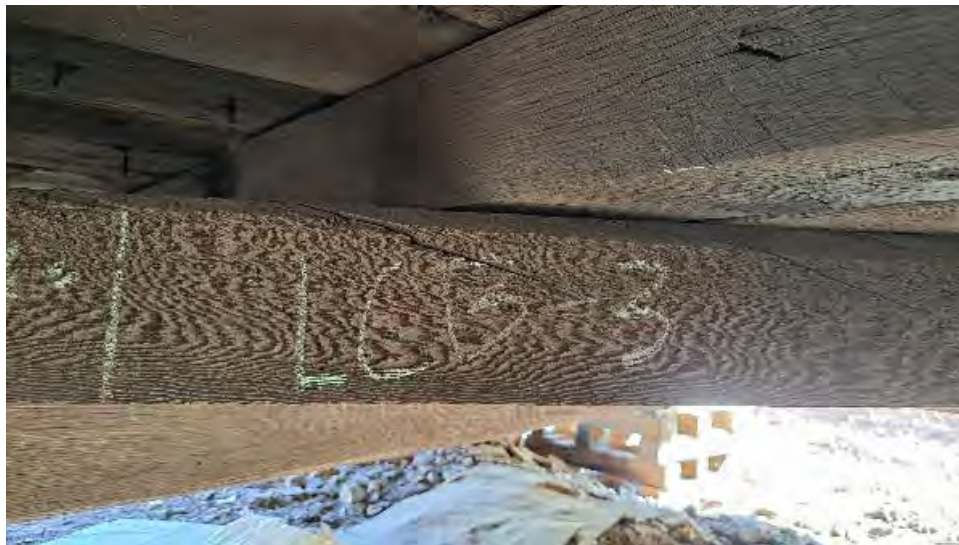
Figure 9-270: LCB-3 has some wane on its top edge facing AB2 with some slope of grain cracking.

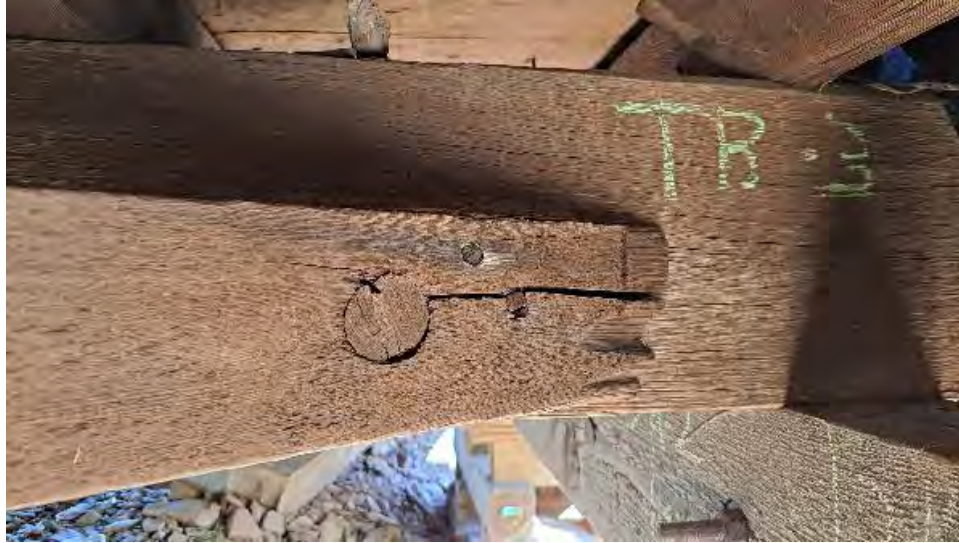
Figure 9-271: The LCB-4 dowel and spikes to TB3 have cleaved.

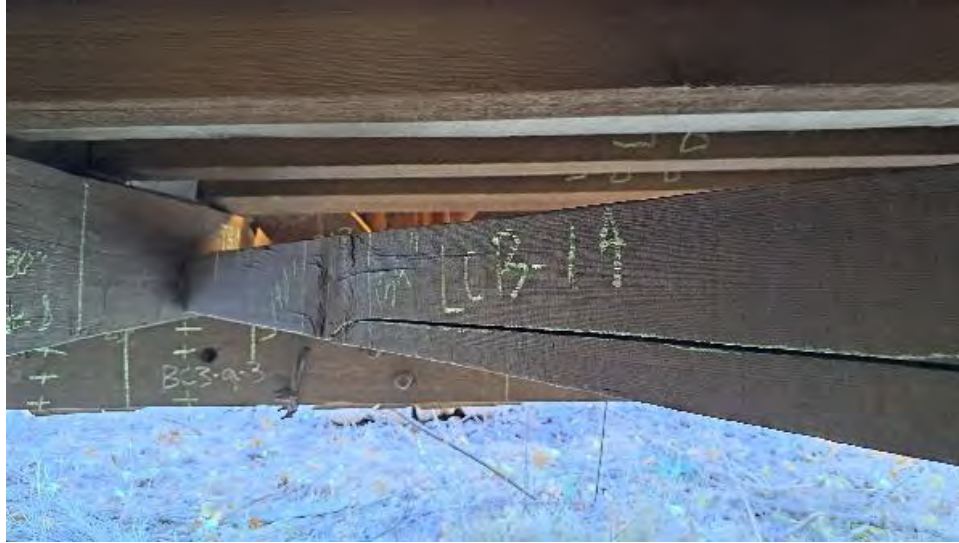
Figure 9-287: LCB-14 has a large knot on the AB1 side that has led to slope of grain cracking.

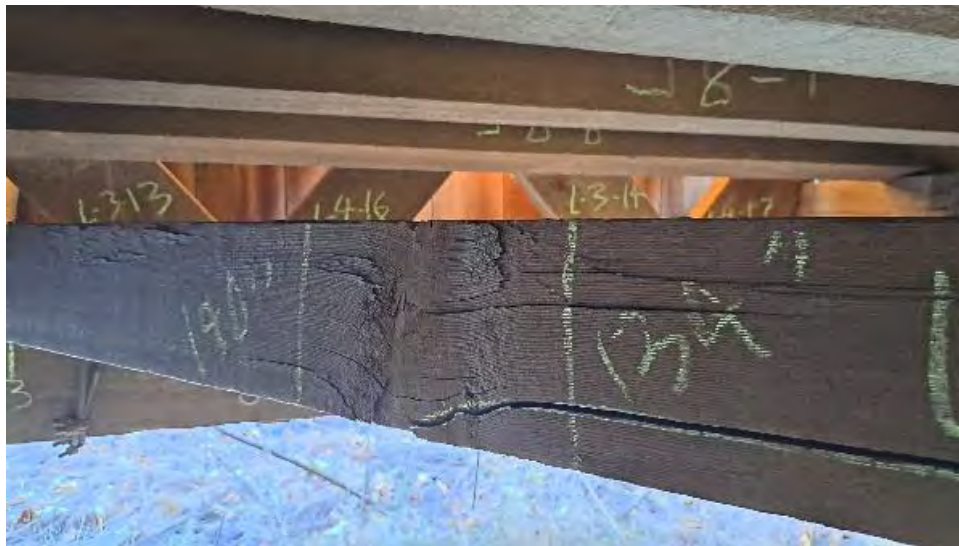
Figure 9-288: LCB-14 has a large knot on the AB1 side that has led to slope of grain cracking.

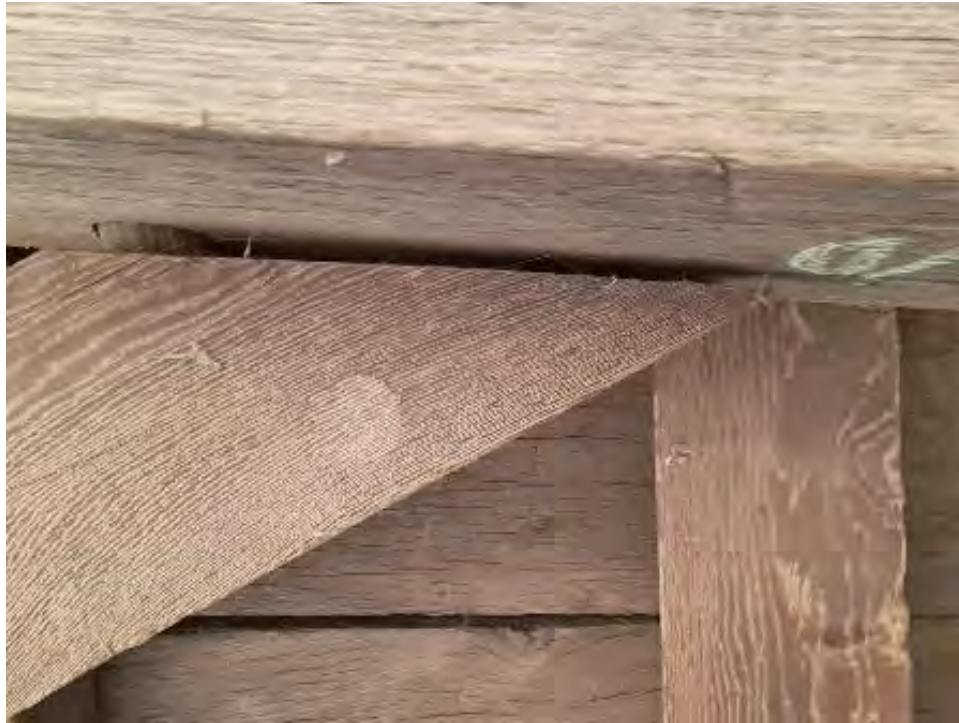
Figure 9-289: LCB-15 is separated from TB10.

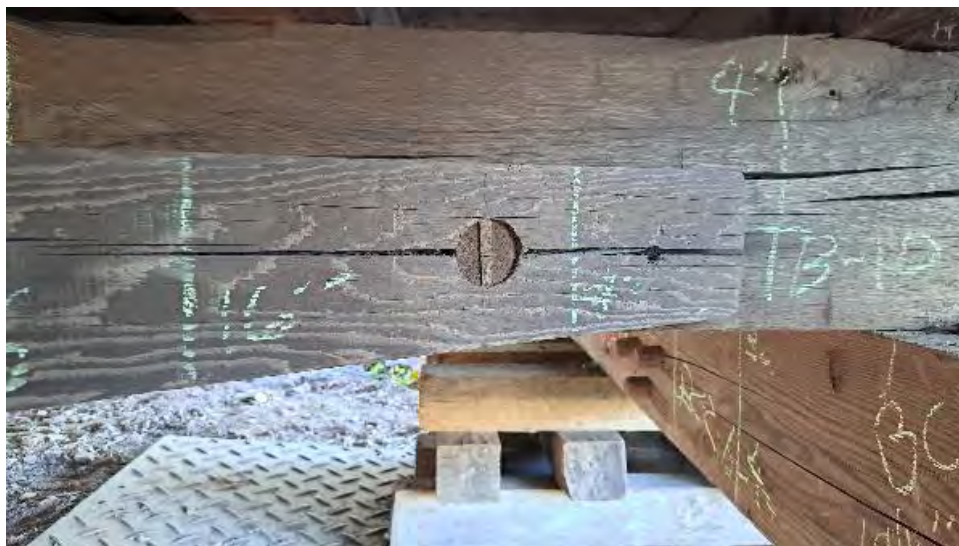
Figure 9-290: LCB-16 has cleaved on the dowel to TB10, resulting in a 2-foot long crack.

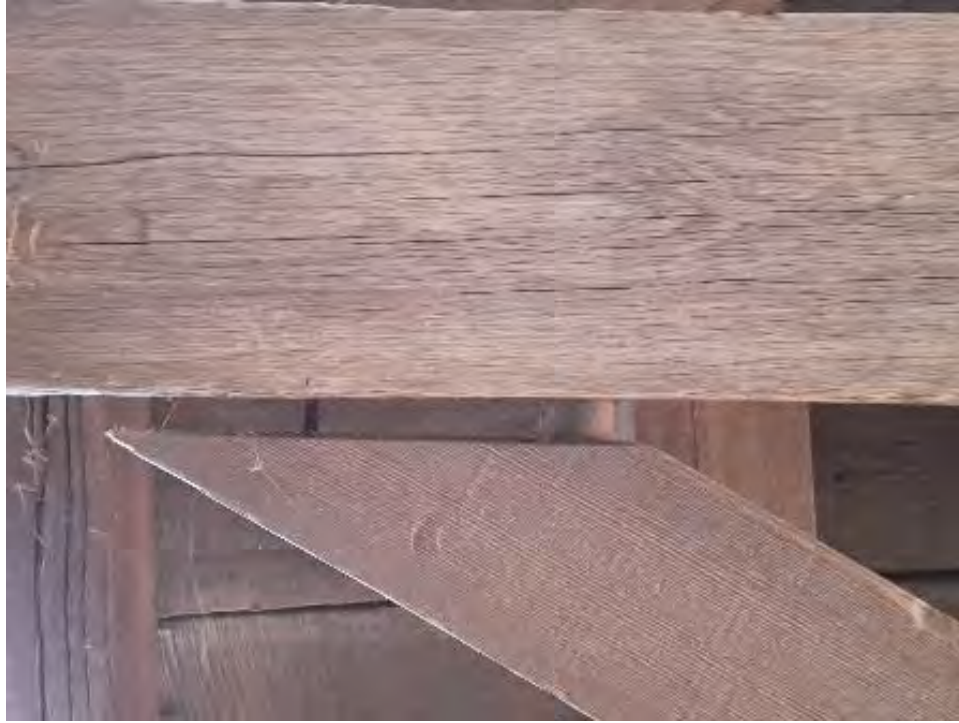
Figure 9-291: LCB-16 is separated from TB 10 by approximately 1-inch.

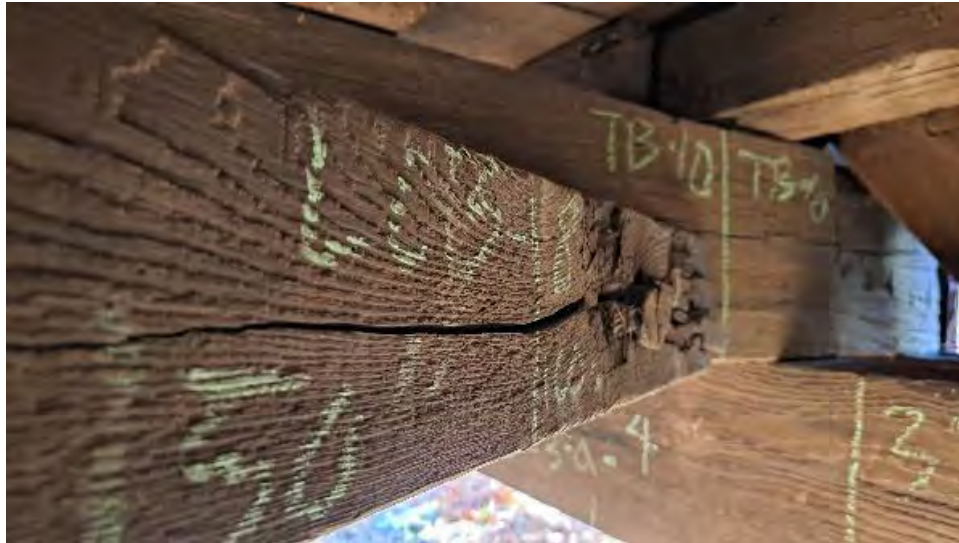
Figure 9-295: LCB-18 has major cracking and cleaving of dowel to TB10. The crack is 2-foot long and is on the AB2 face and meets vertical end crack seen on the bottom face.

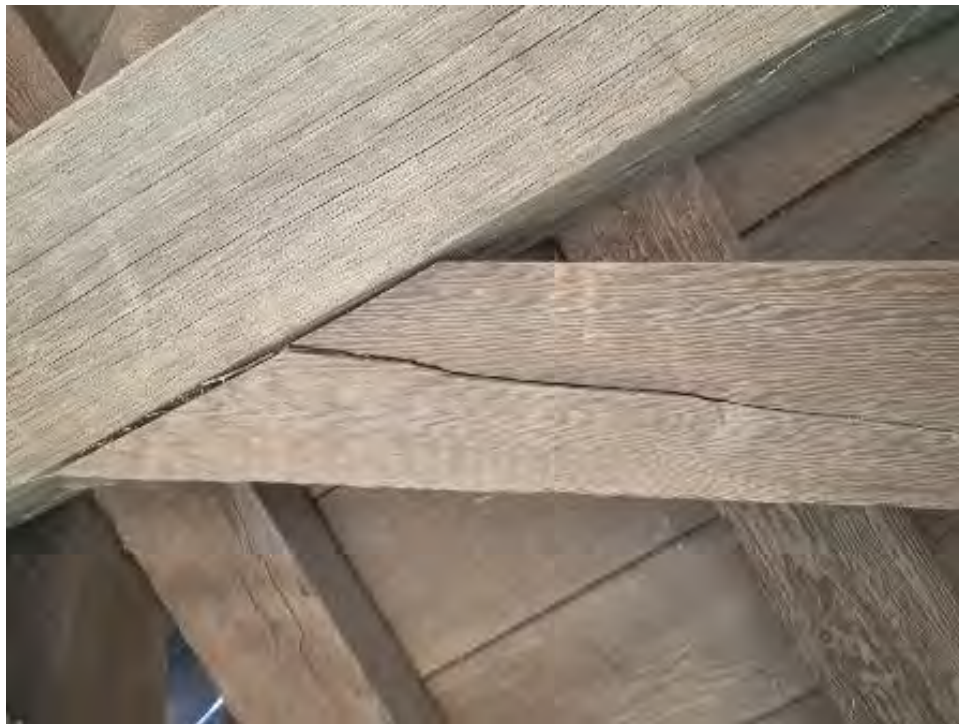
Figure 9-296: LCB-18 major cracking / cleaving of dowel at TB-10. Crack 2-foot long on Abutment 2 face, meets vertical crack on bottom face.
