South Perkasio Covered Bridge Inspection Report

SUBMITTED TO:
Borough Of Perkasio
149 W Walnut St,
Perkasio, PA 18944
(Phone Number TBD); (Email TBD)

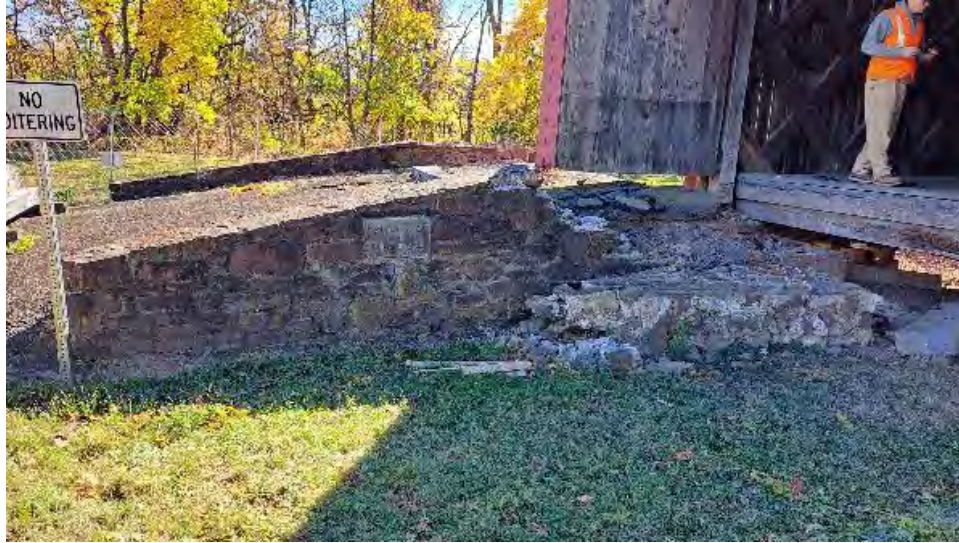
Figure 10-1: The North side of AB1 has an approximately 10-foot length of stone wall dislodged. Backfilling has receded and the asphalt surface is damaged.

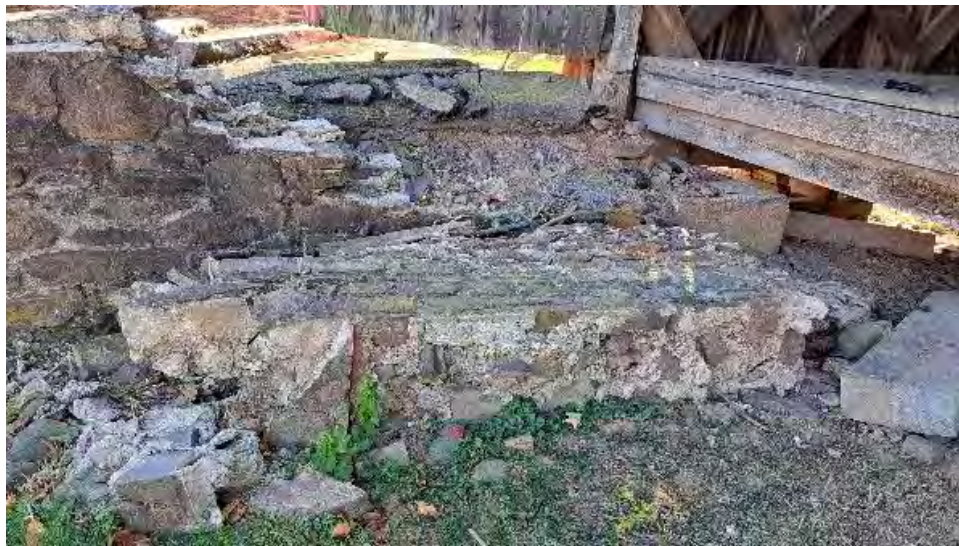
Figure 10-2: The North side of AB1 has approximately 10-foot of stone wall that is dislodged. Backfilling has receded and asphalt surface is damaged.

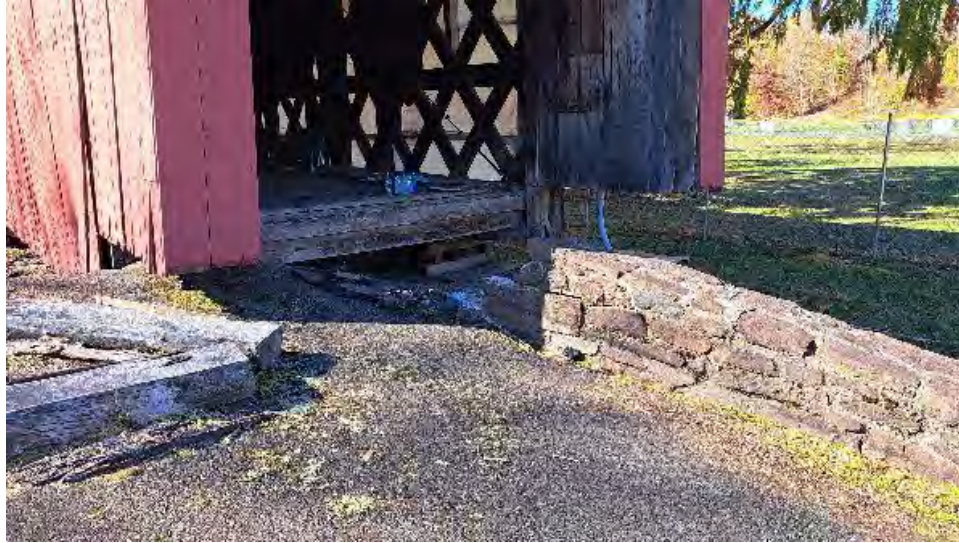
Figure 10-3: The North side of AB1 has approximately 10-foot of stone wall that is dislodged. Backfilling has receded and asphalt surface is damaged.

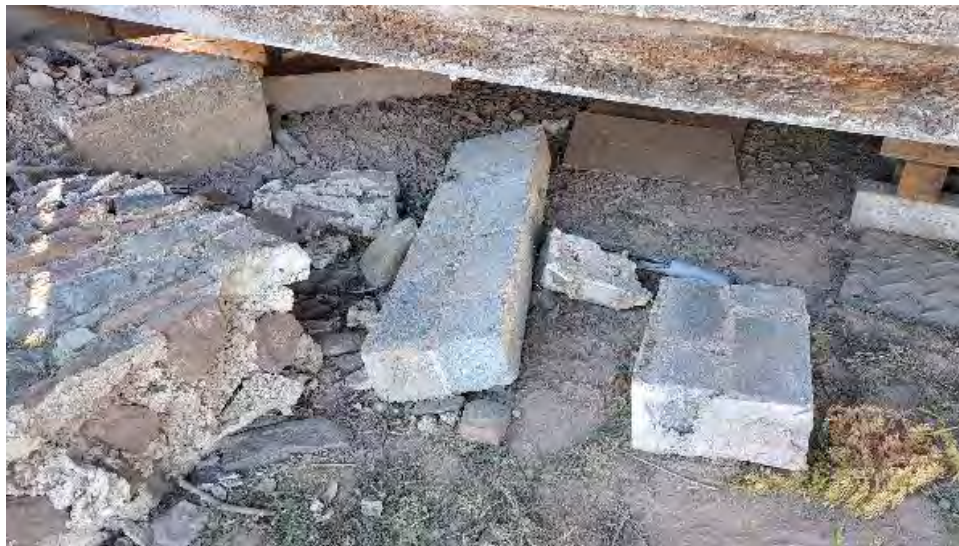
Figure 10-4: Concrete masonry wall segments have been dislodged at AB1. These may have formed the breastwall between the backfill and the timber deck.

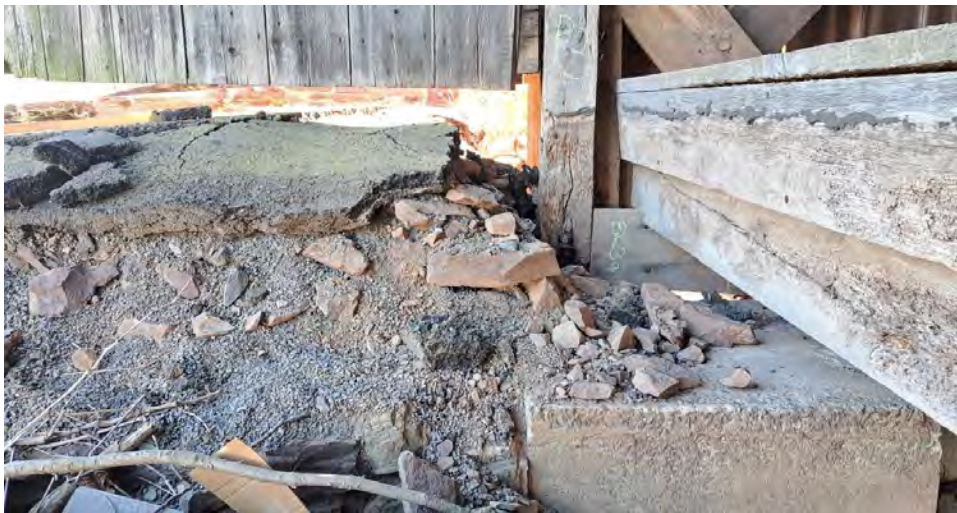
Figure 10-6: The mass concrete foundation at Ab1 appears to be undamaged.

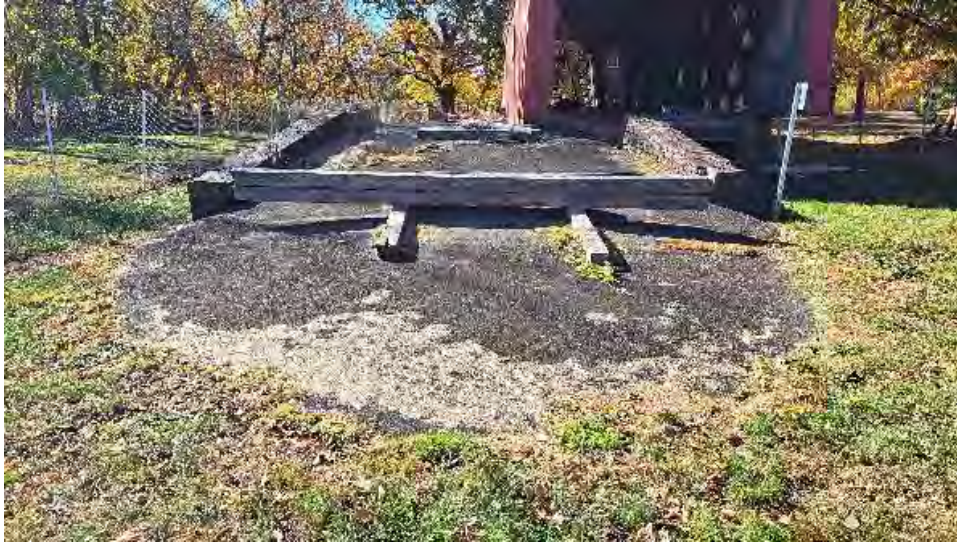
Figure 10-7: A view of the AB1 approach indicates the bridge has moved approximately 10-feet toward the North.

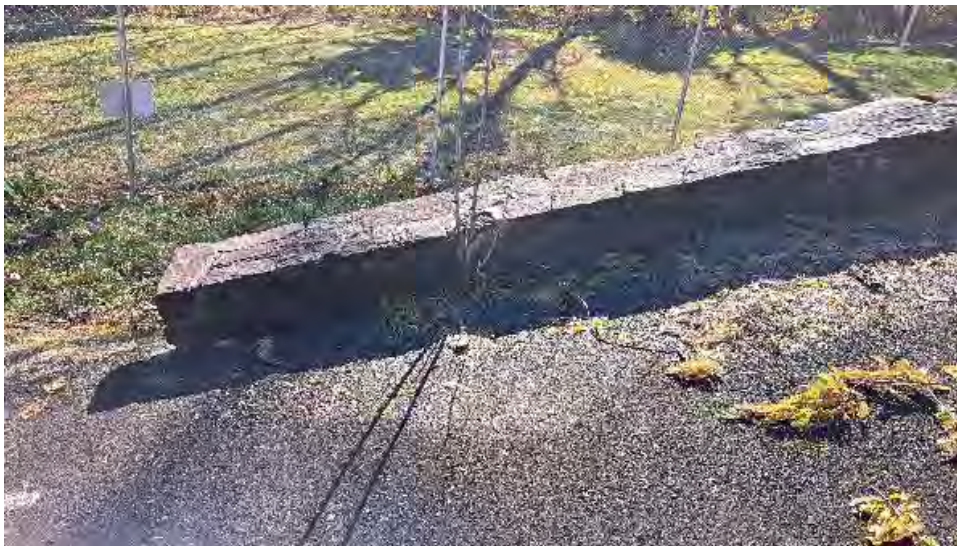
Figure 10-8: Less damage has occurred to the South side stone wall of AB1.

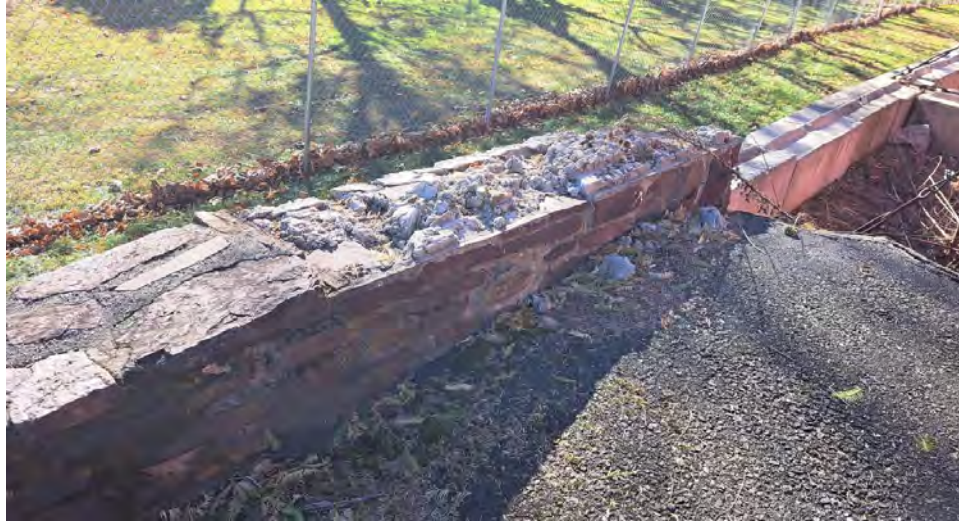
Figure 10-9: The top course of stone is missing from the South side of AB1 for the length of the wing wall.

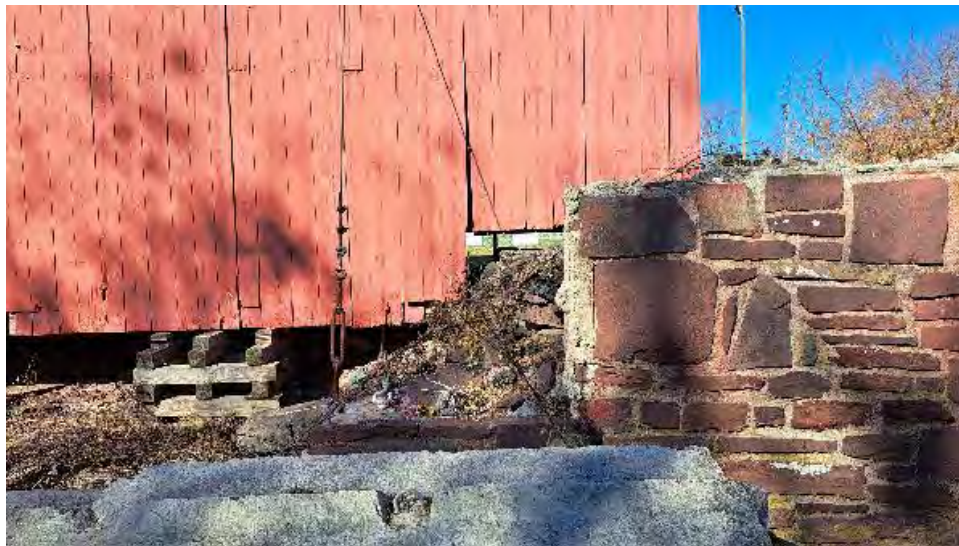
Figure 10-10: The backfilling at AB1 has receded and the asphalt surface is damaged for the full width of AB1.

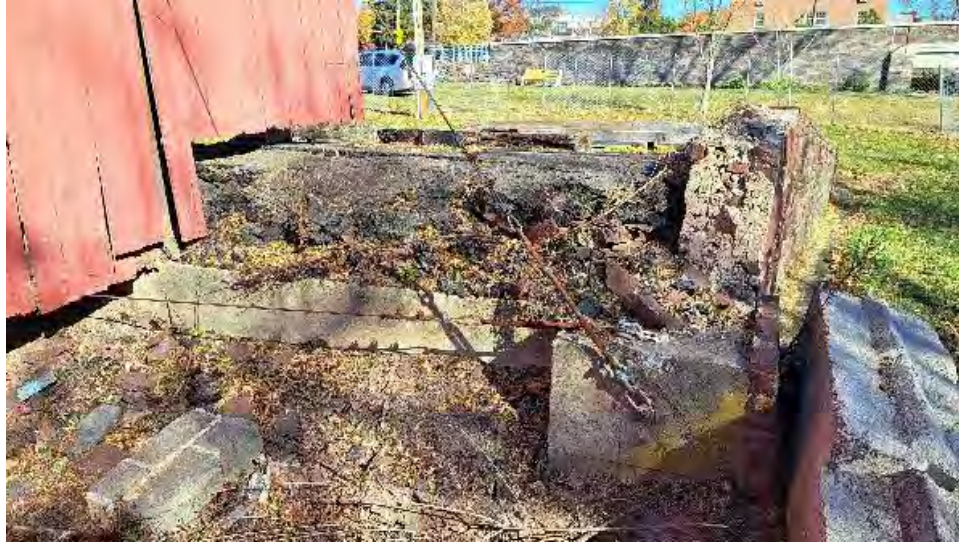
Figure 10-11: The backfilling at AB1 has receded and the asphalt surface is damaged for the full width of AB1.

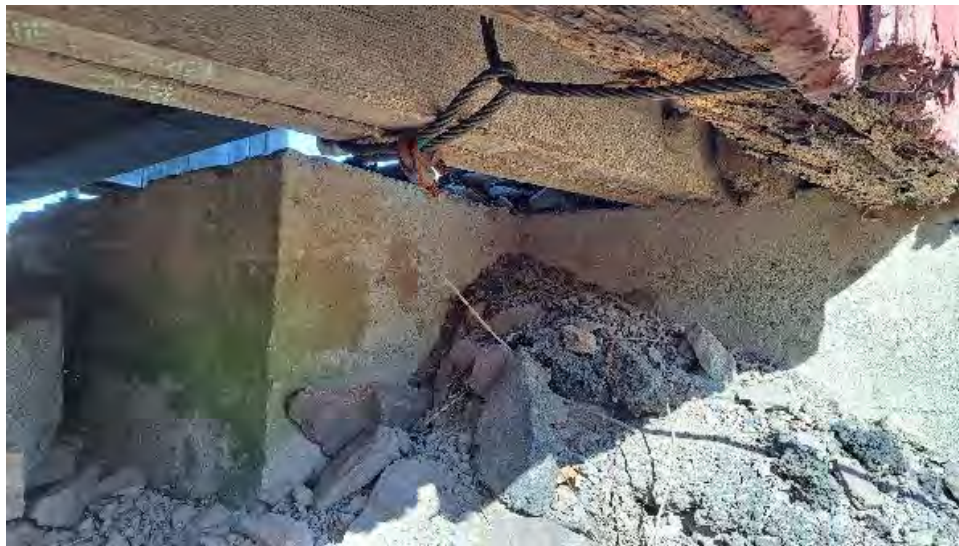
Figure 10-12: The receded backfill and segments of the asphalt surface are scattered against the mass concrete foundation of AB1.

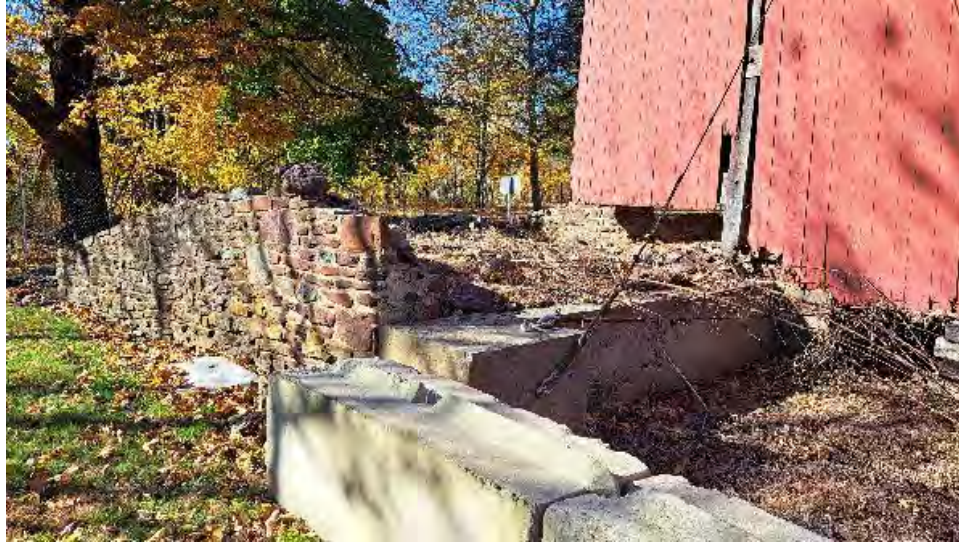
Figure 10-13: The top course of stone is missing for the length of the wing wall at the South side of AB2.

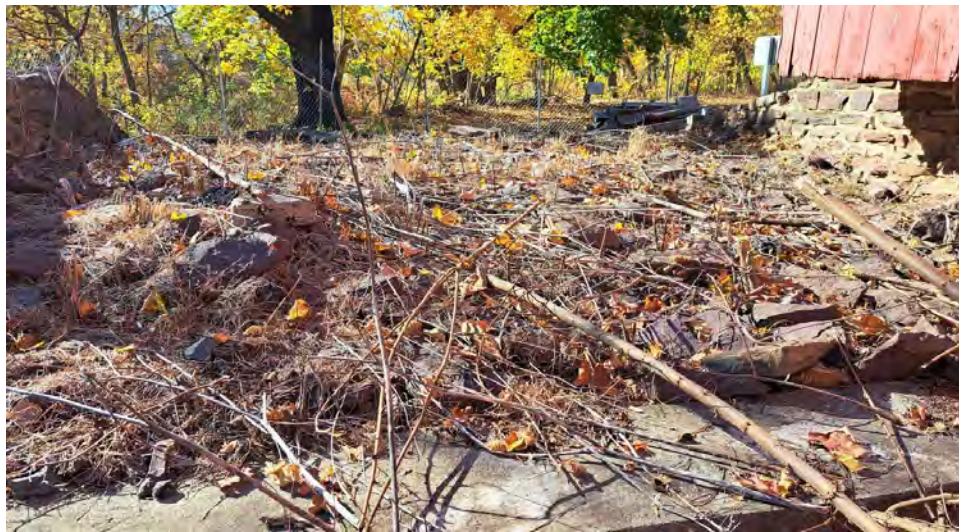
Figure 10-14: The backfilling at AB2 has receded and the asphalt surface is damaged for the full width of AB2. Significant debris exists over the approach.

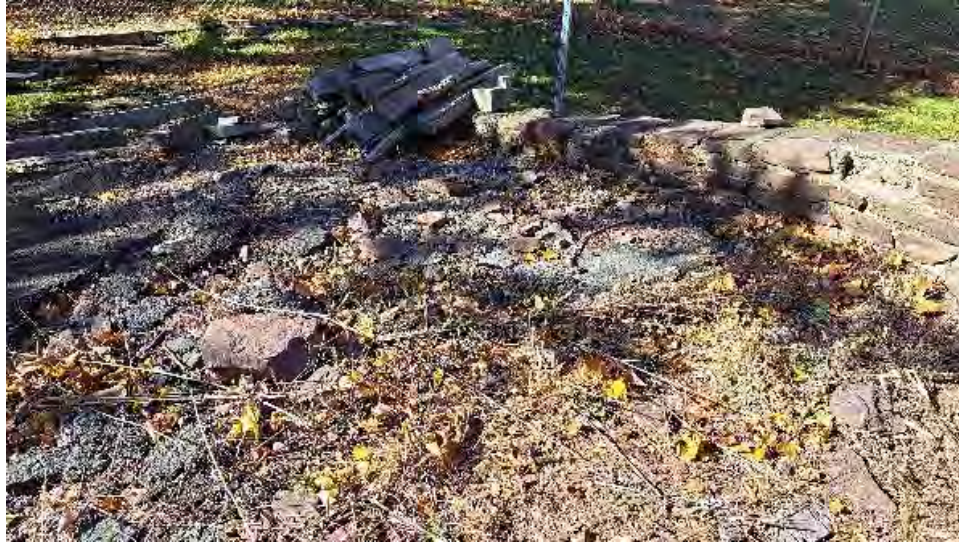
Figure 10-15: The backfilling at AB2 has receded and the asphalt surface is damaged for the full width of AB2. Significant debris exists over the approach. Loose timber elements are stockpiled at AB2.

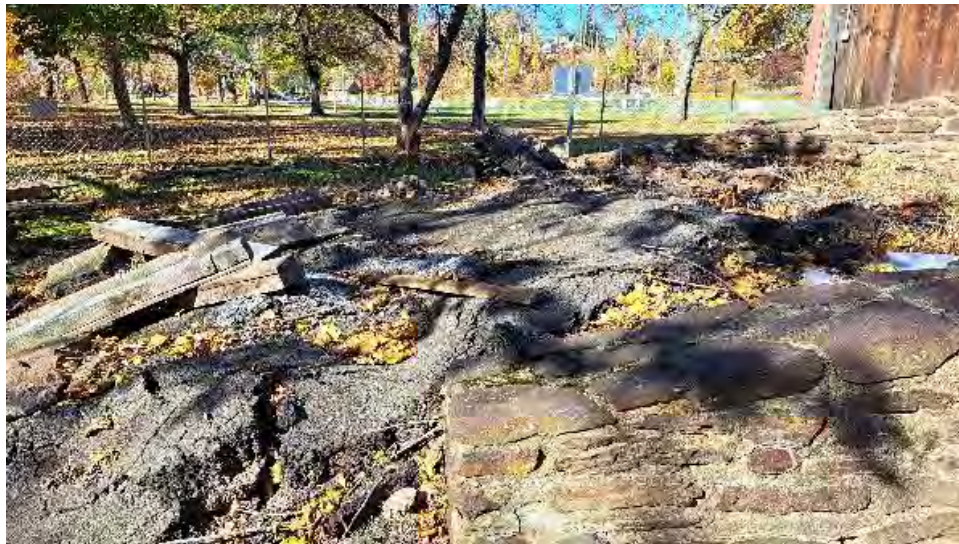
Figure 10-16: The remaining asphalt at AB2 is in poor condition. Loose timber elements are stockpiled at AB2.

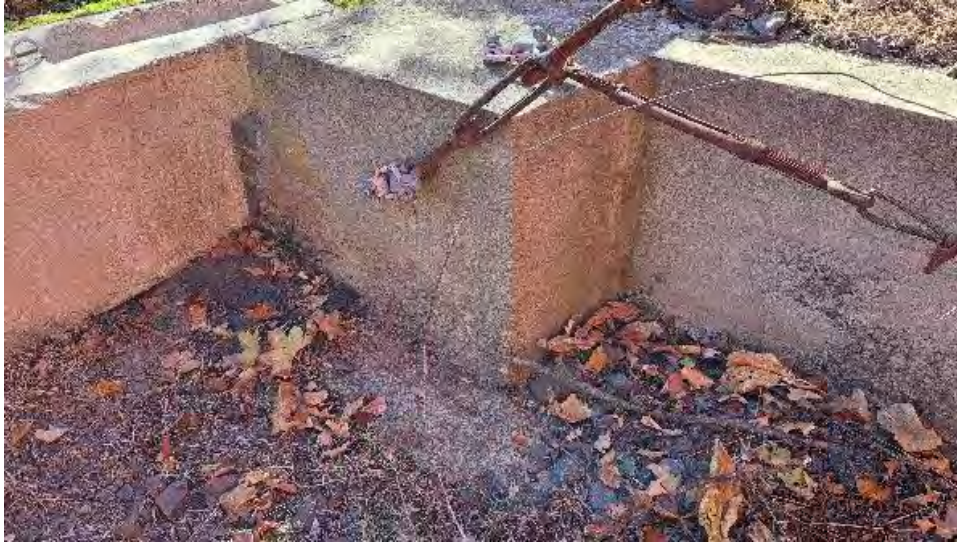
Figure 10-17: The mass concrete foundation at AB2 appears to be undamaged.

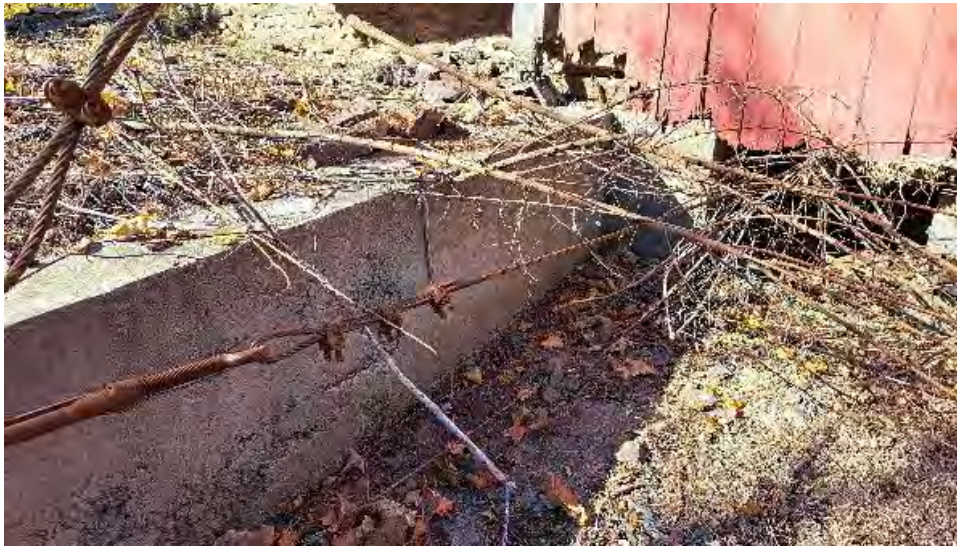
Figure 10-18: The mass concrete foundation at AB2 appears to be undamaged.

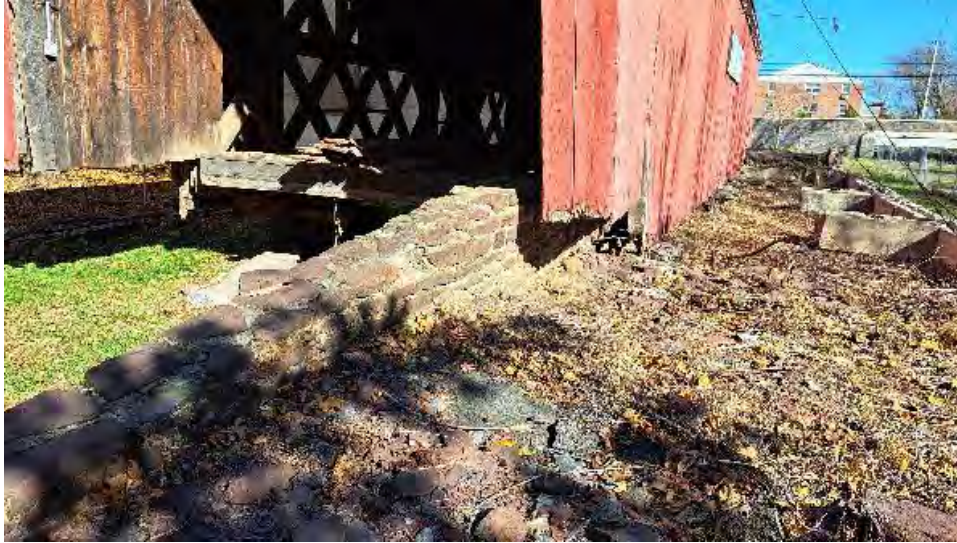
Figure 10-19: The stone wall on the North side of AB2 is in generally good condition away from the original wing wall position.

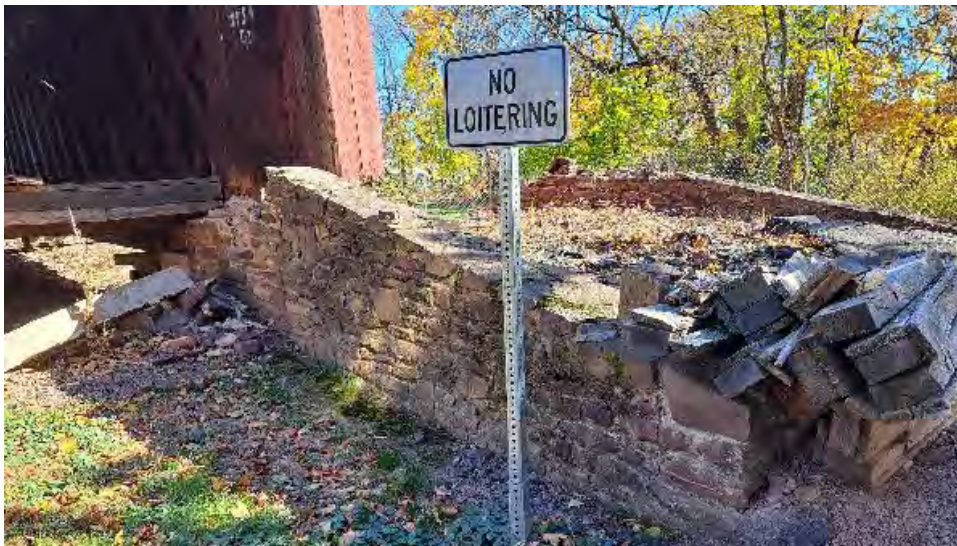
Figure 10-20: The stone wall on the North side of AB2 is in generally good condition away from the original wing wall position. Loose timber elements are stockpiled at AB2.

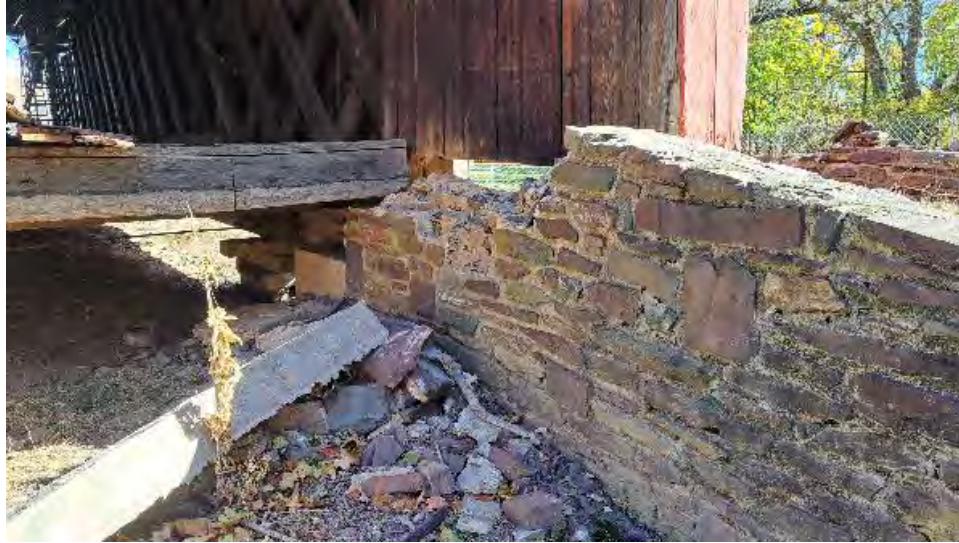
Figure 10-21: The North side of AB2 has approximate 10-foot length of stone wall destroyed for approximately half of its height.

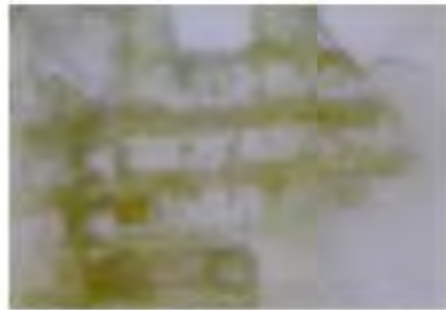
Figure B: Radial View 1 | Observation of the Radial face found cross-field pitting in the form of small pits of variable number.

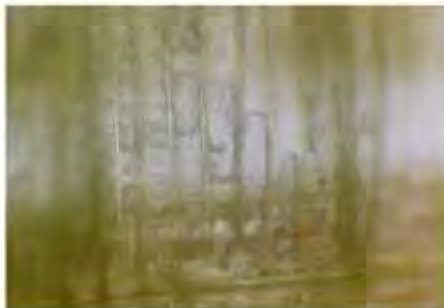
Figure C: Radial View 2 | Additional analysis of the Radial face shows tracheids with abundant spiral thickenings, indicative of Douglas fir.

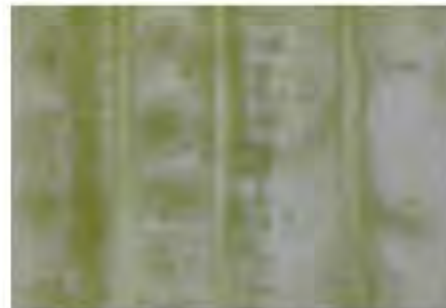
Figure D: Radial View 3 | Further examination of the Radial face found non-aspirated bordered pits, suggesting the coastal variety.

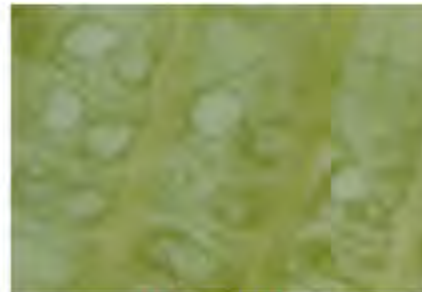
Figure B: Radial View 1 | Observation of the Radial face found ray parenchyma cross-field pitting in the form of large window-like pits with 1-2 per cross-field.

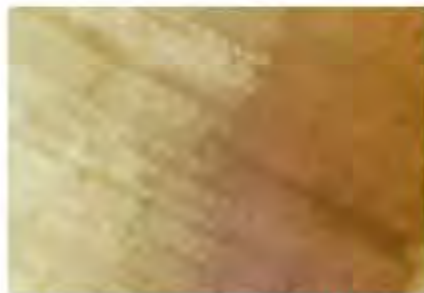
Figure C: Transverse View 1 | Additional analysis of the Transverse face shows distinct growth rings with a gradual EW/LW transition.

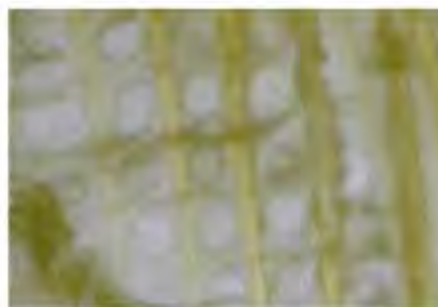
Figure B: Radial View 1 | Observation of the Radial face found ray parenchyma cross-field pitting in the form of large window-like pits with 1-2 per cross-field.

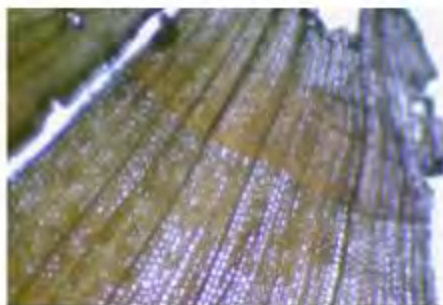
Figure C: Transverse View 2 | Additional analysis of the Transverse face shows distinct growth rings with a gradual EW/LW transition.

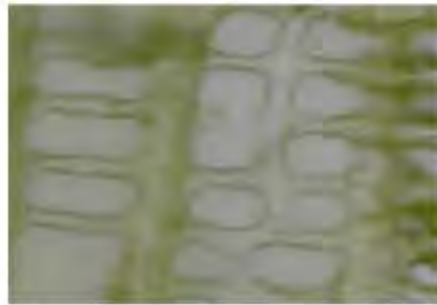
Figure B: Radial View 1 | Observation of the Radial face found ray parenchyma cross-field pitting in the form of large window-like pits with 1-2 per cross-field.

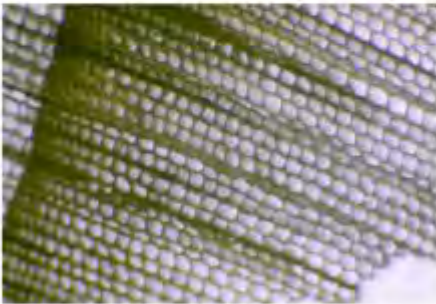
Figure C: Transverse View 1 | Additional analysis of the Transverse face shows distinct growth rings with a gradual EW/LW transition.

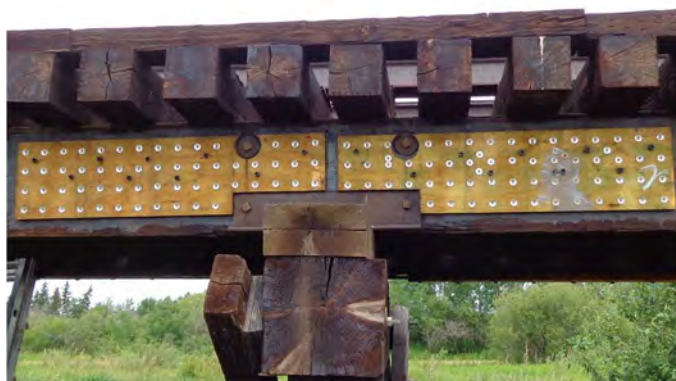
Retroshear™ panels as shear reinforcements for railway stringers.

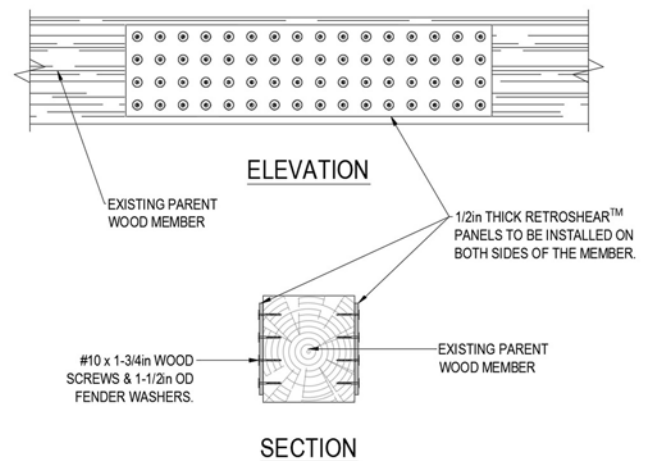
Typical Retroshear™ panel installation.

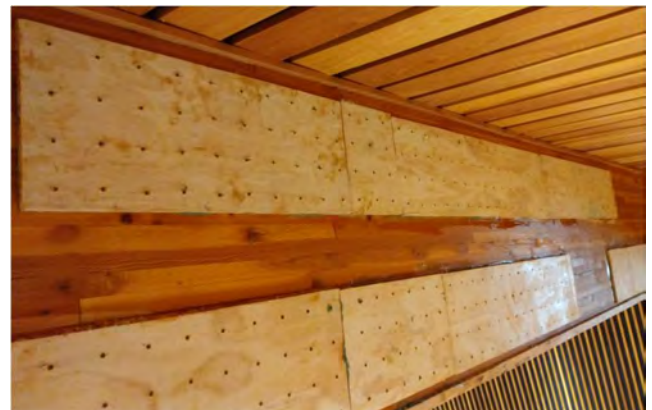
Retroshear™ panels to repair delaminated glulam timber beam.
